## ARBORICULTURAL ASSESSMENT REPORT

<b>For:</b>	<b>Client:</b>	Oriel Services Limited
	<b>Insurer:</b>	Zurich Municipal
<b>Site:</b>	<b>Policyholder:</b>	Camden London Borough Council
	<b>Risk Address:</b>	Camden Arts Centre, Arkwright Road, London, NW3 6DG
<b>Refs:</b>	<b>PRI Ref:</b>	
	<b>Client Ref:</b>	
	<b>Insurer Ref:</b>

<b>Arborist Name:</b>	Edward Clear	<b>Date:</b>	04/09/2019
<b>QC:</b>	Tom Peppiatt	<b>Date:</b>	09/09/2019

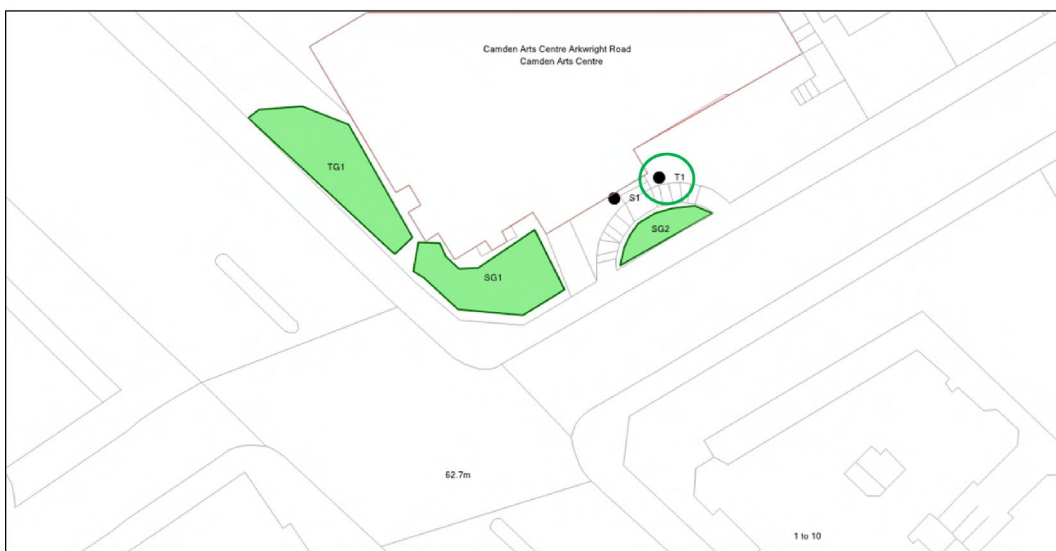
## **7.0 APPENDIX 2: SITE PLAN**

Tree No:	Species	Works Required
SG1	Cherry, elder, Ivy, Privet, Grasses, Buddlia	Fell and treat stumps.
S1	Buddlia	Fell and treat stump.
T1	Cherry	Fell and treat stump.
TG1	Birch, Rowan, Pampas Grass	Remove all shrubs and Rowan tree. No works to remaining group.
