SITE INVESTIGATION FACTUAL REPORT

Report No: [REDACTED]
Client: Sedgwick International UK - Maidstone
Site: Camden Arts Centre, Arkwright Road
Client Ref: [REDACTED]
Date of Visit: 07/05/19

Investigation Layout Plan

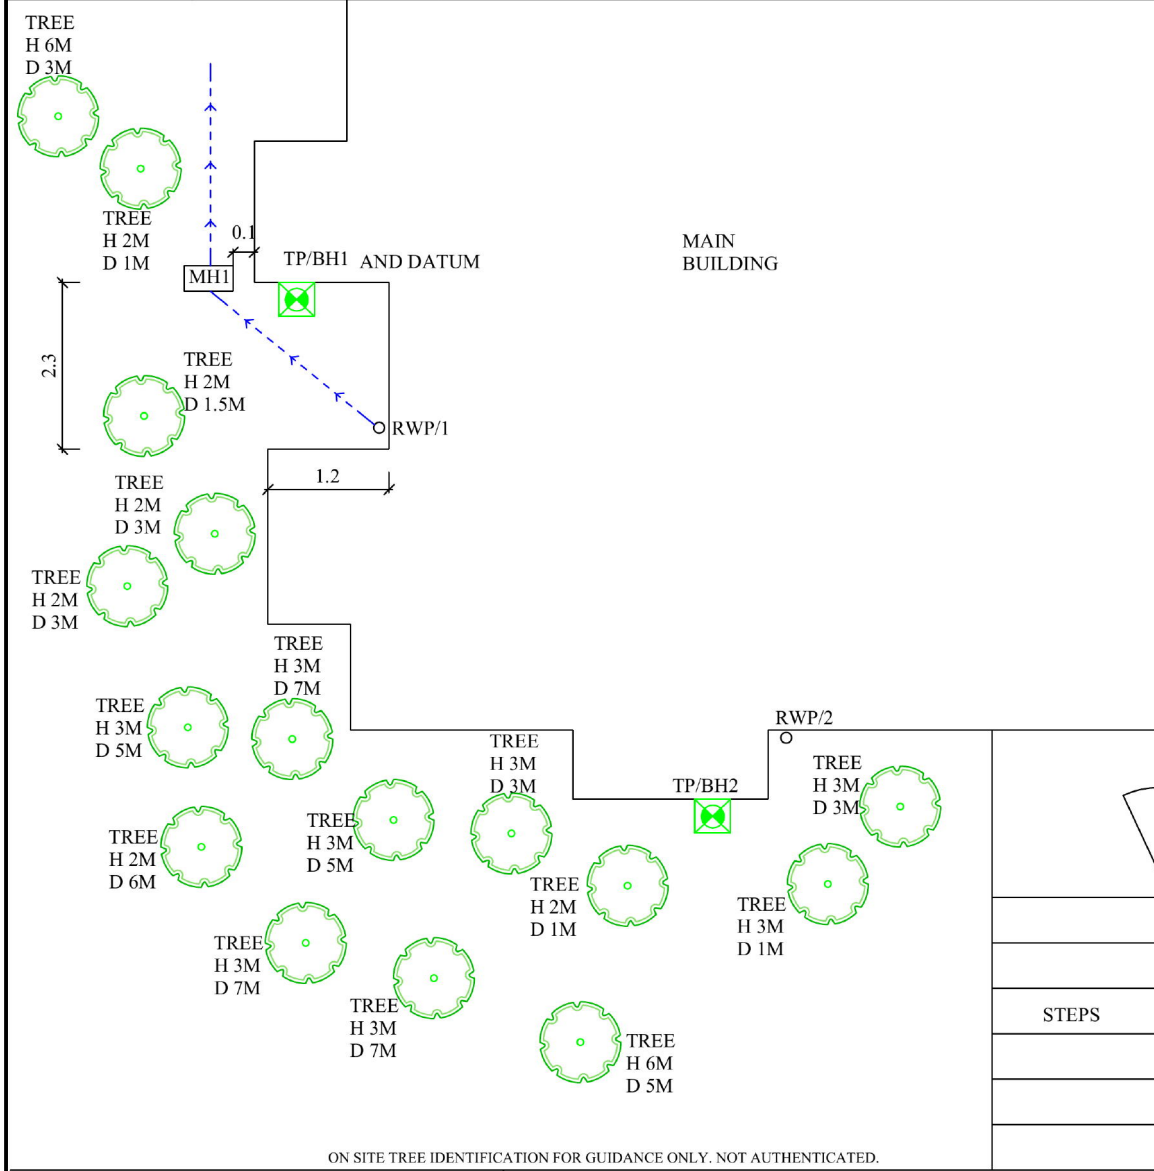
Remarks: RWP/2 OVER 2M AWAY FROM TP2.
DATUM LID HAS ALLEN KEY SCREW
FITTED WILL NEED ONE TO OPEN

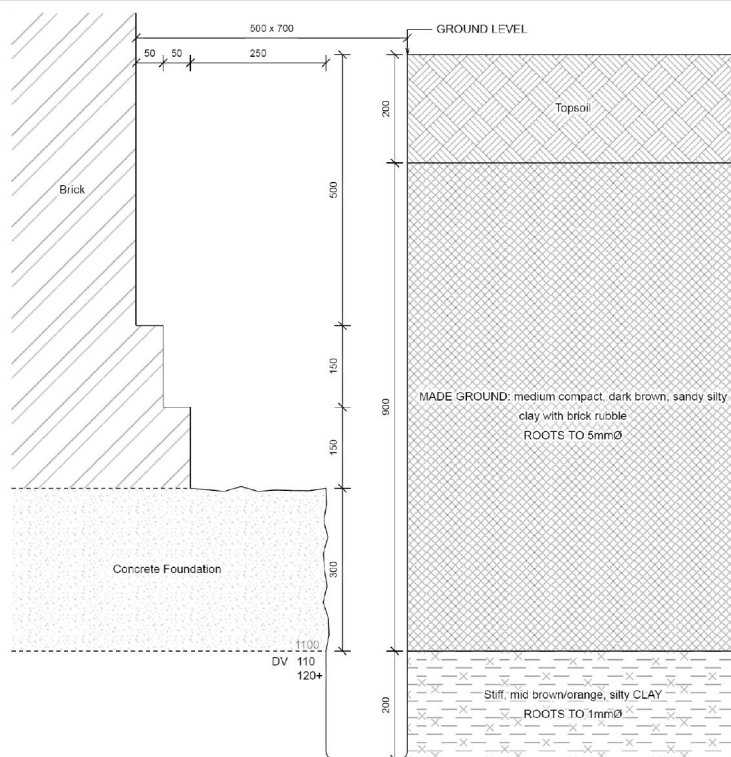
TRIAL PIT REF: TP1

For Strata below 1300mm see Bore Hole log

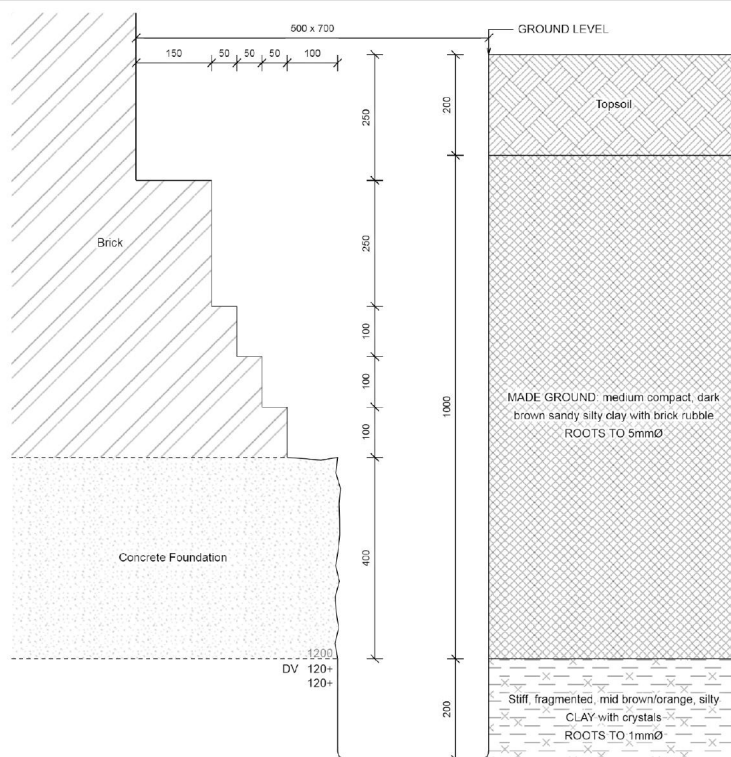
TRIAL PIT REF: TP2

For Strata below 1400mm see Bore Hole log
