TYPE: ENGINEERS PRELIMINARY REPORT
CLAIM: Subsidence

The risk address (1-20 Manor Mansions Belsize Grove London NW3 4NB) is a five storey detached mansion block constructed of traditional materials circa 1890.

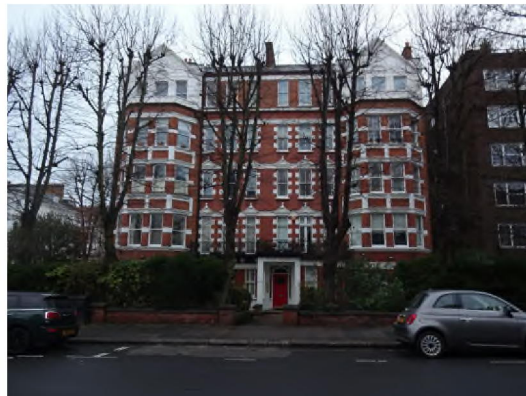
Front elevation of Property
