Pinpoint Drainage Services Ltd

17 Branch Hill Hampstead

21 July 2019

Project Name: 17 Branch Hill Hampstead	Project Number: SJC21719	Date: 21/07/2019	Contact: Karl Zadeh
--	------------------------------------	----------------------------	-------------------------------

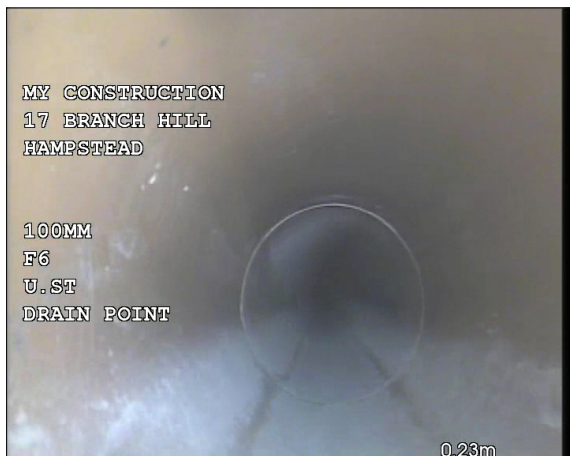
Photo: 1_3A, 00:00:01
0m, Water level, 5% of sewer height

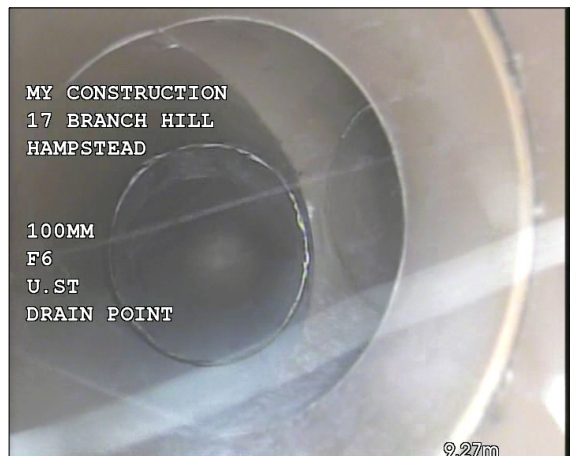
Photo: 1_4A, 00:00:01
9.22m, Junction, at 3 o'clock, 100mm diameter

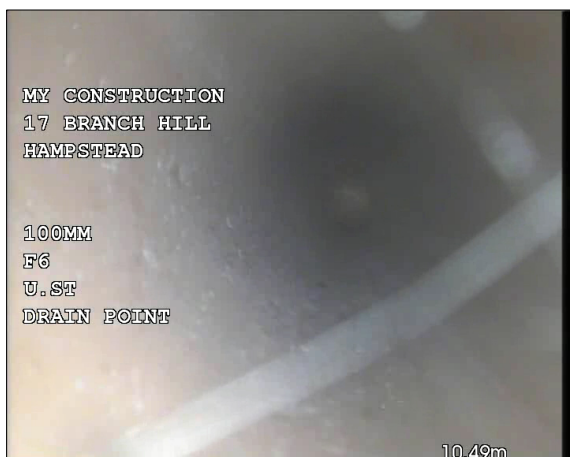
Photo: 1_6A, 00:00:01
10.49m, General observation Remarks: Soil Vent Pipe Reached (SVP)

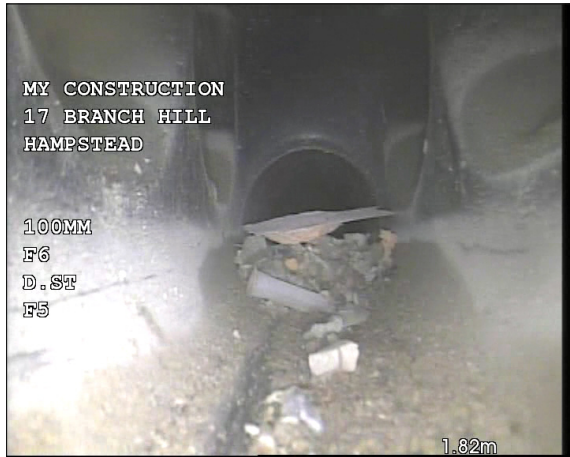
Photo: 2_4A, 00:00:01
1.99m, Manhole Remarks: F5 Reached

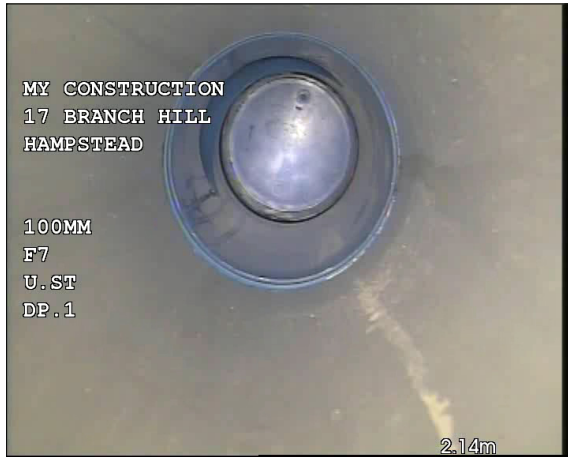
Photo: 3_6A, 00:00:01
2.14m, General observation Remarks: Drain Point 1 Reached

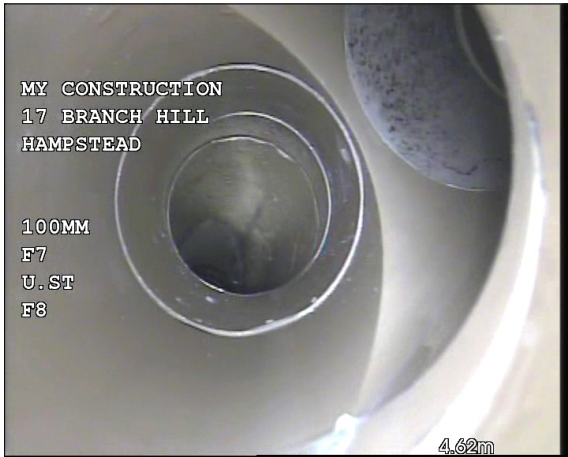
Photo: 4_6A, 00:00:01
4.62m, Junction, at 3 o'clock, 100mm diameter

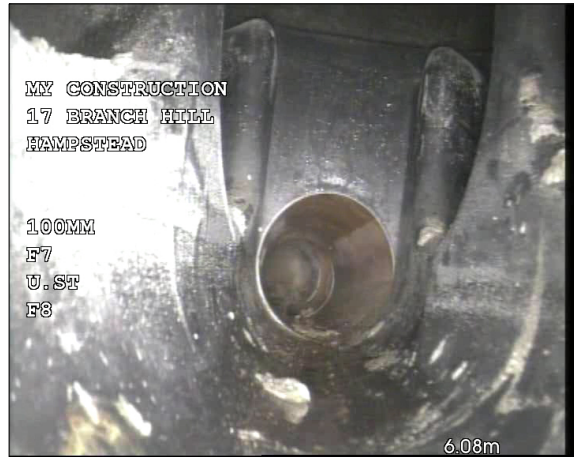
Photo: 4_8A, 00:00:01
6.08m, Manhole Remarks: F8 Reached

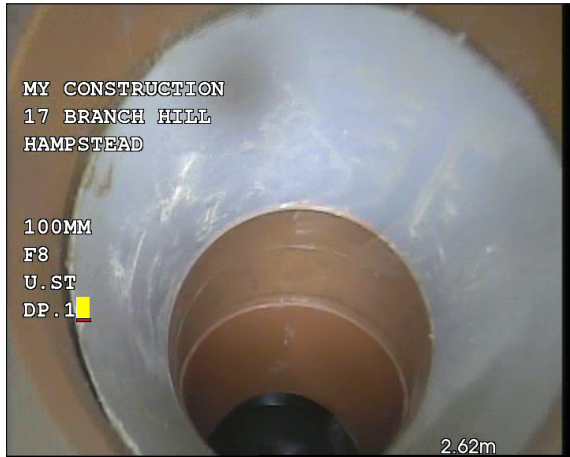
Photo: 5_5A, 00:00:01
2.62m, General observation Remarks: Floor Gully 1 Reached

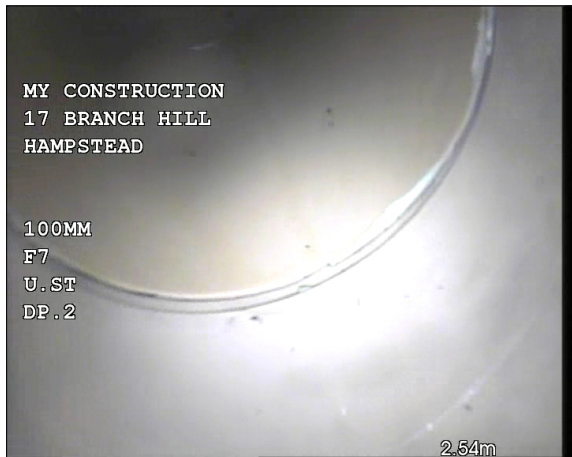
Photo: 6_5A, 00:00:01
2.54m, Line of sewer deviates up

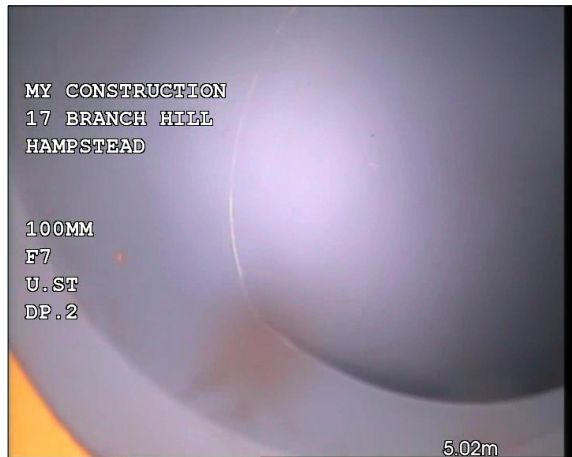
Photo: 6_6A, 00:00:01
5.02m, General observation Remarks: Drain Point 2 Reached

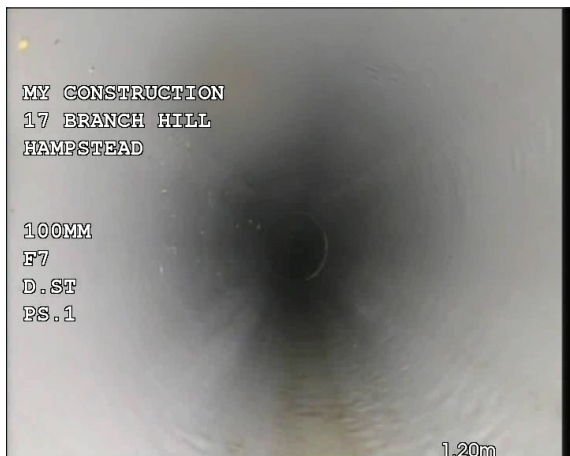
Photo: 7_3A, 00:00:01
0m, Water level, 5% of sewer height

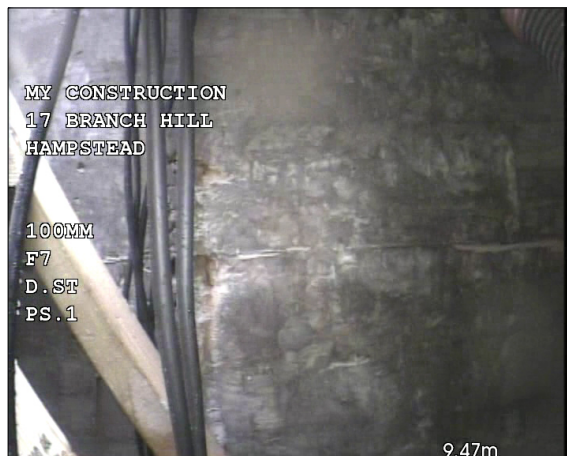
Photo: 7_4A, 00:00:01
9.47m, Manhole Remarks: PS.1 Reached

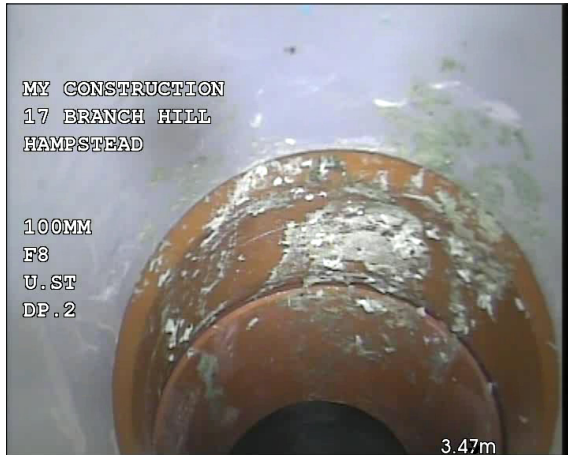
Photo: 8_7A, 00:00:01
3.47m, General observation Remarks: Floor Gully 2 Reached

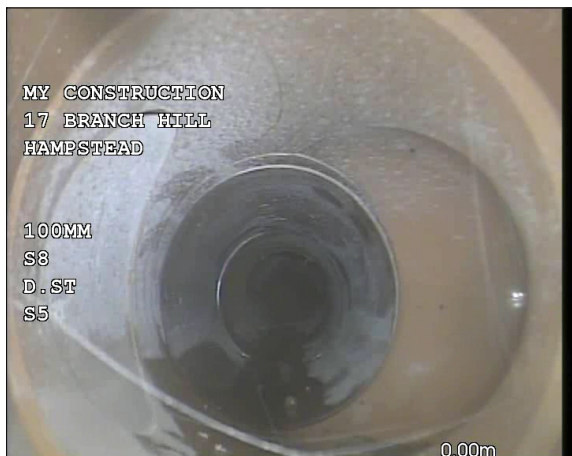
Photo: 11_4A, 00:00:01
0.1m, Junction, at 3 o'clock, 100mm diameter

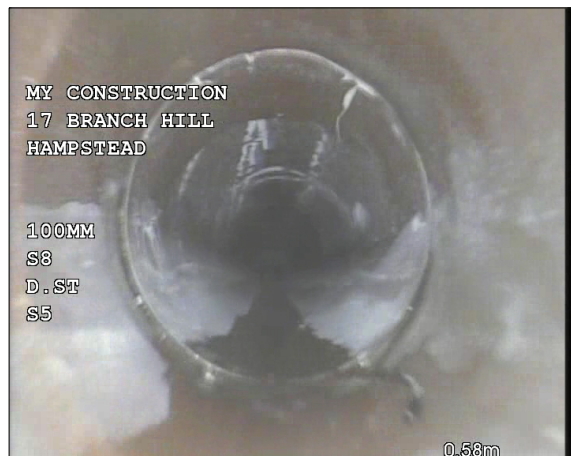
Photo: 11_5A, 00:00:01
0.36m, Junction, at 9 o'clock, 100mm diameter

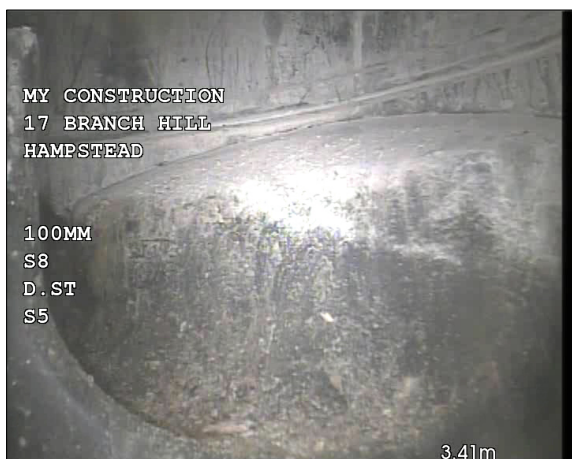
Photo: 11_6A, 00:00:01
3.41m, Manhole Remarks: S5 Reached

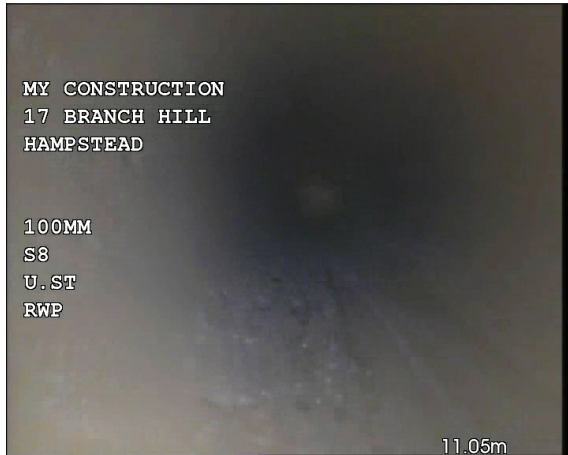
Photo: 12_8A, 00:00:01
11.65m, General observation Remarks: RWP Reached

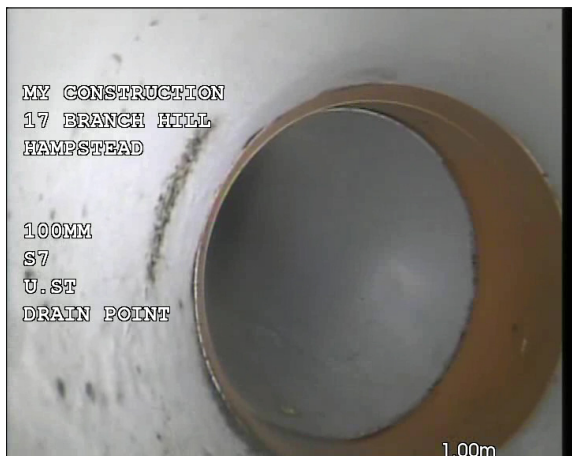
Photo: 13_6A, 00:00:01
1.22m, Line of sewer deviates left

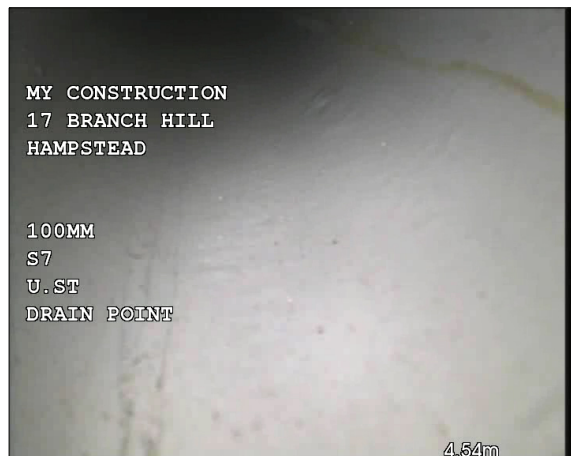
Photo: 13_9A, 00:00:01
4.54m, General observation Remarks: Drain Point Reached

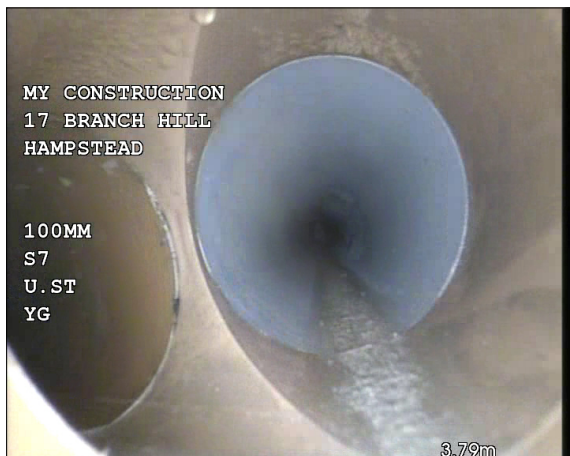
Photo: 14_5A, 00:00:01
3.79m, Junction, at 9 o'clock, 100mm diameter

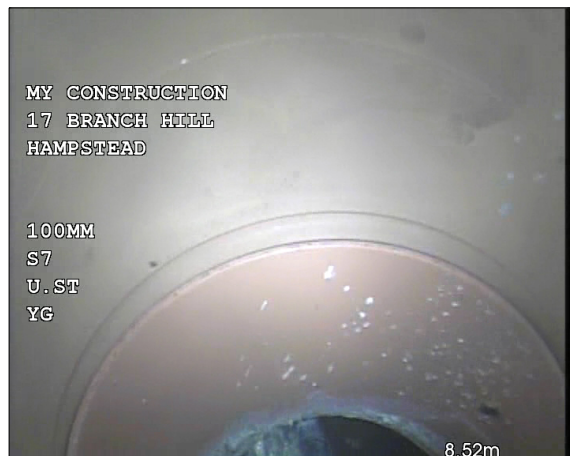
Photo: 14_7A, 00:00:01
8.26m, General observation Remarks: Yard Gully Reached

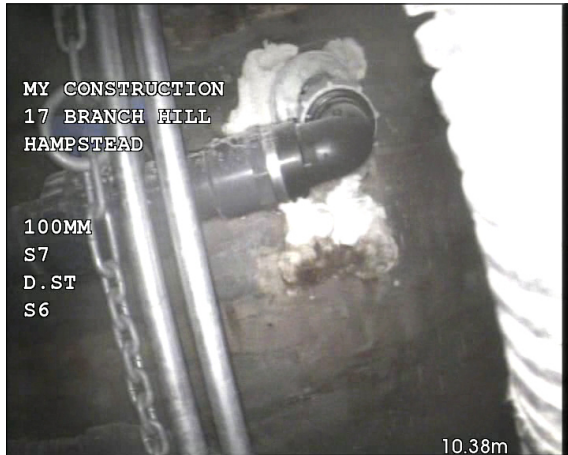
Photo: 15_6A, 00:00:01
10.38m, Manhole Remarks: S6 Reached (PS)

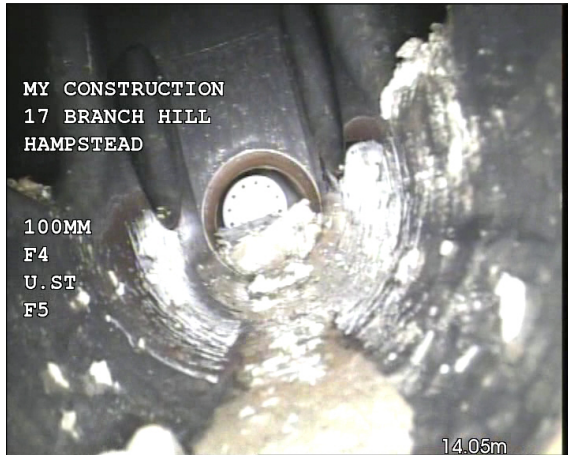
Photo: 16_5A, 00:00:01
14.05m, Manhole Remarks: F5 Reached

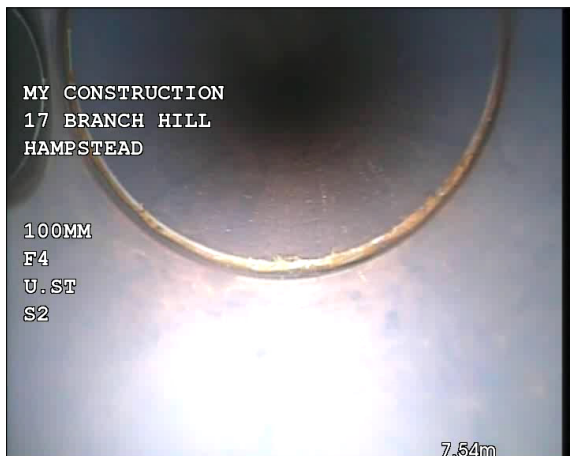
Photo: 17_6A, 00:00:01
7.54m, Manhole Remarks: S2 Reached

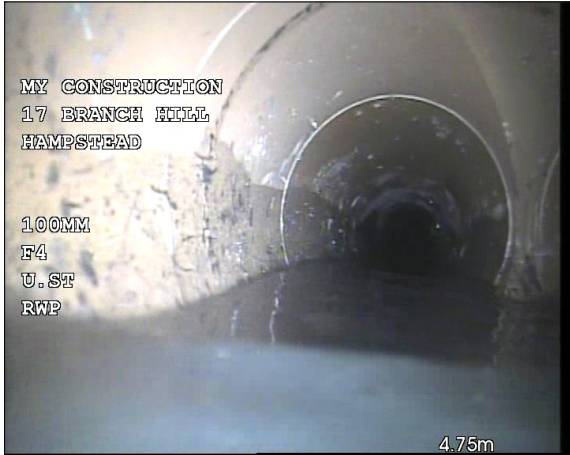
Photo: 18_7A, 00:00:01
4.75m, Junction, at 3 o'clock, 100mm diameter

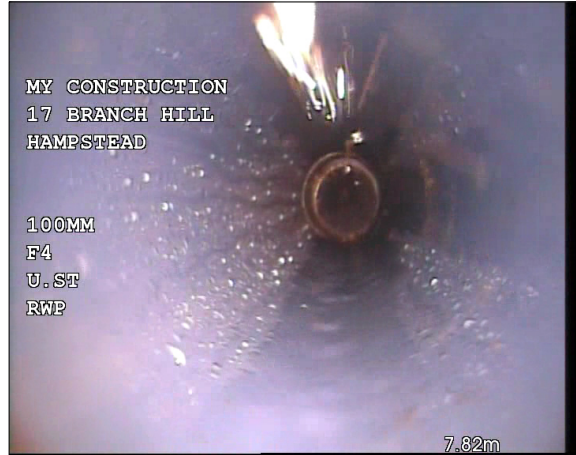
Photo: 18_10A, 00:00:01
7.82m, General observation Remarks: Rain Water Pipe Reached

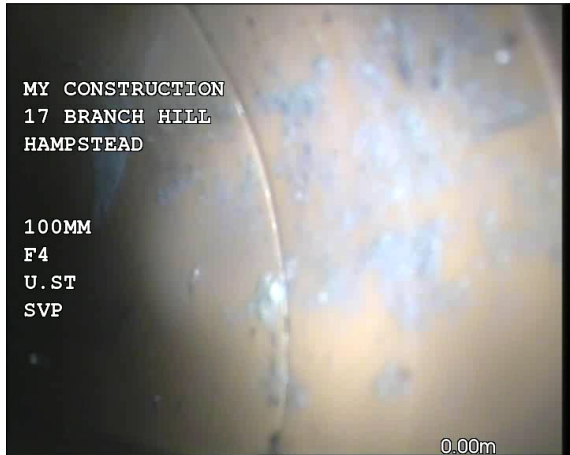
Photo: 19_11A, 00:00:01
15.15m, General observation Remarks: Soil Vent Pipe Reached

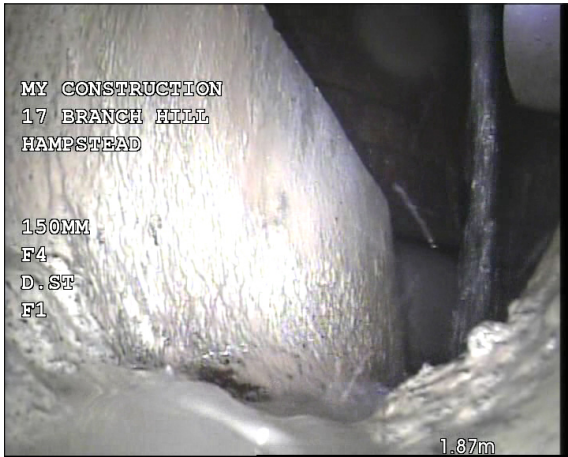
Photo: 20_4A, 00:00:01
1.87m, Manhole Remarks: F1 Reached

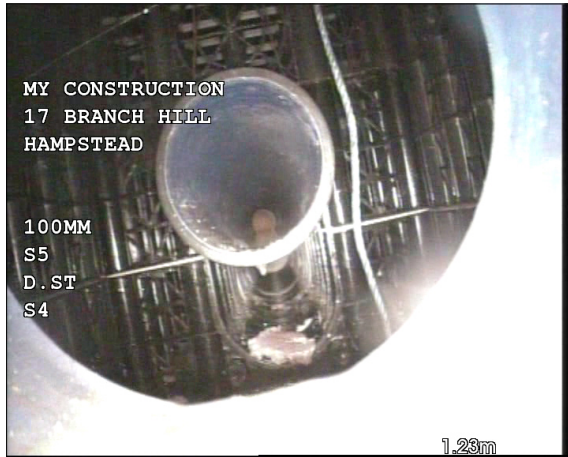
Photo: 21_5A, 00:00:01
1.23m, Manhole Remarks: S4 Reached
