Arboricultural Appraisal Report

Subsidence Damage Investigation at:

13 Arkwright Road
London
NW3 6AA

CLIENT: Crawford & Company
 CLIENT REF: [REDACTED]
 MWA REF: [REDACTED]
 MWA CONSULTANT: George Peters BSc. (Hons), M.Arbor.A
 REPORT DATE: 18/07/2019

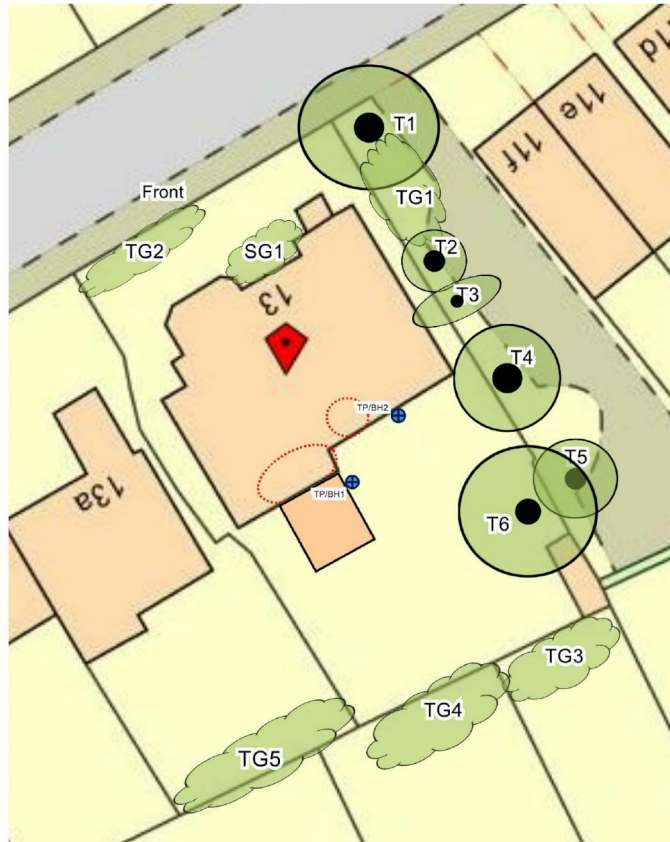
Site Plan

Approximate areas of damage

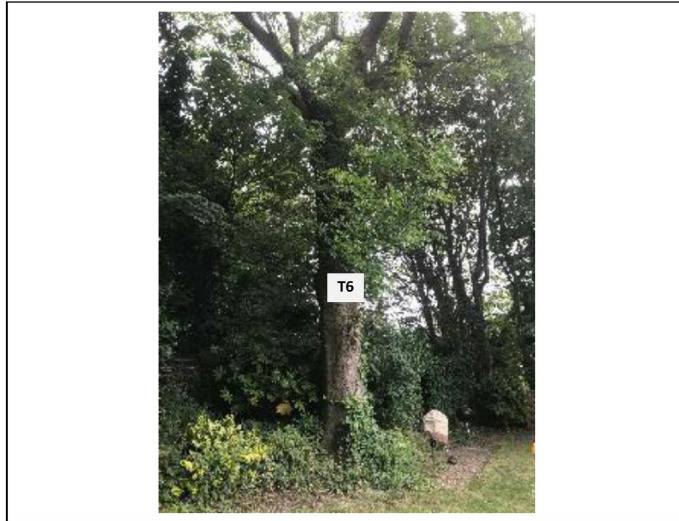
Roots were observed to a depth of 2500mm bgl in TP/BH1 and TP/BH2, recovered samples have been positively identified (using anatomical analysis) as *Fraxinus* spp., the origin of which will be T6 (Ash) confirming its influence on the soils below the foundations.

Based on the technical reports currently available, engineering opinion and our own site assessment we conclude the damage is consistent with shrinkage of the clay subsoil related to moisture abstraction by vegetation. Having considered the information currently available, it is our opinion that T6 is the principal cause of or is materially contributing to the current subsidence damage.

View of T6 Ash, current claim.

If an arboricultural solution is to be implemented to mitigate the influence of the implicated trees/vegetation we recommend that T6 is removed. Other vegetation recorded presents a potential future risk to building stability and management is therefore recommended. Prior to removing T6, the construction date of the conservatory extension to the rear of the property should be confirmed as the tree may predate this structure.

Tree No.	Species	Ht (m)	Dia (mm)	Crown Spread (m)	Dist. to building (m)	Age Classification	Ownership
T6	Ash	16	600 *	14	9	Younger than Property	Policy Holder
Management history		Subject to past management/pruning.					
Recommendation		Remove (fell) to near ground level and treat stump to inhibit regrowth.

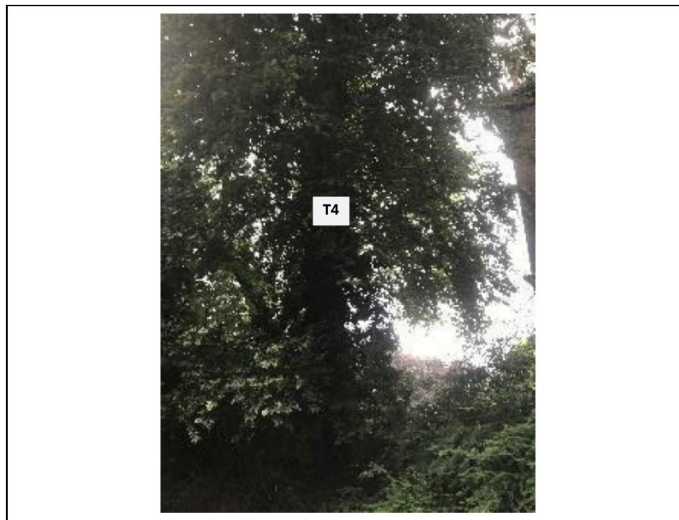
Consideration has been afforded to T4 (Beech) and its possible contribution to the current claim damage, which is currently deemed equivocal. Should movement persist following recommended removals, the future of this tree should be considered further.

View of T4 Beech, future risk.

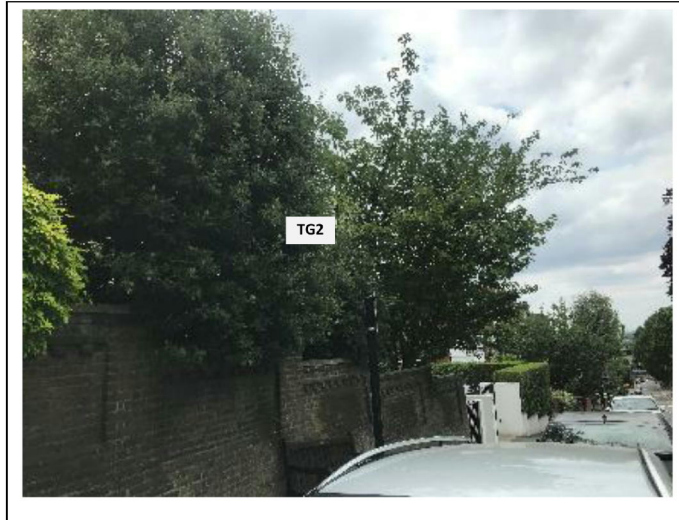
View of TG2 mixed species, future risk.

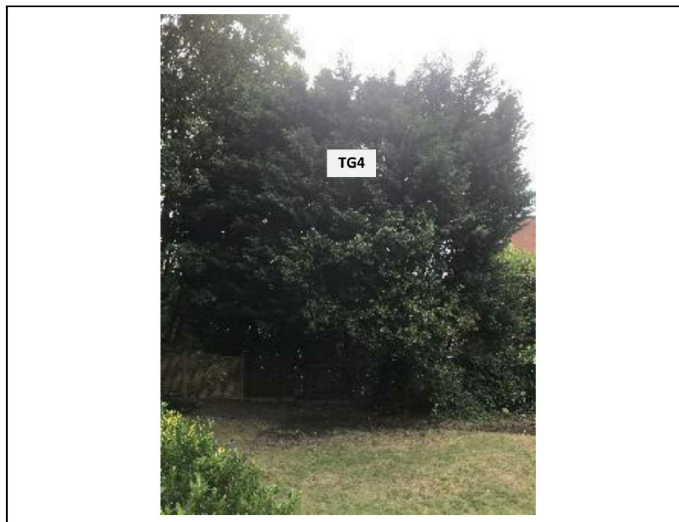
View of TG4 Cypress, future risk.

Tree No.	Species	Ht (m)	Dia (mm)	Crown Spread (m)	Dist. to building (m)	Age Classification	Ownership
TG1	Species include Hazel and Elder	6	100	8	2	Younger than Property	Third Party: 11f Arkwright Road NW3 6AA
Management history		Subject to past management/pruning.					
Recommendation		Maintain broadly at no more than current dimensions by periodic pruning.					
TG2	Cherry and Holm Oak	5	190 Ms *	8	4	Younger than Property	Policy Holder
Management history		Subject to past management/pruning.					
Recommendation		Maintain broadly at no more than current dimensions by periodic pruning.					
TG3	Sycamore	16	400 Ms *	9	21	Younger than Property	Third Party: 47c Netherhall Gdns NW3 5RJ
Management history		No recent management noted.					
Recommendation		Maintain broadly at no more than current dimensions by periodic pruning.					
TG4	Cypress	8	300 Ms *	10	12 *	Younger than Property	Third Party: 47b Netherhall Gdns NW3 5RJ

Management history		No recent management noted.					
Recommendation		Maintain broadly at no more than current dimensions by periodic pruning.					
TG5	Beech	9.4	300 *	18	14	Younger than Property	Third Party: 13a Arkwright Road NW3 6AA
Management history		No past management noted.					
Recommendation		Maintain broadly at no more than current dimensions by periodic pruning.
