**TECHNICAL REPORT ON A SUBSIDENCE CLAIM**

**Welford House  
13 Arkwright Road  
London  
NW3 6AA**

DATE 30 November 2018

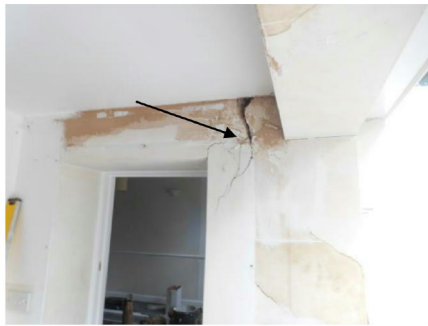
Cracks around door – conservatory/kitchen area leading to the rear right lounge

Cracks above right of door way to rear right hand lounge

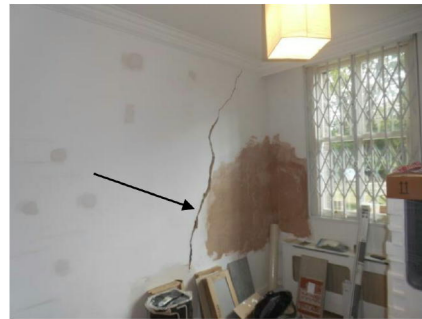
Structural crack to left partition in the rear middle room

Diagonal crack to left partition 5 to 50mm

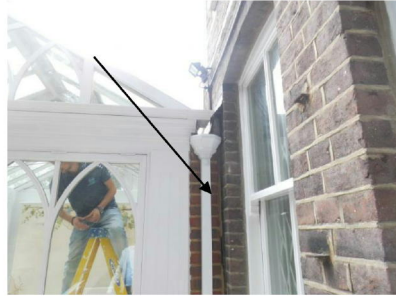
Vertical upward tapering crack at junction of the conservatory

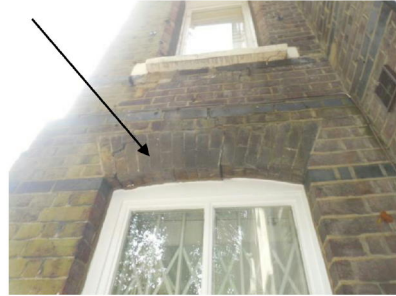
Damage to brick arch

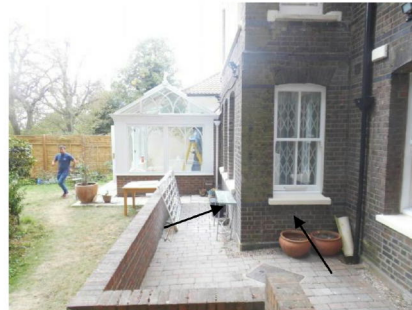
Bay structure and conservatory seen from the left – damage to brickwork at low level

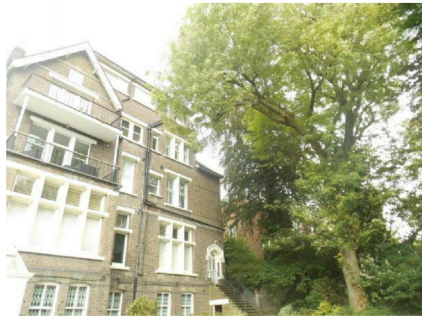
Nearby tree to the rear T1

Although the cause of the movement needs to be dealt with, we note the vegetation is subject to a Preservation Order. Unfortunately, current legislation requires certain investigations to be carried out to support an application for the tree works.

It will also be necessary to obtain a specialist Arboricultural Report.

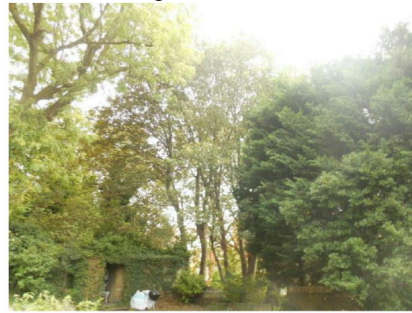
Neighbouring trees T2, T3 and T4
