DR WILLIAMS'S LIBRARY- 14 Gordon Square, London WC1H 0AR

CONDITION SURVEY | OCTOBER 2019

8555-CPM- ZZ-ZZ-RP-A-10004_P01

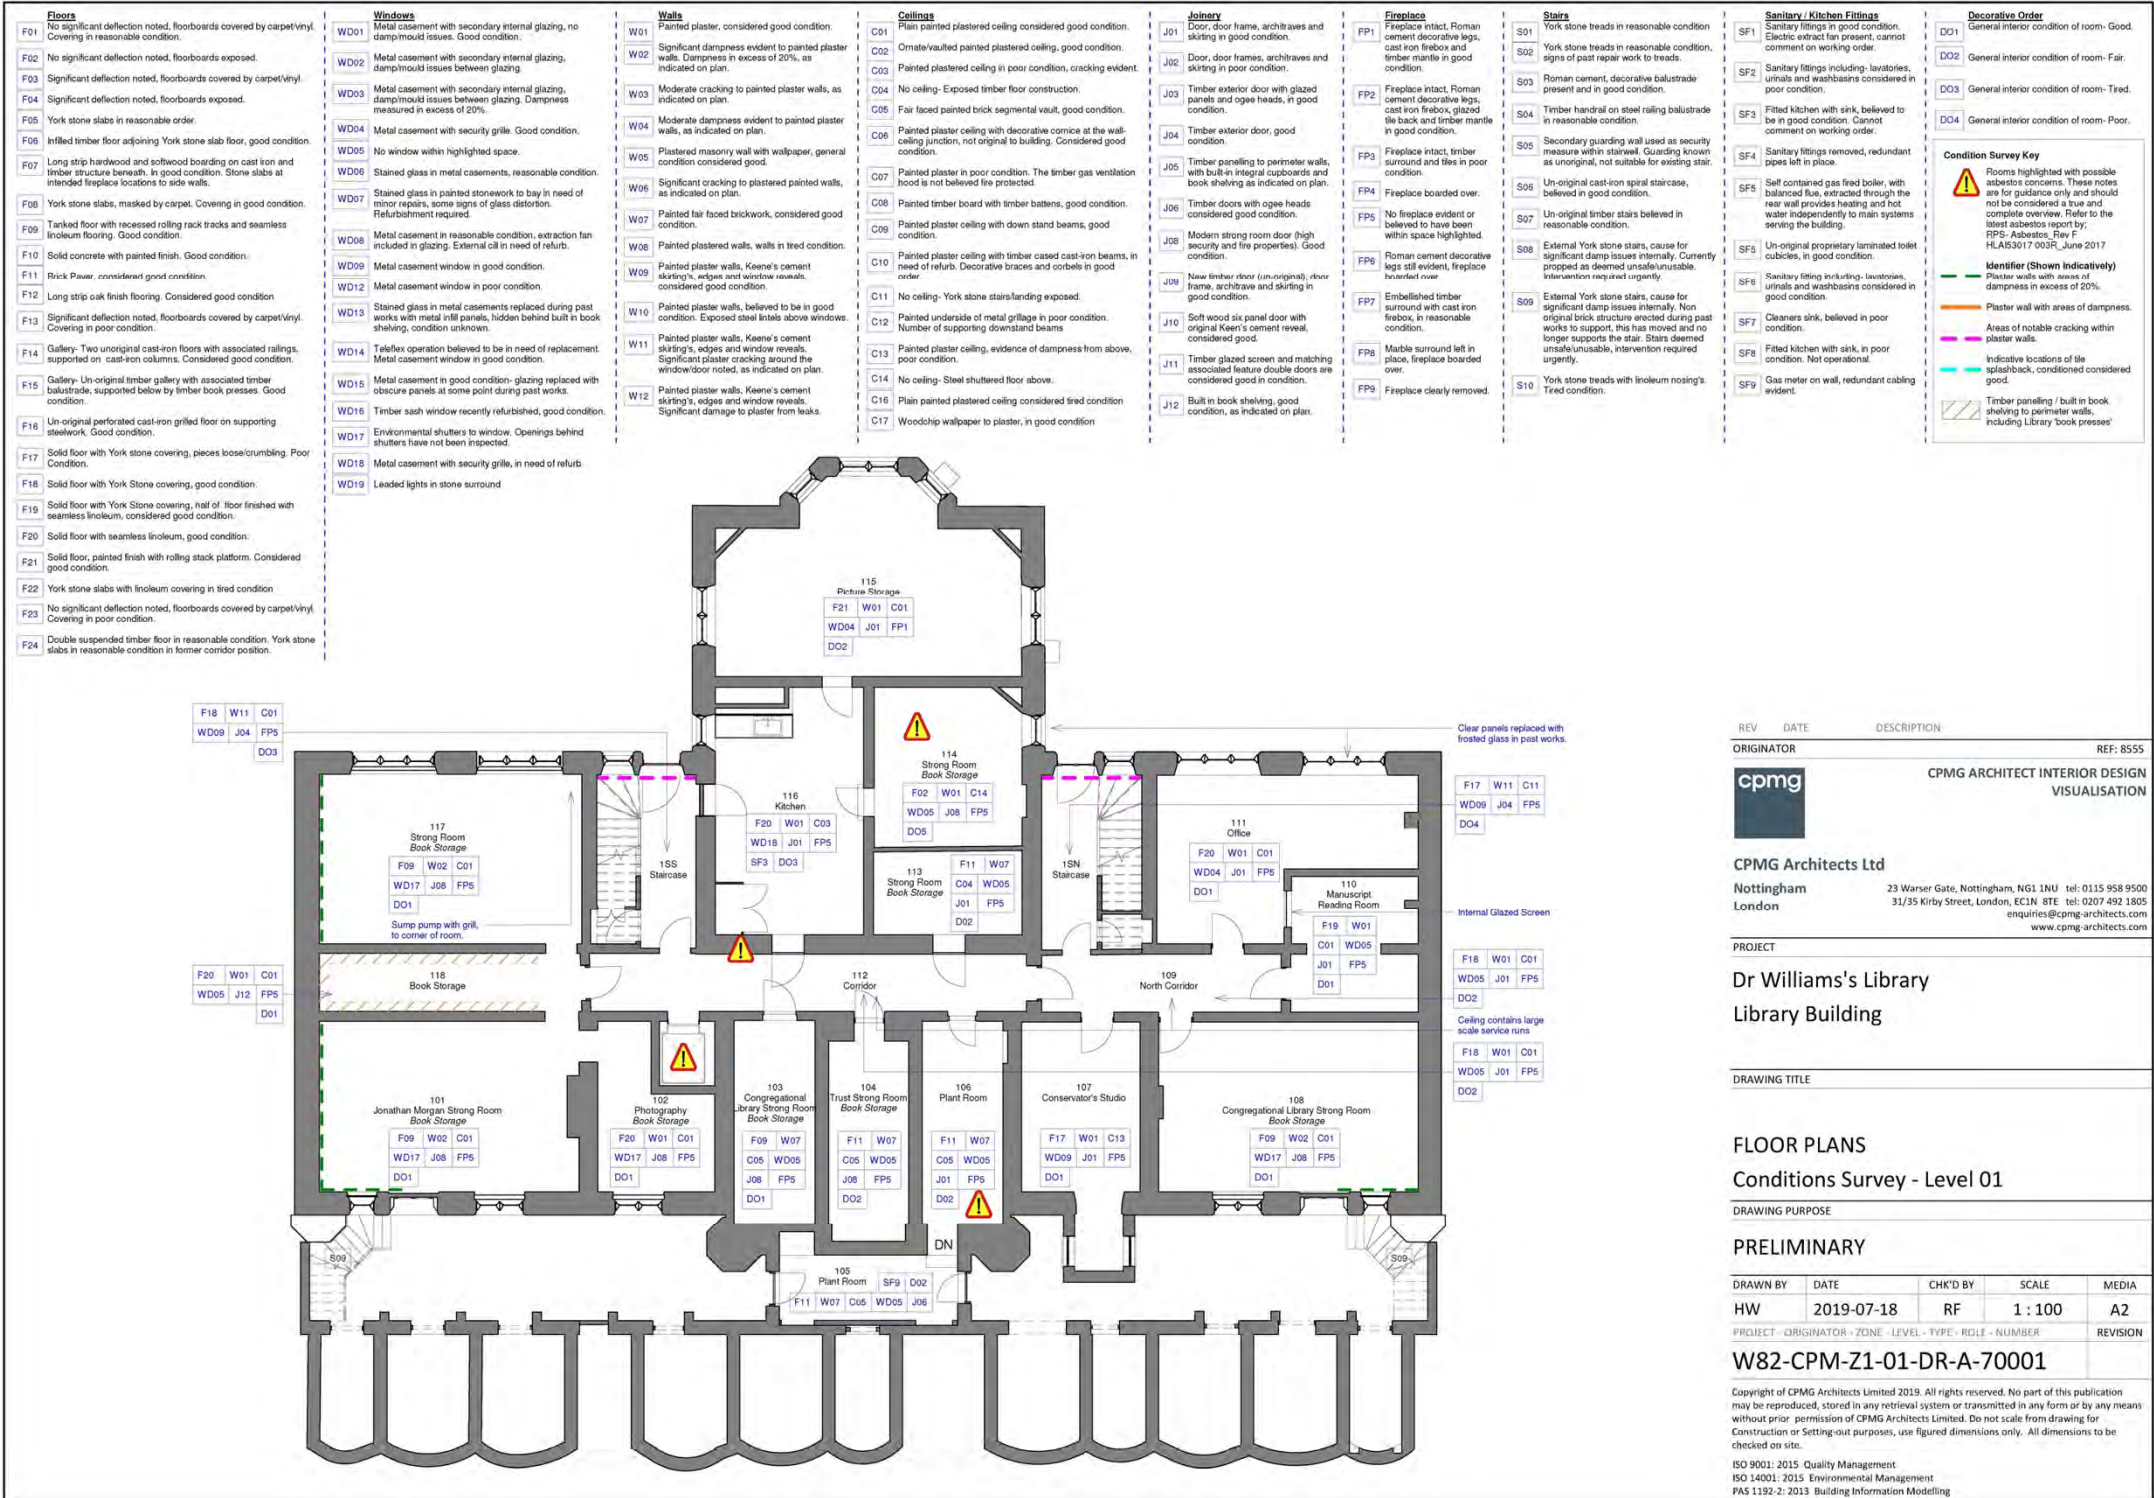
F17 Solid floor with York stone covering, pieces loose/crumbling, poor condition.

F18 Solid floor with York Stone covering, good condition.

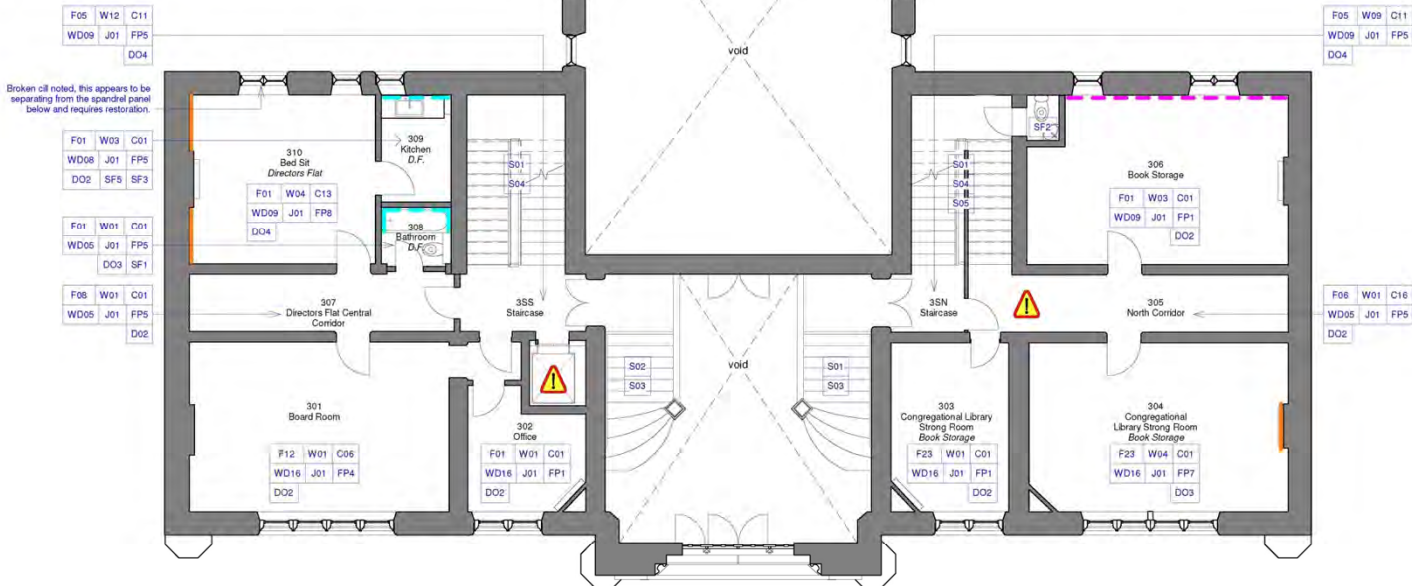
Broken oil noted, this appears to be separating from the spandrel panel below and requires restoration.
