Re-inspection (Material Only) Asbestos Survey

**Dr. Williams's Library
14 Gordon Square
London
WC1H 0AR**

Report Ref: HLA153017/003R

June 2017

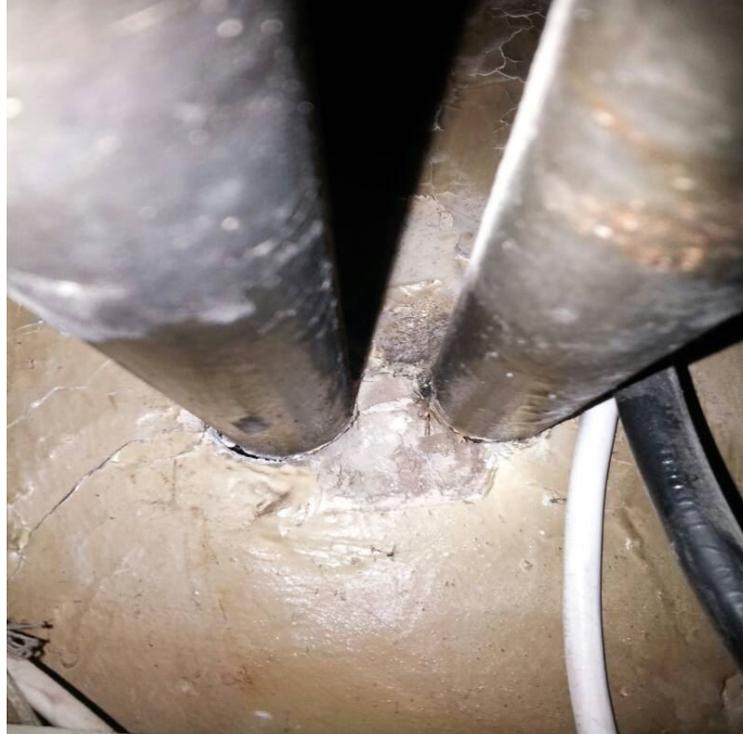
Material Risk	Priority Risk	Risk Assessment
10	-	10/A

Recommendations	Action Date
<i>Seal gap around pipe penetrations leading to wall cavity and label appropriately. Re-inspect at recommended intervals.</i>	13/11/2017

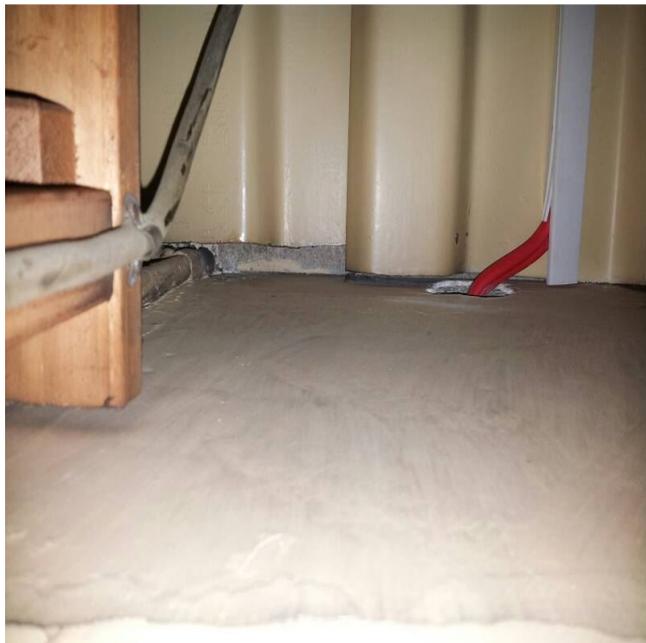
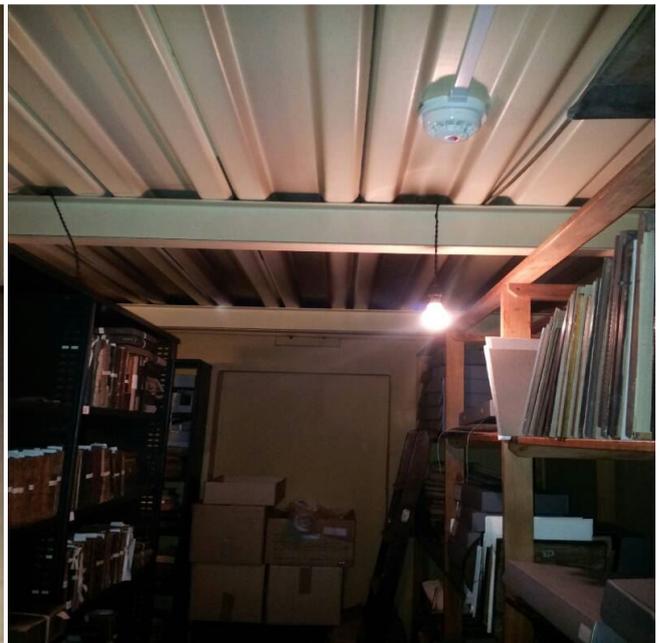
Site:	Dr. Williams's Library	Date of Survey:	17th May 2017
Building:		Survey Conducted By:	Michael Page (Lead)
Floor:	Basement		
Room Ref:	-1/010 Archive	Sample No:	B507787B
Form:	Cement Products	Lab Analysis Result:	Chrysotile
Extent:	18 sqm		
Location:	Ceiling panels above metal ceiling

Total Scores		
Material Risk	Priority Risk	Risk Assessment
3	-	3/D

Recommendations	Action Date
<i>Re-inspect at recommended intervals.</i>	17/05/2018

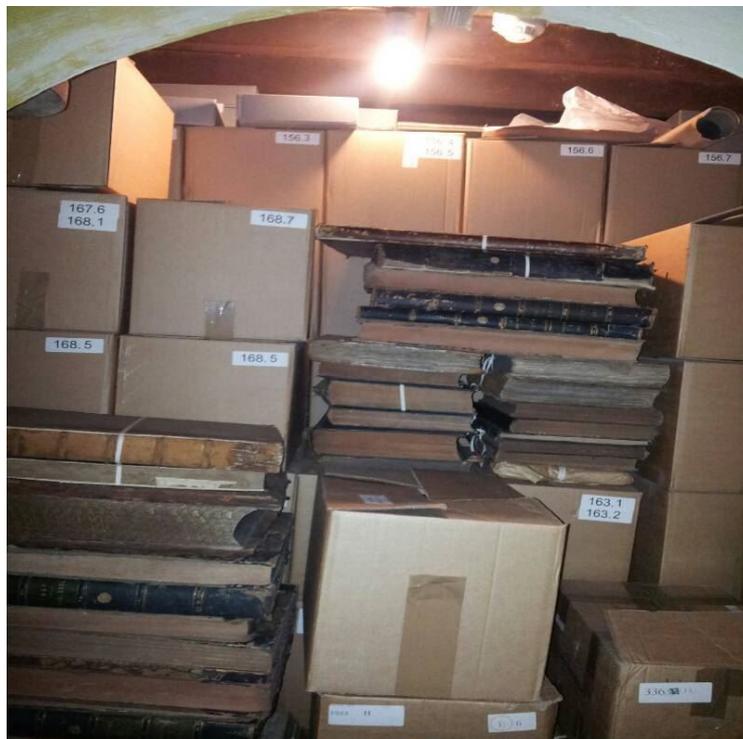
Site:	Dr. Williams's Library	Date of Survey:	17th May 2017
Building:		Survey Conducted By:	Michael Page (Lead)
Floor:	Basement		
Room Ref:	-1/011 Store	Sample No:	-
Form:	-	Lab Analysis Result:	Presumed
Extent:	-		
Location:	Access limited by stored items

Total Scores		
Material Risk	Priority Risk	Risk Assessment
-	-	TBC

Recommendations	Action Date
<i>Non-accessed area. This area should be regarded as containing asbestos until assessed by a competent person.</i>	Before Works

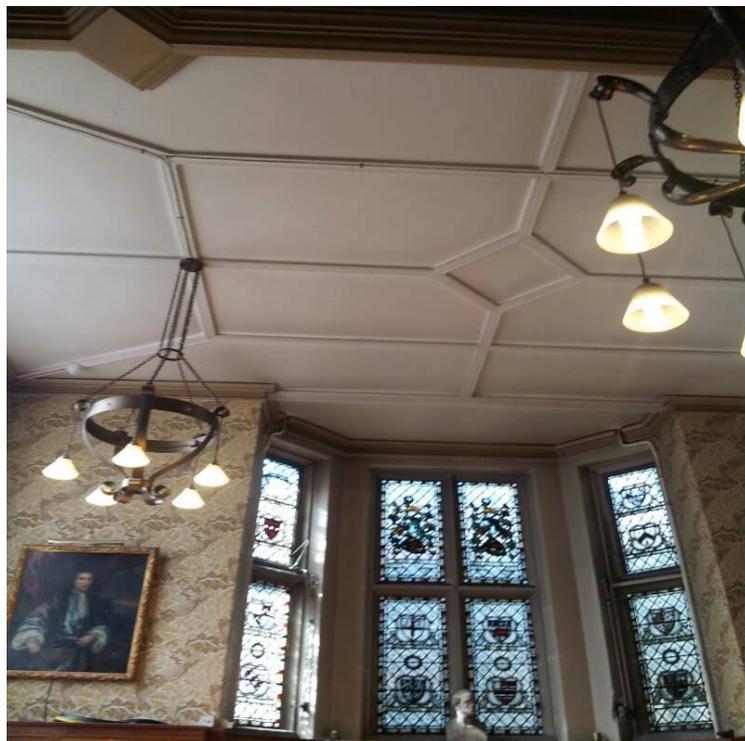
Site:	Dr. Williams's Library	Date of Survey:	17th May 2017
Building:		Survey Conducted By:	Michael Page (Lead)
Floor:	Ground Floor		
Room Ref:	0/009 Lecture Hall		
Form:	-	Sample No:	-
Extent:	-	Lab Analysis Result:	Presumed
Location:	No access to high level ceiling

Total Scores		
Material Risk	Priority Risk	Risk Assessment
-	-	TBC

Recommendations	Action Date
<i>Non-accessed area. This area should be regarded as containing asbestos until assessed by a competent person.</i>	Before Works

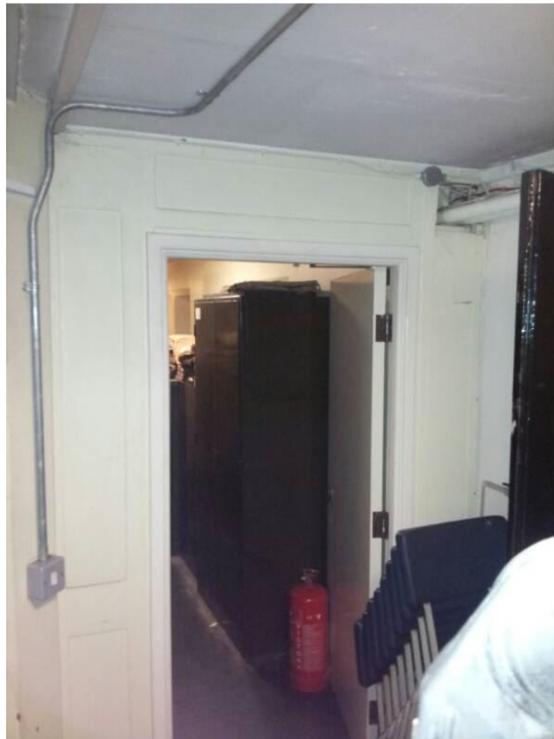
Site:	Dr. Williams's Library	Date of Survey:	17th May 2017
Building:		Survey Conducted By:	Michael Page (Lead)
Floor:	Ground Floor		
Room Ref:	0/010 Stair lobby	Sample No:	B507796B
Form:	Insulating Board Products	Lab Analysis Result:	Amosite, Chrysotile
Extent:	2 sqm		
Location:	Door surround panels

Total Scores		
Material Risk	Priority Risk	Risk Assessment
5	-	5/C

Recommendations	Action Date
<i>Re-inspect at recommended intervals.</i>	17/05/2018

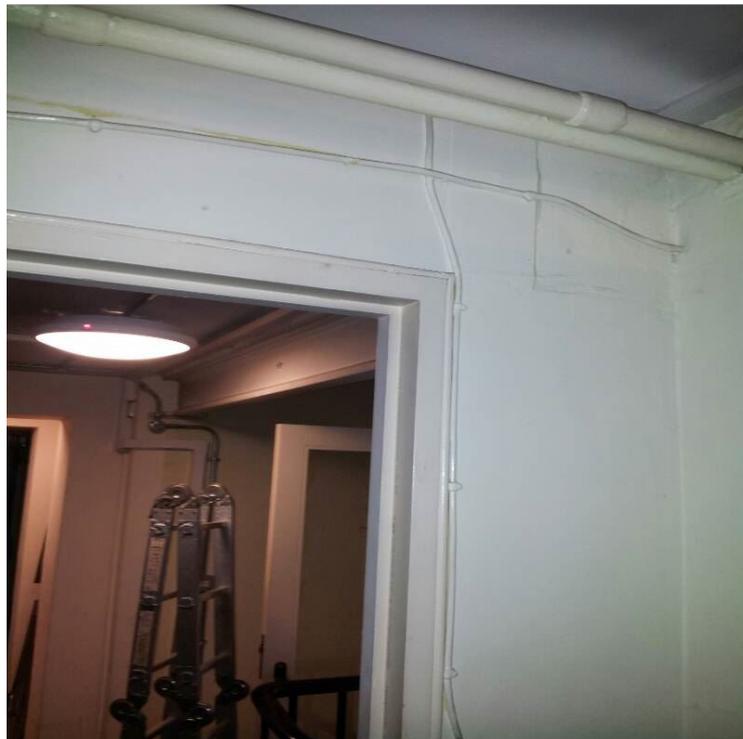
Site:	Dr. Williams's Library	Date of Survey:	17th May 2017
Building:		Survey Conducted By:	Michael Page (Lead)
Floor:	Ground Floor		
Room Ref:	0/011 Corridor	Sample No:	As B507796B
Form:	Insulating Board Products	Lab Analysis Result:	Amosite, Chrysotile
Extent:	2 sqm		
Location:	Door surround panels

Total Scores		
Material Risk	Priority Risk	Risk Assessment
5	-	5/C

Recommendations	Action Date
<i>Re-inspect at recommended intervals.</i>	17/05/2018

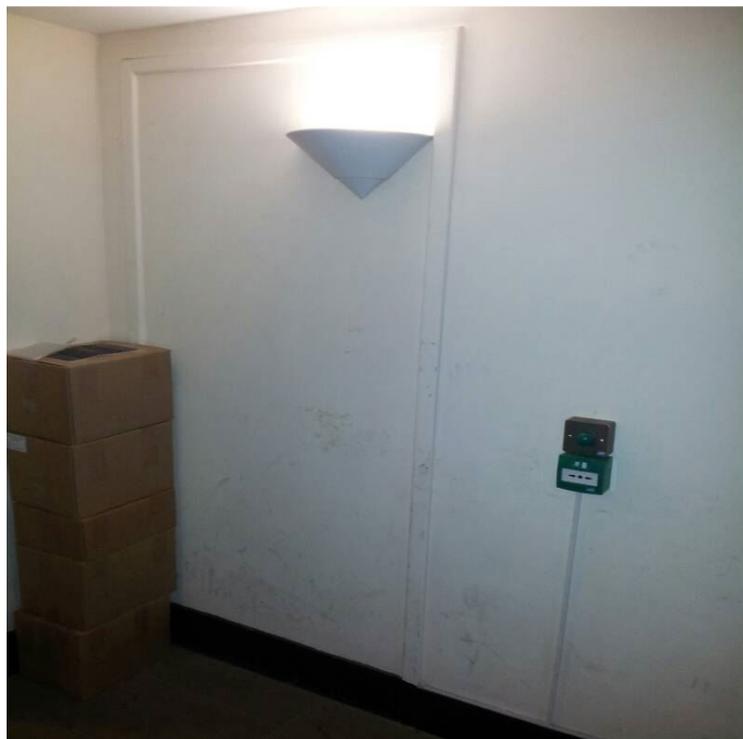
Site:	Dr. Williams's Library	Date of Survey:	17th May 2017
Building:		Survey Conducted By:	Michael Page (Lead)
Floor:	Ground Floor		
Room Ref:	0/015 Store		
Form:	Insulating Board Products	Sample No:	As B507797B
Extent:	2 sqm	Lab Analysis Result:	Amosite, Chrysotile
Location:	Insulating board panel to wall behind book shelves

Recommendations	Action Date
<i>Re-inspect at recommended intervals.</i>	17/05/2018

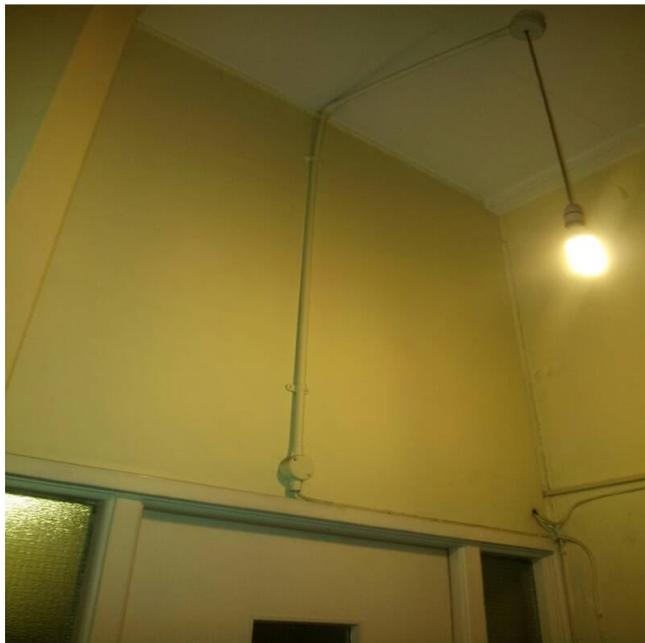
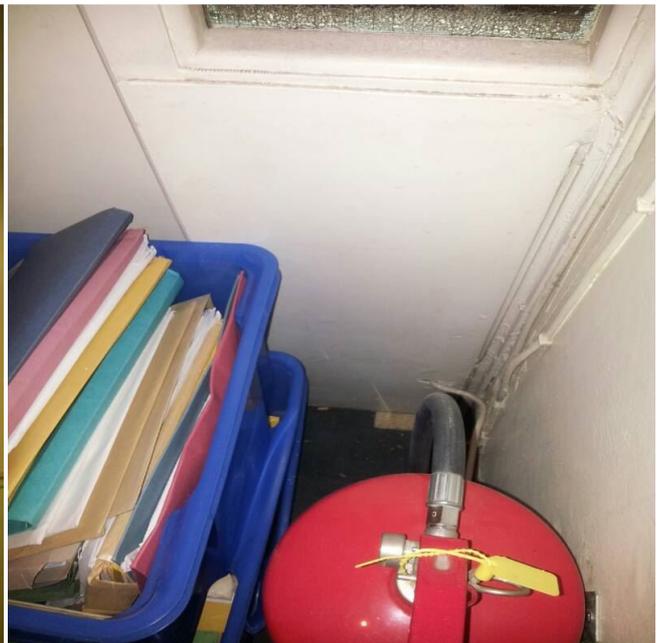
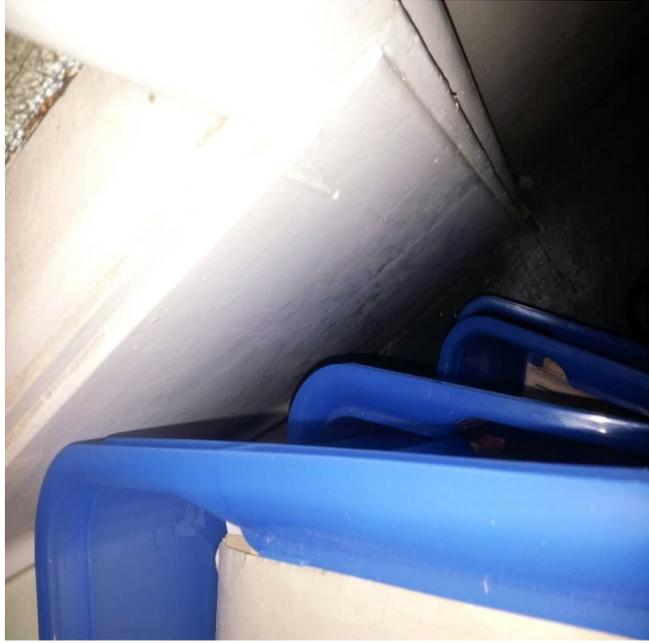
Site:	Dr. Williams's Library	Date of Survey:	17th May 2017
Building:		Survey Conducted By:	Michael Page (Lead)
Floor:	First Floor		
Room Ref:	1/005 Stair lobby	Sample No:	As B507796B
Form:	Insulating Board Products	Lab Analysis Result:	Amosite, Chrysotile
Extent:	4 sqm		
Location:	Door surround panels and panel above door

Total Scores		
Material Risk	Priority Risk	Risk Assessment
6	-	6/C

Recommendations	Action Date
<i>Re-inspect at recommended intervals.</i>	17/05/2018

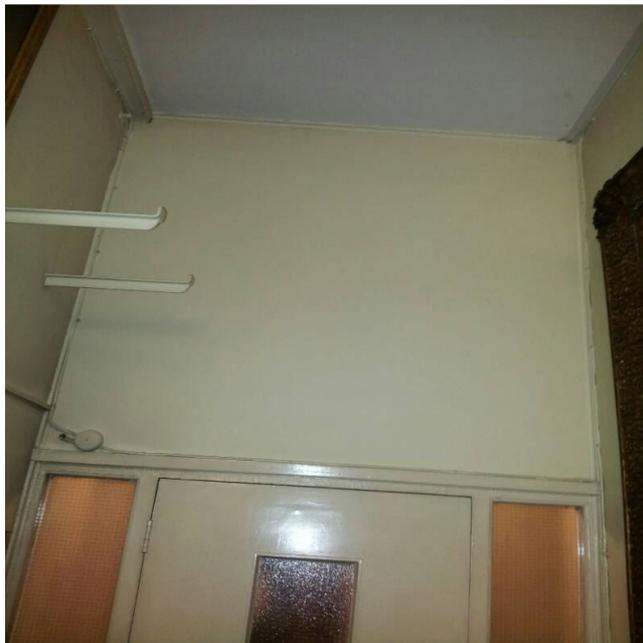
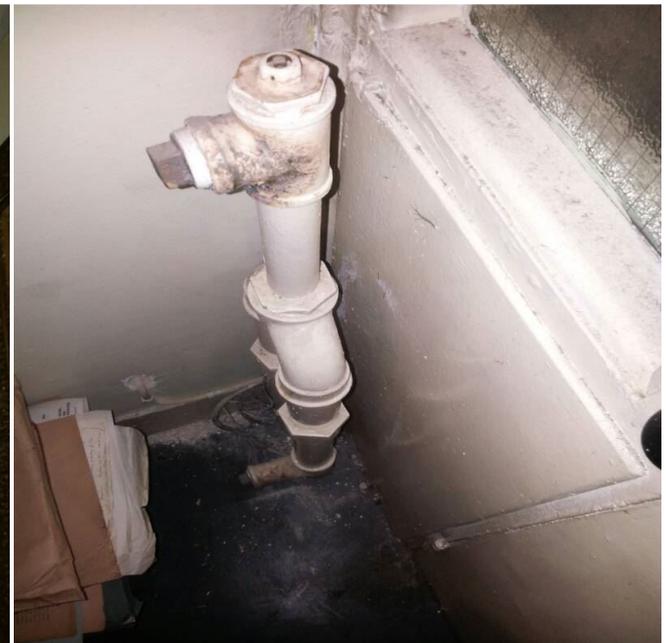
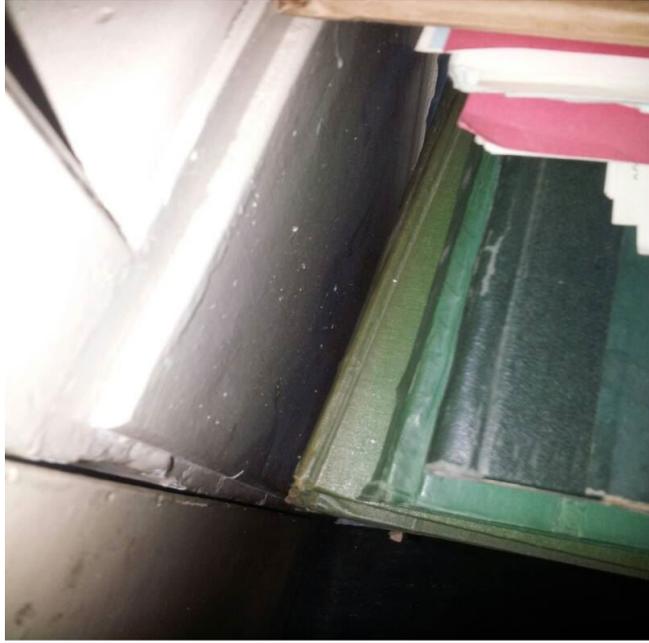
Site:	Dr. Williams's Library	Date of Survey:	17th May 2017
Building:		Survey Conducted By:	Michael Page (Lead)
Floor:	First Floor		
Room Ref:	1/006 Corridor	Sample No:	As B507796B
Form:	Insulating Board Products	Lab Analysis Result:	Amosite, Chrysotile
Extent:	4 sqm		
Location:	Door surround panels and panel above door

Total Scores		
Material Risk	Priority Risk	Risk Assessment
6	-	6/C

Recommendations	Action Date
<i>Re-inspect at recommended intervals.</i>	17/05/2018

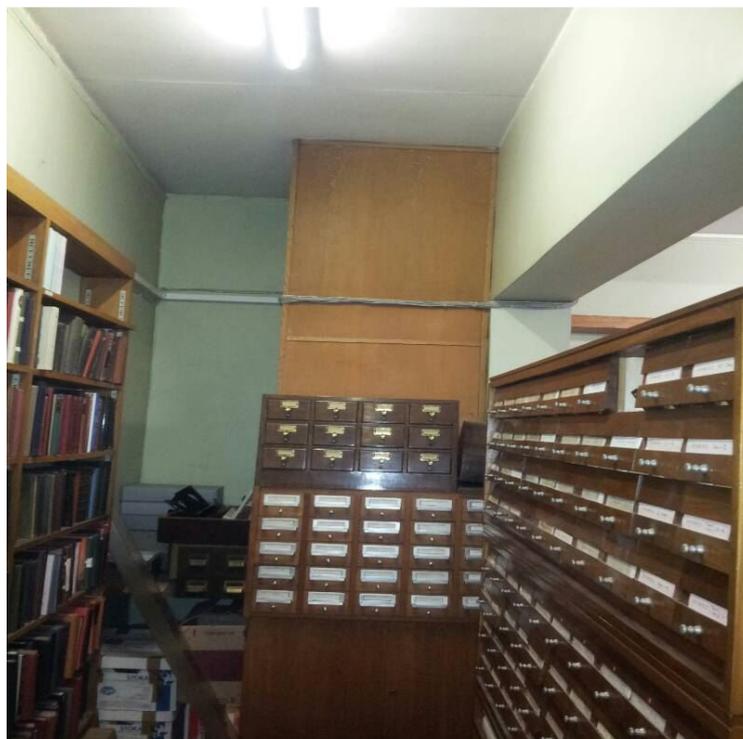
Site:	Dr. Williams's Library	Date of Survey:	17th May 2017
Building:		Survey Conducted By:	Michael Page (Lead)
Floor:	Second Floor		
Room Ref:	2/014 Store		
Form:	-	Sample No:	-
Extent:	-	Lab Analysis Result:	Presumed
Location:	No access behind timber panelling to shaft

Total Scores		
Material Risk	Priority Risk	Risk Assessment
-	-	TBC

Recommendations	Action Date
<i>It is suspected that asbestos may be present in the area. Any major refurbishment or demolition should proceed with extreme caution. Any suspect materials found during the works should be sampled and analysed by a UKAS accredited laboratory before any further works.</i>	Before Works

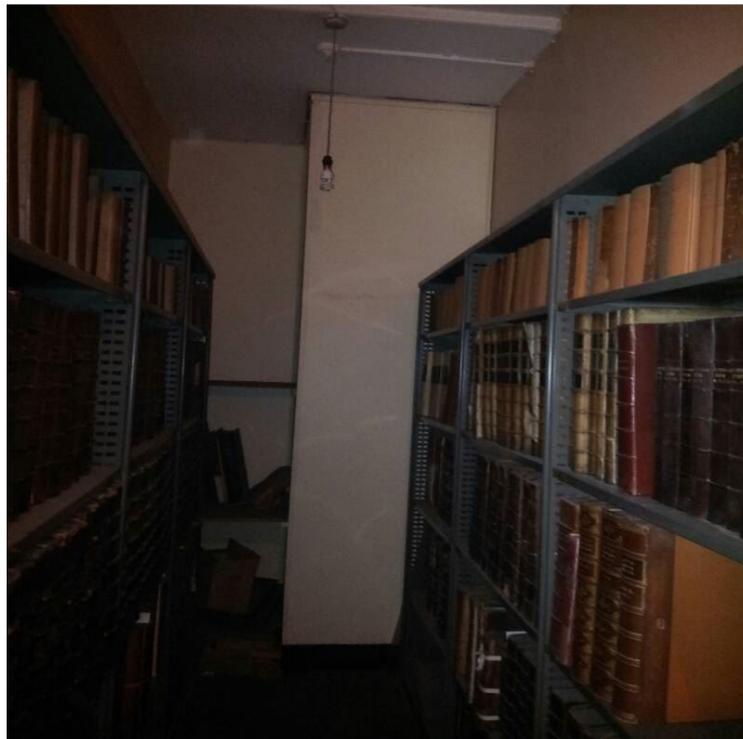
Site:	Dr. Williams's Library	Date of Survey:	17th May 2017
Building:		Survey Conducted By:	Michael Page (Lead)
Floor:	Third Floor		
Room Ref:	3/003 Corridor	Sample No:	B507803B
Form:	Insulating Board Products	Lab Analysis Result:	Amosite, Chrysotile
Extent:	4 sqm		
Location:	Panels forming walls to shaft

Material Risk	Priority Risk	Risk Assessment
5	-	5/C

Recommendations	Action Date
<i>Re-inspect at recommended intervals.</i>	17/05/2018

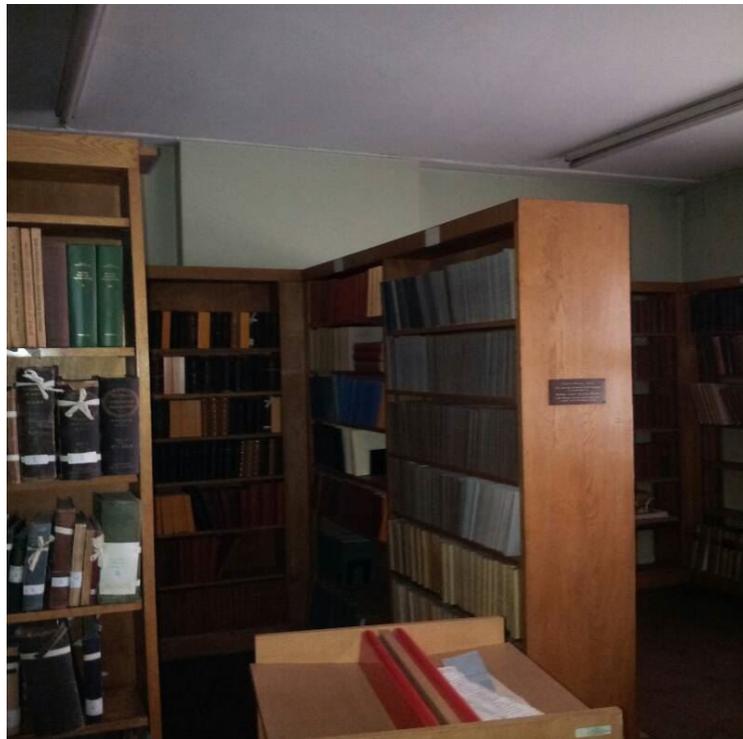
Site:	Dr. Williams's Library	Date of Survey:	17th May 2017
Building:		Survey Conducted By:	Michael Page (Lead)
Floor:	Third Floor		
Room Ref:	3/005 Office		
Form:	-	Sample No:	-
Extent:	-	Lab Analysis Result:	Presumed
Location:	Access to fireplace blocked by book cases

Material Risk	Priority Risk	Risk Assessment
-	-	TBC

Recommendations	Action Date
<i>Non-accessed area. This area should be regarded as containing asbestos until assessed by a competent person.</i>	Before Works

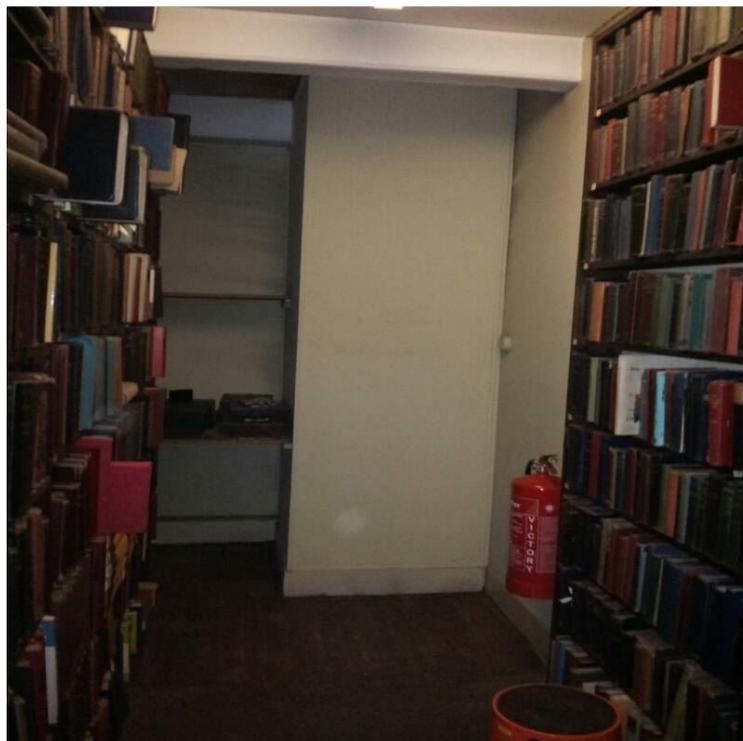
Site:	Dr. Williams's Library	Date of Survey:	17th May 2017
Building:		Survey Conducted By:	Michael Page (Lead)
Floor:	Fourth Floor		
Room Ref:	4/003 Corridor	Sample No:	As B507803B
Form:	Insulating Board Products	Lab Analysis Result:	Amosite, Chrysotile
Extent:	4 sqm		
Location:	Panels forming walls to shaft

Total Scores		
Material Risk	Priority Risk	Risk Assessment
5	-	5/C

Recommendations	Action Date
<i>Re-inspect at recommended intervals.</i>	17/05/2018

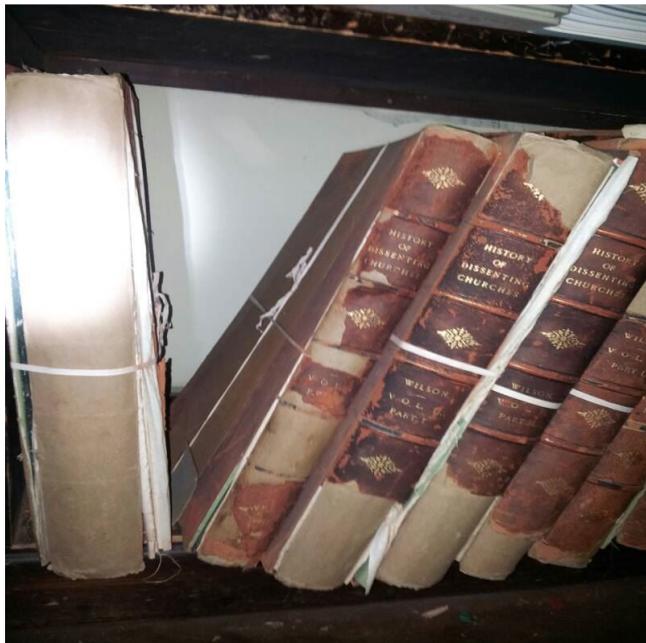
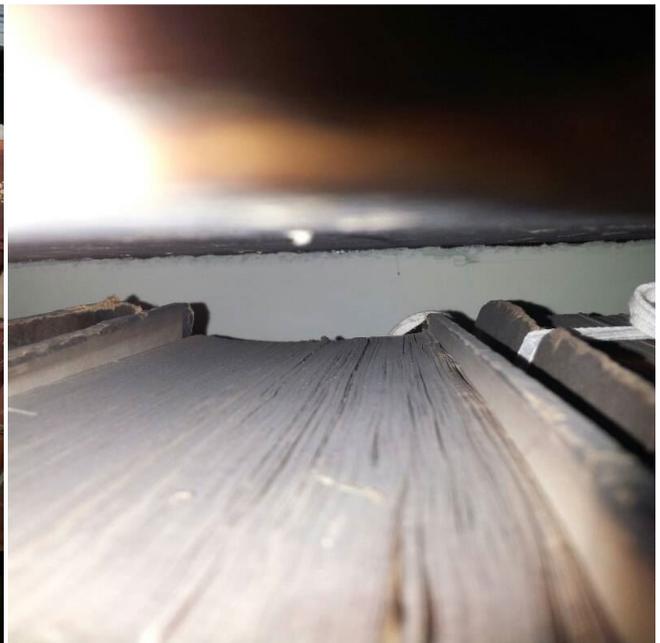
Site:	Dr. Williams's Library	Date of Survey:	17th May 2017
Building:		Survey Conducted By:	Michael Page (Lead)
Floor:	Fourth Floor		
Room Ref:	4/005 Office	Sample No:	B507805B
Form:	Cement Products	Lab Analysis Result:	Chrysotile
Extent:	1 sqm		
Location:	Low level cement panel within bookcase

Total Scores		
Material Risk	Priority Risk	Risk Assessment
4	-	4/D

Recommendations	Action Date
<i>Re-inspect at recommended intervals.</i>	17/05/2018

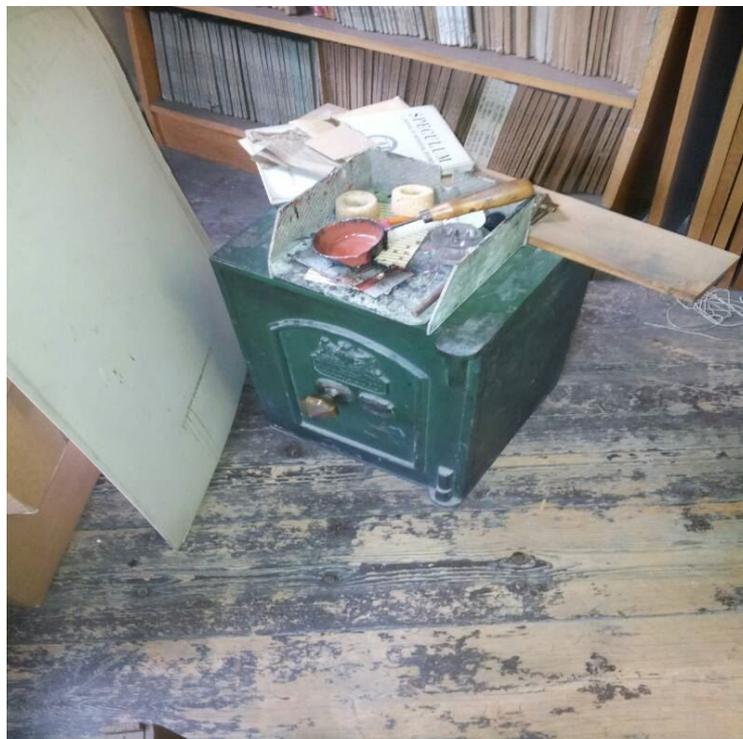
Site:	Dr. Williams's Library	Date of Survey:	17th May 2017
Building:		Survey Conducted By:	Michael Page (Lead)
Floor:	Fourth Floor		
Room Ref:	4/009 Office		
Form:	-	Sample No:	-
Extent:	-	Lab Analysis Result:	Presumed
Location:	No access within safe internals

Total Scores		
Material Risk	Priority Risk	Risk Assessment
-	-	TBC

Recommendations	Action Date
<i>Non-accessed area. This area should be regarded as containing asbestos until assessed by a competent person.</i>	Before Works

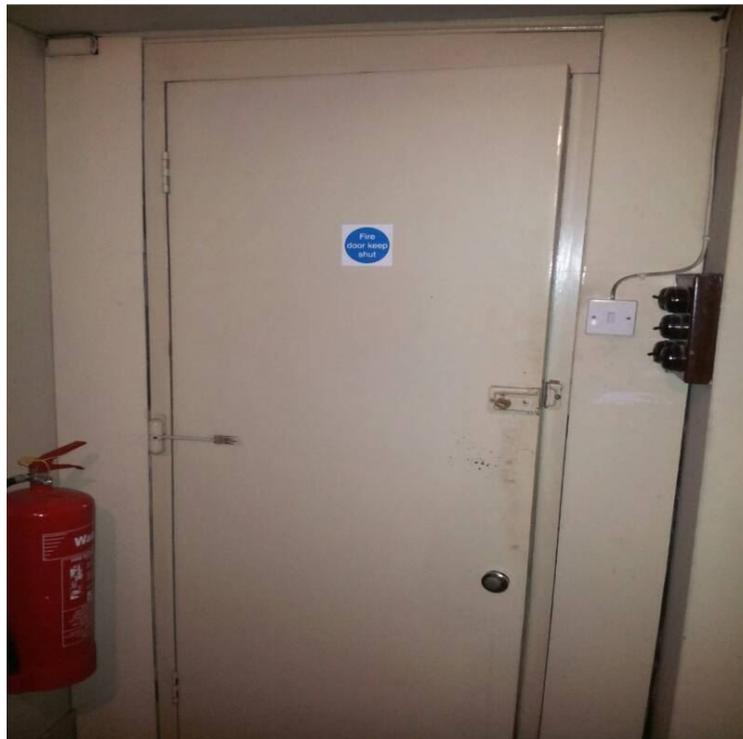
Site:	Dr. Williams's Library	Date of Survey:	17th May 2017
Building:		Survey Conducted By:	Michael Page (Lead)
Floor:	Fifth Floor		
Room Ref:	5/011 Office	Sample No:	As B507796B
Form:	Insulating Board Products	Lab Analysis Result:	Amosite, Chrysotile
Extent:	2 sqm		
Location:	Door surround panels

Material Risk	Priority Risk	Risk Assessment
6	-	6/C

Recommendations	Action Date
<i>Re-inspect at recommended intervals.</i>	17/05/2018

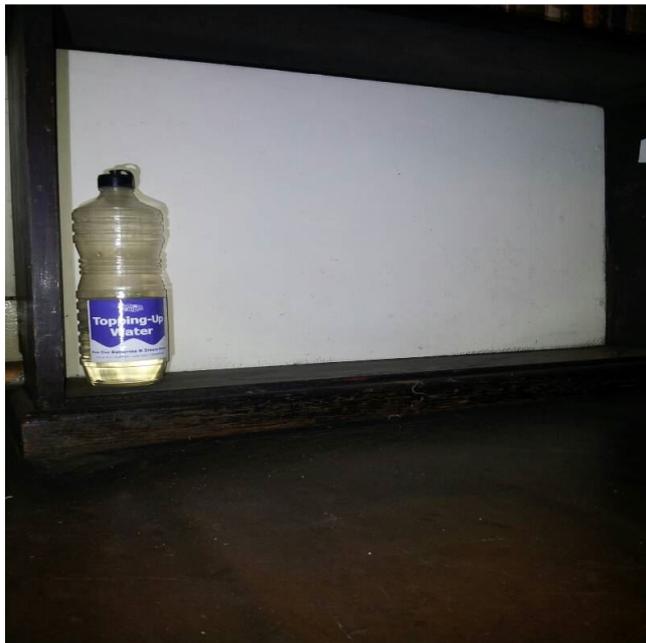
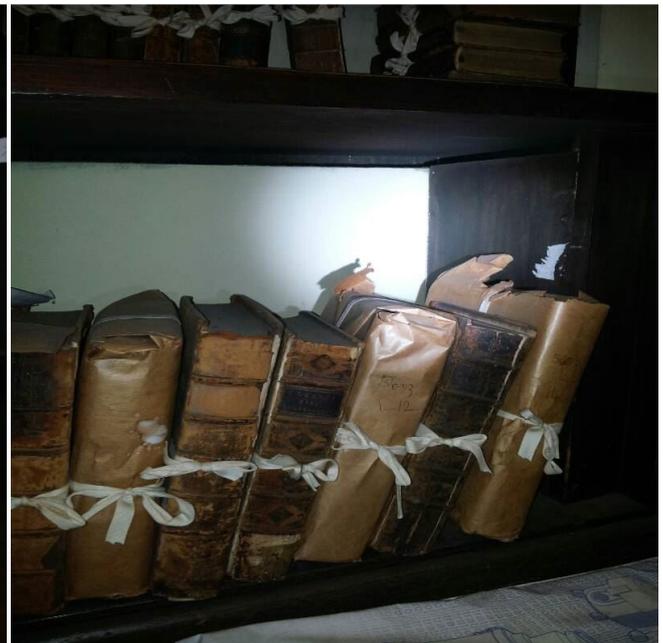
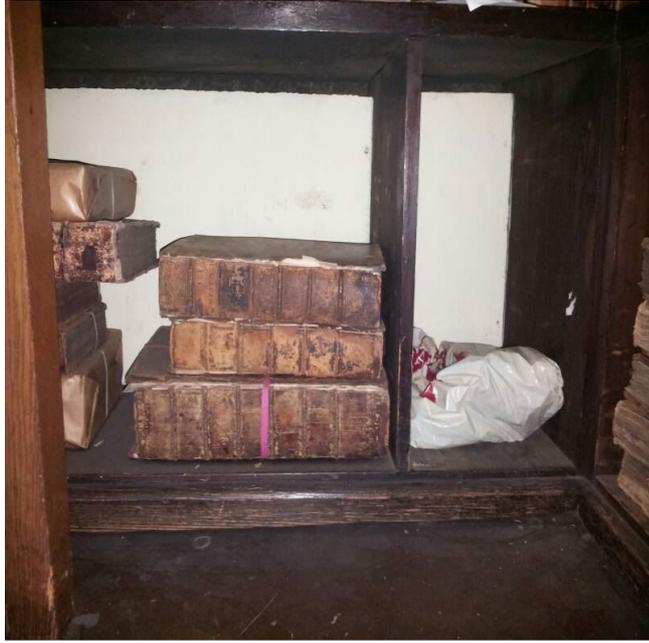
Site:	Dr. Williams's Library	Date of Survey:	17th May 2017
Building:		Survey Conducted By:	Michael Page (Lead)
Floor:	Fifth Floor		
Room Ref:	5/017 Office	Sample No:	As B507805B
Form:	Cement Products	Lab Analysis Result:	Chrysotile
Extent:	2 sqm		
Location:	Low level cement panels within bookcase

Total Scores		
Material Risk	Priority Risk	Risk Assessment
3	-	3/D

Recommendations	Action Date
<i>Re-inspect at recommended intervals.</i>	17/05/2018

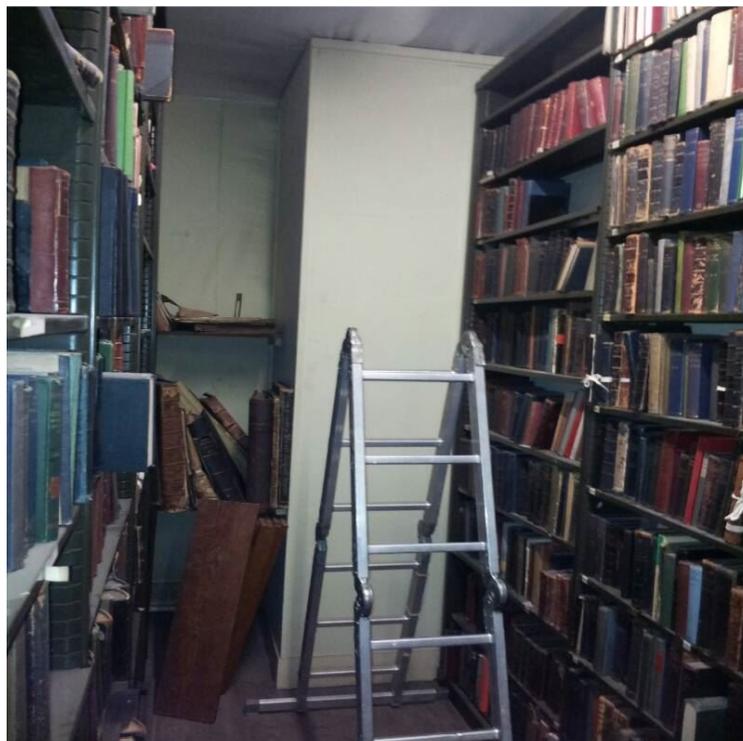
Site:	Dr. Williams's Library	Date of Survey:	17th May 2017
Building:		Survey Conducted By:	Michael Page (Lead)
Floor:	Fifth Floor		
Room Ref:	5/018 Corridor	Sample No:	As B507803B
Form:	Insulating Board Products	Lab Analysis Result:	Amosite, Chrysotile
Extent:	4 sqm		
Location:	Panels forming walls to shaft

Total Scores		
Material Risk	Priority Risk	Risk Assessment
5	-	5/C

Recommendations	Action Date
<i>Re-inspect at recommended intervals.</i>	17/05/2018
