Dr Williams's Library Library Building

FLOOR PLANS

Conditions Survey - Level 01

DRAWN BY	DATE	CHK'D BY	SCALE	MEDIA
HW	2019-07-18	RF	1 : 100	A2
PROJECT - ORIGINATOR - ZONE - LEVEL - TYPE - ROLE - NUMBER				REVISION
W82-CPM-Z1-01-DR-A-70001				P02

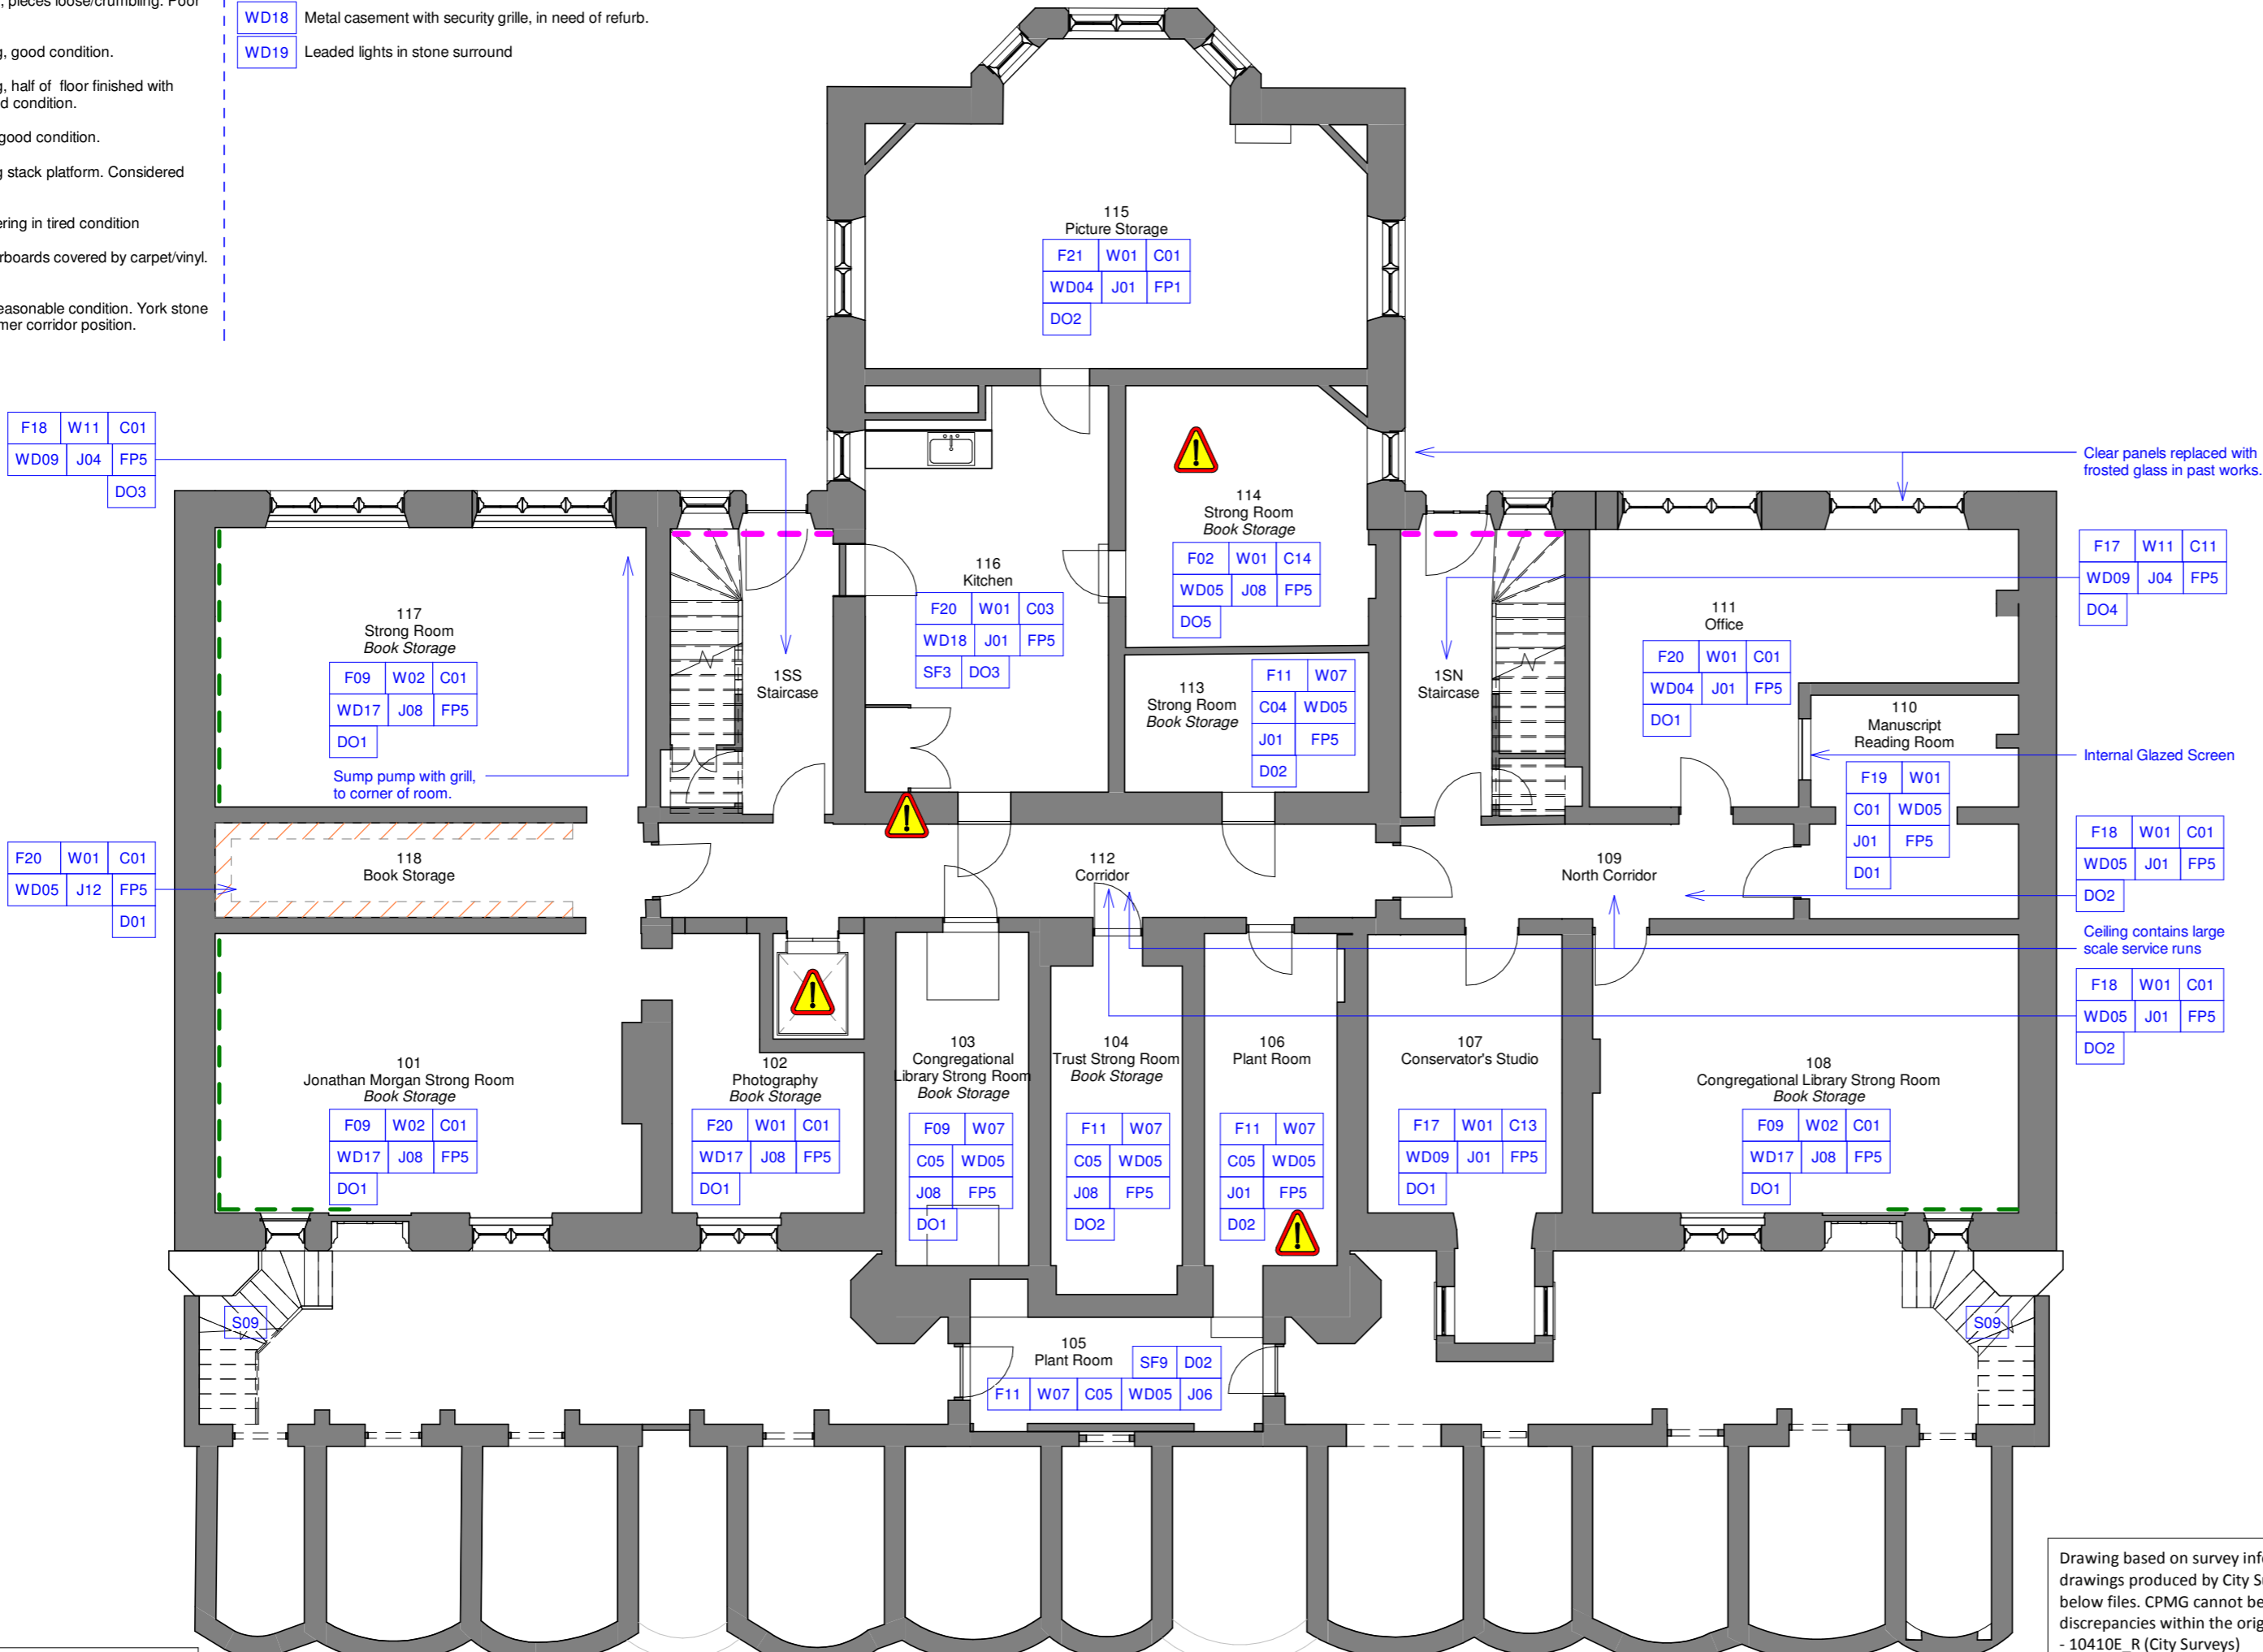
- F03 Significant deflection noted, floorboards covered by carpet/vinyl.
 - F04 Significant deflection noted, floorboards exposed.
 - F05 York stone slabs in reasonable order.

- F17 Solid floor with York stone covering, pieces loose/crumbling. Poor Condition.
 - F18 Solid floor with York Stone covering, good condition.
 - F19 Solid floor with York Stone covering, half of floor finished with seamless linoleum, considered good condition.

- WD03 Metal casement with secondary internal glazing, dampness measured in excess of 20%.
 - WD04 Metal casement with security grille. Good condition.

- WD12 Metal casement window in poor condition.
 - WD13 Stained glass in metal casements replaced during past works with metal infill panels, hidden behind built in book shelving, condition unknown.

- Walls**
- W01 Painted plaster, considered good condition.
 - W02 Significant dampness evident to painted plaster walls. Dampness in excess of 20%, as indicated on plan.

- W03 Moderate cracking to painted plaster walls, as indicated on plan.
 - W04 Moderate dampness evident to painted plaster walls, as indicated on plan.

- W05 Plastered masonry wall with wallpaper, general condition considered good.
 - W06 Significant cracking to plastered painted walls, as indicated on plan.

- W10 Painted plaster walls, believed to be in good condition. Exposed steel lintels above windows.
 - W11 Painted plaster walls, Keene's cement skirting's, edges and window reveals. Significant plaster cracking around the window/door noted, as indicated on plan.

- W12 Painted plaster walls, Keene's cement skirting's, edges and window reveals. Significant damage to plaster from leaks.

- Ceilings**
- C01 Plain painted plastered ceiling considered good condition.
 - C02 Ornate/vaulted painted plastered ceiling, good condition.
 - C03 Painted plastered ceiling in poor condition, cracking evident.

- C07 Painted plaster in poor condition. The timber gas ventilation hood is not believed fire protected.
 - C08 Painted timber board with timber battens, good condition.

- C13 Painted plaster ceiling, evidence of dampness from above, poor condition.
 - C14 No ceiling- Steel shuttered floor above.
 - C16 Plain painted plastered ceiling considered tired condition

- S06 Un-original cast-iron spiral staircase, believed in good condition.
 - S07 Un-original timber stairs believed in reasonable condition.
 - S08 External York stone stairs, cause for significant damp issues internally. Currently propped as deemed unsafe/unusable. Intervention required urgently.

- S09 External York stone stairs, cause for significant damp issues internally. Non original brick structure erected during past works to support, this has moved and no longer supports the stair. Stairs deemed unsafe/unusable, intervention required urgently.
