Dr Williams's Library Library Building

FLOOR PLANS

Condition Survey - Level 02

W82-CPM-Z1-02-DR-A-70002 P02

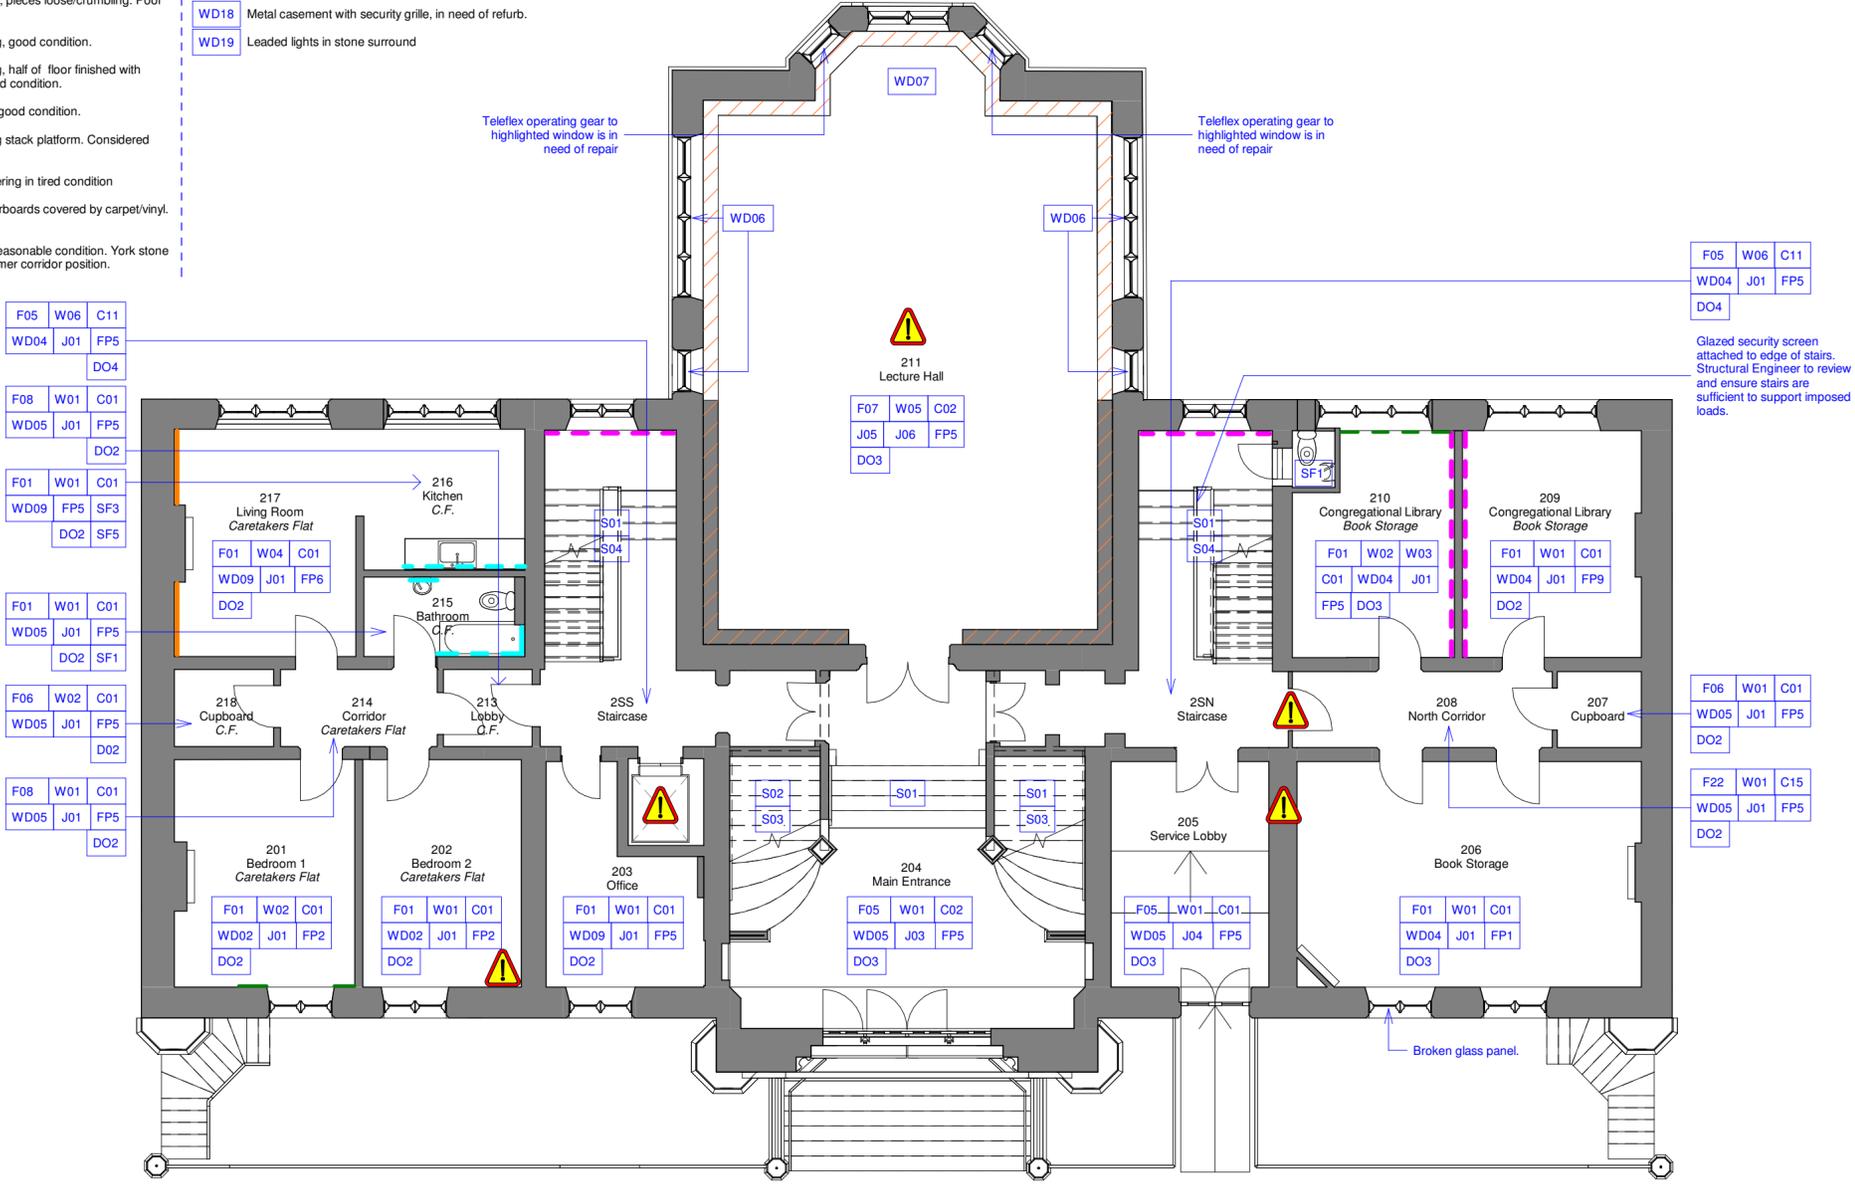
- F03 Significant deflection noted, floorboards covered by carpet/vinyl.
 - F04 Significant deflection noted, floorboards exposed.
 - F05 York stone slabs in reasonable order.

- F17 Solid floor with York stone covering, pieces loose/crumbling. Poor Condition.
 - F18 Solid floor with York Stone covering, good condition.
 - F19 Solid floor with York Stone covering, half of floor finished with seamless linoleum, considered good condition.

- WD03 Metal casement with secondary internal glazing, damp/mould issues between glazing. Dampness measured in excess of 20%.
 - WD04 Metal casement with security grille. Good condition.

- Walls**
- W01 Painted plaster, considered good condition.
 - W02 Significant dampness evident to painted plaster walls. Dampness in excess of 20%, as indicated on plan.

- W03 Moderate cracking to painted plaster walls, as indicated on plan.
 - W04 Moderate dampness evident to painted plaster walls, as indicated on plan.

- W05 Plastered masonry wall with wallpaper, general condition considered good.
 - W06 Significant cracking to plastered painted walls, as indicated on plan.

- W10 Painted plaster walls, believed to be in good condition. Exposed steel lintels above windows.
 - W11 Painted plaster walls, Keene's cement skirting's, edges and window reveals. Significant plaster cracking around the window/door noted, as indicated on plan.

- W12 Painted plaster walls, Keene's cement skirting's, edges and window reveals. Significant damage to plaster from leaks.

- Ceilings**
- C01 Plain painted plastered ceiling considered good condition.
 - C02 Ornate/vaulted painted plastered ceiling, good condition.
 - C03 Painted plastered ceiling in poor condition, cracking evident.

- C07 Painted plaster in poor condition. The timber gas ventilation hood is not believed fire protected.
 - C08 Painted timber board with timber battens, good condition.

- S06 Un-original cast-iron spiral staircase, believed in good condition.
 - S07 Un-original timber stairs believed in reasonable condition.
 - S08 External York stone stairs, cause for significant damp issues internally. Currently propped as deemed unsafe/unusable. Intervention required urgently.

- S09 External York stone stairs, cause for significant damp issues internally. Non original brick structure erected during past works to support, this has moved and no longer supports the stair. Stairs deemed unsafe/unusable, intervention required urgently.
