**Dr Williams's Library Library Building**

FLOOR PLANS

Condition Survey - Level 03

**W82-CPM-Z1-03-DR-A-70003 P02**

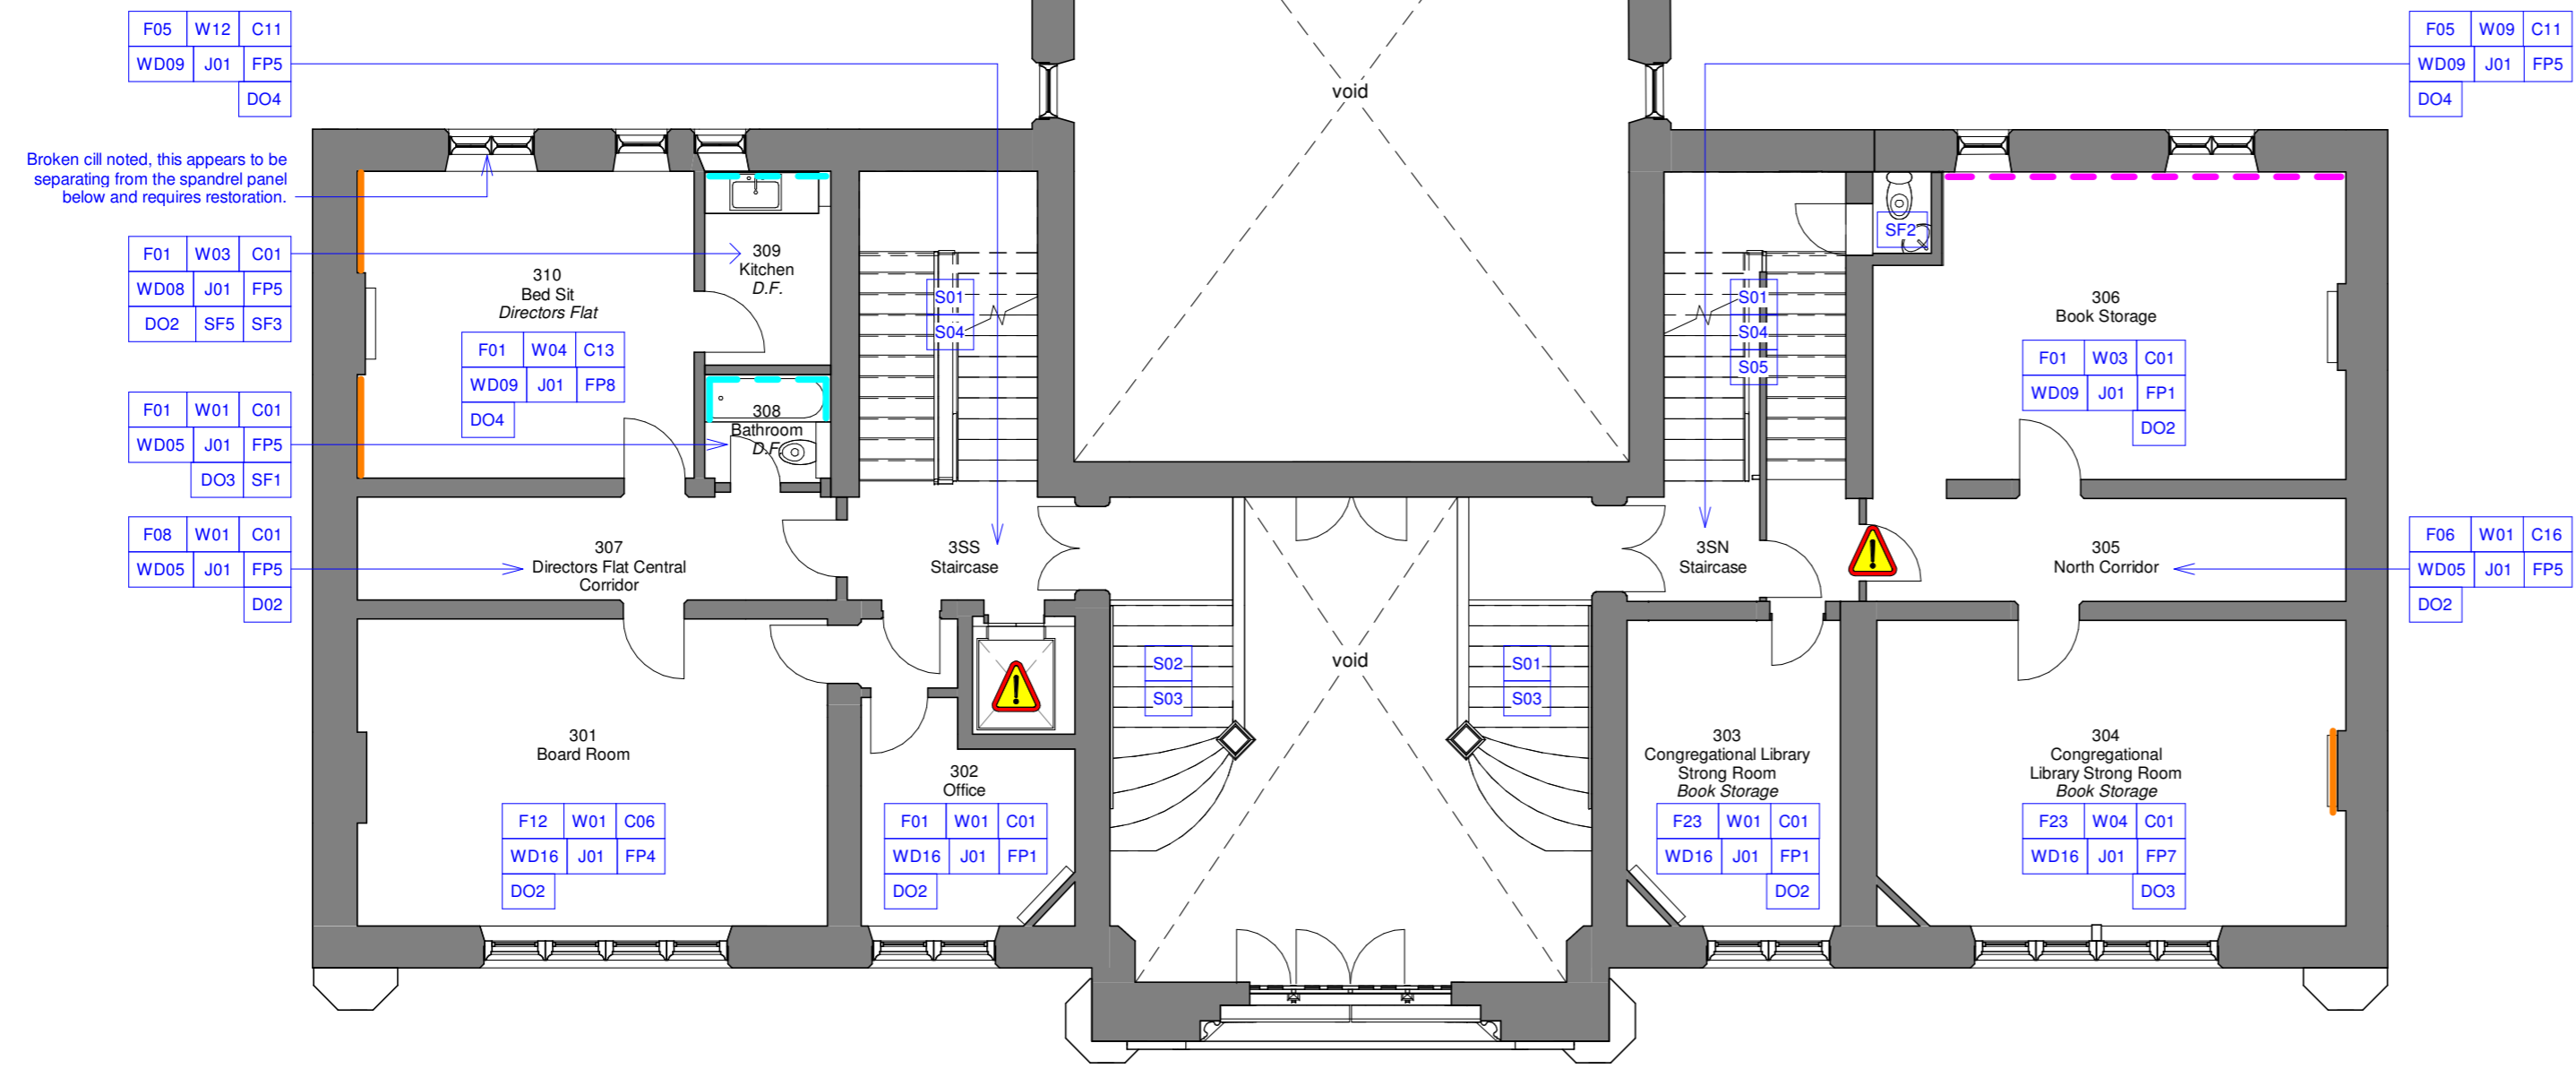
Broken cill noted, this appears to be separating from the spandrel panel below and requires restoration.
