Dr Williams's Library
Library Building

FLOOR PLANS

Condition Survey - Level 06

W82-CPM-Z1-06-DR-A-70006 **P02**

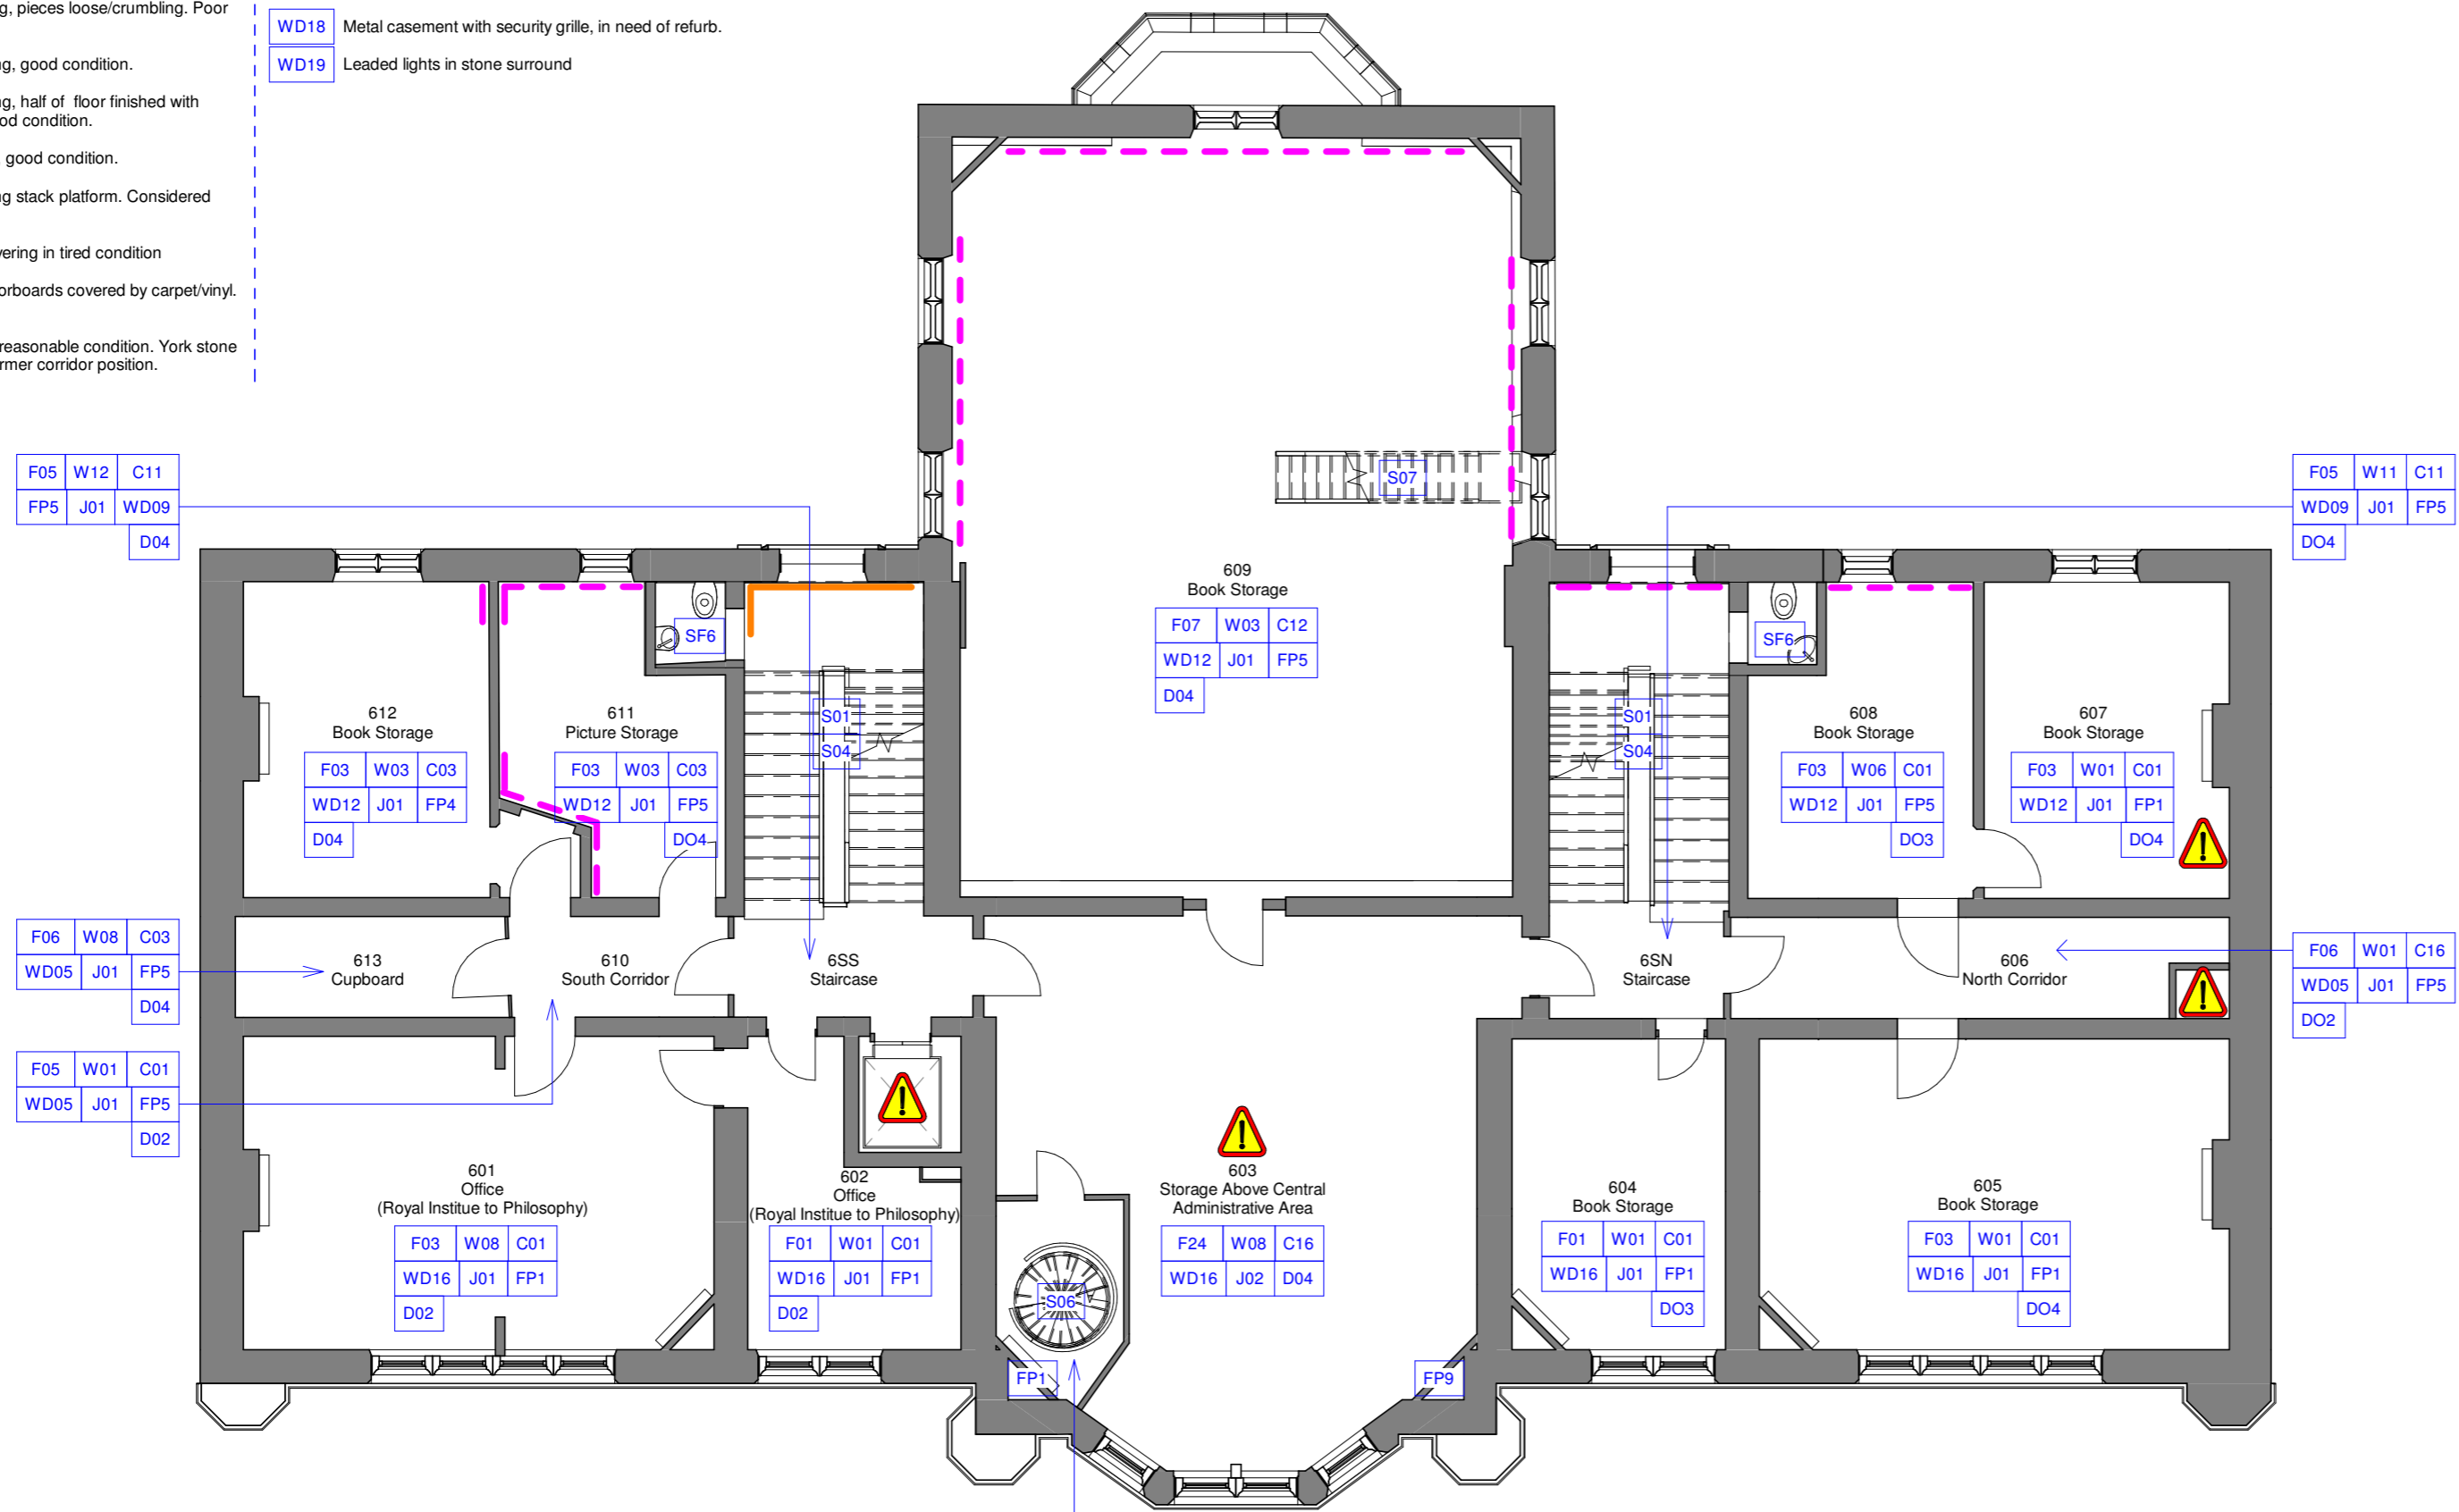
Timber enclosed spiral staircase with glazed panels. Appears to be in reasonable condition.
