**Dr Williams's Library**  
**Library Building**

**Condition Survey - Level 07**

**PLANNING SUBMISSION**

**W82-CPM-Z1-07-DR-A-70007** **P02**

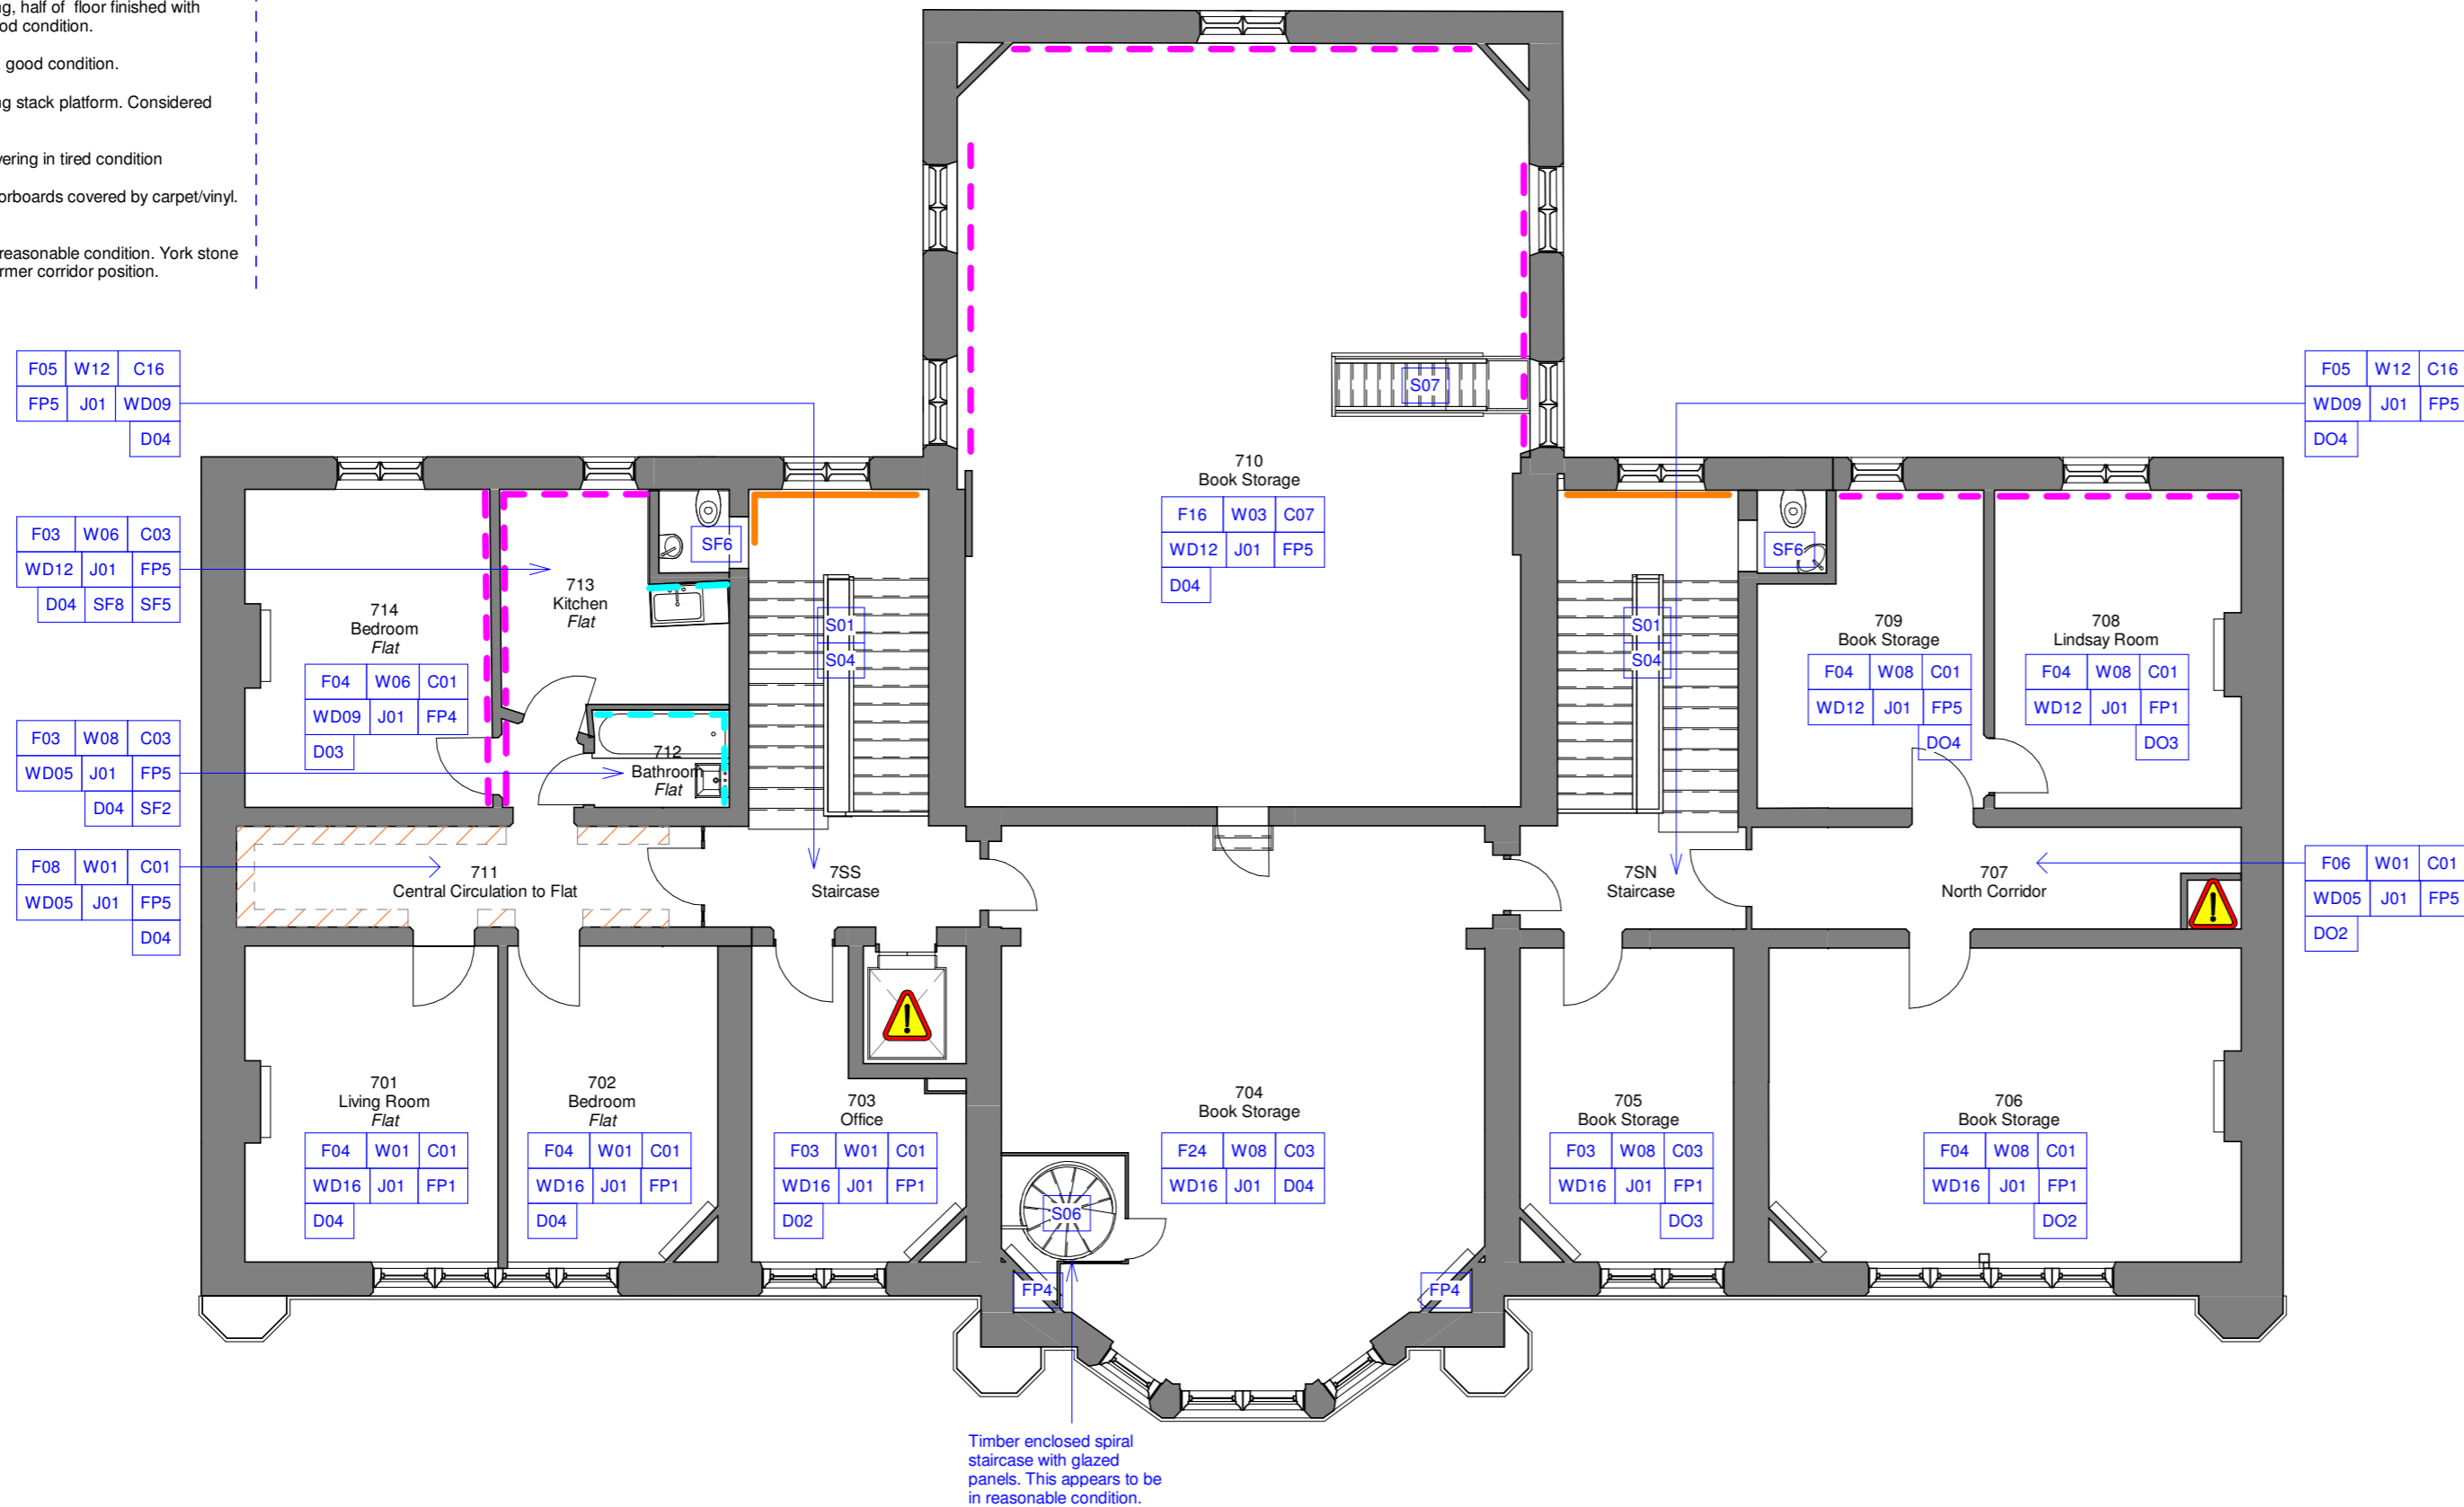
- Floors**
- F01 No significant deflection noted, floorboards covered by carpet/vinyl. Covering in reasonable condition.
  - F02 No significant deflection noted, floorboards exposed.

- F03 Significant deflection noted, floorboards covered by carpet/vinyl.
  - F04 Significant deflection noted, floorboards exposed.
  - F05 York stone slabs in reasonable order.

- F06 Infilled timber floor adjoining York stone slab floor, good condition.
  - F07 Long strip hardwood and softwood boarding on cast iron and timber structure beneath. In good condition. Stone slabs at intended fireplace locations to side walls.

- F08 York stone slabs, masked by carpet. Covering in good condition.
  - F09 Tanked floor with recessed rolling rack tracks and seamless linoleum flooring. Good condition.

- F10 Solid concrete with painted finish. Good condition.
  - F11 Brick Paver, considered good condition.
  - F12 Long strip oak finish flooring. Considered good condition

- F13 Significant deflection noted, floorboards covered by carpet/vinyl. Covering in poor condition.
  - F14 Gallery- Two unoriginal cast-iron floors with associated railings, supported on cast-iron columns. Considered good condition.

- F15 Gallery- Un-original timber gallery with associated timber balustrade, supported below by timber book presses. Good condition.
  - F16 Un-original perforated cast-iron gridded floor on supporting steelwork. Good condition.

- F17 Solid floor with York stone covering, pieces loose/crumbling. Poor Condition.
  - F18 Solid floor with York Stone covering, good condition.
  - F19 Solid floor with York Stone covering, half of floor finished with seamless linoleum, considered good condition.

- F20 Solid floor with seamless linoleum, good condition.
  - F21 Solid floor, painted finish with rolling stack platform. Considered good condition.
  - F22 York stone slabs with linoleum covering in tired condition

- F23 No significant deflection noted, floorboards covered by carpet/vinyl. Covering in poor condition.
  - F24 Double suspended timber floor in reasonable condition. York stone slabs in reasonable condition in former corridor position.

- Windows**
- WD01 Metal casement with secondary internal glazing, no damp/mould issues. Good condition.
  - WD02 Metal casement with secondary internal glazing, damp/mould issues between glazing.

- WD03 Metal casement with secondary internal glazing, dampness measured in excess of 20%.
  - WD04 Metal casement with security grille. Good condition.

- WD05 No window within highlighted space.
  - WD06 Stained glass in metal casements, reasonable condition.
  - WD07 Stained glass in painted stonework to bay in need of minor repairs, some signs of glass distortion. Refurbishment required.

- WD08 Metal casement in reasonable condition, extraction fan included in glazing. External cill in need of refurb.
  - WD09 Metal casement window in good condition.

- WD12 Metal casement window in poor condition.
  - WD13 Stained glass in metal casements replaced during past works with metal infill panels, hidden behind built in book shelving, condition unknown.

- WD14 Teleflex operation believed to be in need of replacement. Metal casement window in good condition.
  - WD15 Metal casement in good condition- glazing replaced with obscure panels at some point during past works.

- WD16 Timber sash window recently refurbished, good condition.
  - WD17 Environmental shutters to window. Openings behind shutters have not been inspected.

- WD18 Metal casement with security grille, in need of refurb.
  - WD19 Leaded lights in stone surround

- Walls**
- W01 Painted plaster, considered good condition.
  - W02 Significant dampness evident to painted plaster walls. Dampness in excess of 20%, as indicated on plan.

- W03 Moderate cracking to painted plaster walls, as indicated on plan.
  - W04 Moderate dampness evident to painted plaster walls, as indicated on plan.

- W05 Plastered masonry wall with wallpaper, general condition considered good.
  - W06 Significant cracking to plastered painted walls, as indicated on plan.

- W07 Painted fair faced brickwork, considered good condition.
  - W08 Painted plastered walls, walls in tired condition.
  - W09 Painted plaster walls, Keene's cement skirting's, edges and window reveals, considered good condition.

- W10 Painted plaster walls, believed to be in good condition. Exposed steel lintels above windows.
  - W11 Painted plaster walls, Keene's cement skirting's, edges and window reveals. Significant plaster cracking around the window/door noted, as indicated on plan.

- W12 Painted plaster walls, Keene's cement skirting's, edges and window reveals. Significant damage to plaster from leaks.

- Ceilings**
- C01 Plain painted plastered ceiling considered good condition.
  - C02 Ornate/vaulted painted plastered ceiling, good condition.
  - C03 Painted plastered ceiling in poor condition, cracking evident.

- C04 No ceiling- Exposed timber floor construction.
  - C05 Fair faced painted brick segmental vault, good condition.
  - C06 Painted plaster ceiling with decorative cornice at the wall-ceiling junction, not original to building. Considered good condition.

- C07 Painted plaster in poor condition. The timber gas ventilation hood is not believed fire protected.
  - C08 Painted timber board with timber battens, good condition.

- C09 Painted plaster ceiling with down stand beams, good condition.
  - C10 Painted plaster ceiling with timber cased cast-iron beams, in need of refurb. Decorative braces and corbels in good order.

- C11 No ceiling- York stone stairs/landing exposed.
  - C12 Painted underside of metal grillage in poor condition. Number of supporting downstand beams

- C13 Painted plaster ceiling, evidence of dampness from above, poor condition.
  - C14 No ceiling- Steel shuttered floor above.
  - C16 Plain painted plastered ceiling considered tired condition

- C17 Woodchip wallpaper to plaster, in good condition

- Joinery**
- J01 Door, door frame, architraves and skirting in good condition.
  - J02 Door, door frames, architraves and skirting in poor condition.
  - J03 Timber exterior door with glazed panels and ogee heads, in good condition.

- J04 Timber exterior door, good condition.
  - J05 Timber panelling to perimeter walls, with built-in integral cupboards and book shelving as indicated on plan.

- J06 Timber doors with ogee heads considered good condition.
  - J08 Modern strong room door (high security and fire properties). Good condition.
  - J09 New timber door (un-original), door frame, architrave and skirting in good condition.

- J10 Soft wood six panel door with original Keen's cement reveal, considered good.
  - J11 Timber glazed screen and matching associated feature double doors are considered good in condition.

- J12 Built in book shelving, good condition, as indicated on plan.

- Fireplace**
- FP1 Fireplace intact, Roman cement decorative legs, cast iron firebox and timber mantle in good condition.
  - FP2 Fireplace intact, Roman cement decorative legs, cast iron firebox, glazed tile back and timber mantle in good condition.
  - FP3 Fireplace intact, timber surround and tiles in poor condition.
  - FP4 Fireplace boarded over.
  - FP5 No fireplace evident or believed to have been within space highlighted.
  - FP6 Roman cement decorative legs still evident, fireplace boarded over.
  - FP7 Embellished timber surround with cast iron firebox, in reasonable condition.
  - FP8 Marble surround left in place, fireplace boarded over.
  - FP9 Fireplace clearly removed.

- Stairs**
- S01 York stone treads in reasonable condition
  - S02 York stone treads in reasonable condition, signs of past repair work to treads.
  - S03 Roman cement, decorative balustrade present and in good condition.

- S04 Timber handrail on steel railing balustrade in reasonable condition.
  - S05 Secondary guarding wall used as security measure within stairwell. Guarding known as unoriginal, not suitable for existing stair.

- S06 Un-original cast-iron spiral staircase, believed in good condition.
  - S07 Un-original timber stairs believed in reasonable condition.
  - S08 External York stone stairs, cause for significant damp issues internally. Currently propped as deemed unsafe/unusable. Intervention required urgently.

- S09 External York stone stairs, cause for significant damp issues internally. Non original brick structure erected during past works to support, this has moved and no longer supports the stair. Stairs deemed unsafe/unusable, intervention required urgently.

- S10 York stone treads with linoleum nosing's. Tired condition.

- Sanitary / Kitchen Fittings**
- SF1 Sanitary fittings in good condition. Electric extract fan present, cannot comment on working order.
  - SF2 Sanitary fittings including- lavatories, urinals and washbasins considered in poor condition.

- SF3 Fitted kitchen with sink, believed to be in good condition. Cannot comment on working order.
  - SF4 Sanitary fittings removed, redundant pipes left in place.

- SF5 Self contained gas fired boiler, with balanced flue, extracted through the rear wall provides heating and hot water independently to main systems serving the building.

- SF5 Un-original proprietary laminated toilet cubicles, in good condition.
  - SF6 Sanitary fitting including- lavatories, urinals and washbasins considered in good condition.

- SF7 Cleaners sink, believed in poor condition.
  - SF8 Fitted kitchen with sink, in poor condition. Not operational.
  - SF9 Gas meter on wall, redundant cabling evident.

- Decorative Order**
- DO1 General interior condition of room- Good.
  - DO2 General interior condition of room- Fair.
  - DO3 General interior condition of room- Tired.
  - DO4 General interior condition of room- Poor.
