**Tree Survey, Arboricultural Impact Assessment
Arboricultural Method Statement & Tree Protection Plan
In Accordance with BS 5837:2012**

| Proj. No 7757 | 16 Downshire Hill, Hampstead, London, NW3 1NT | | |
| Date of Report: | 05/11/2019 | Revision: | A |

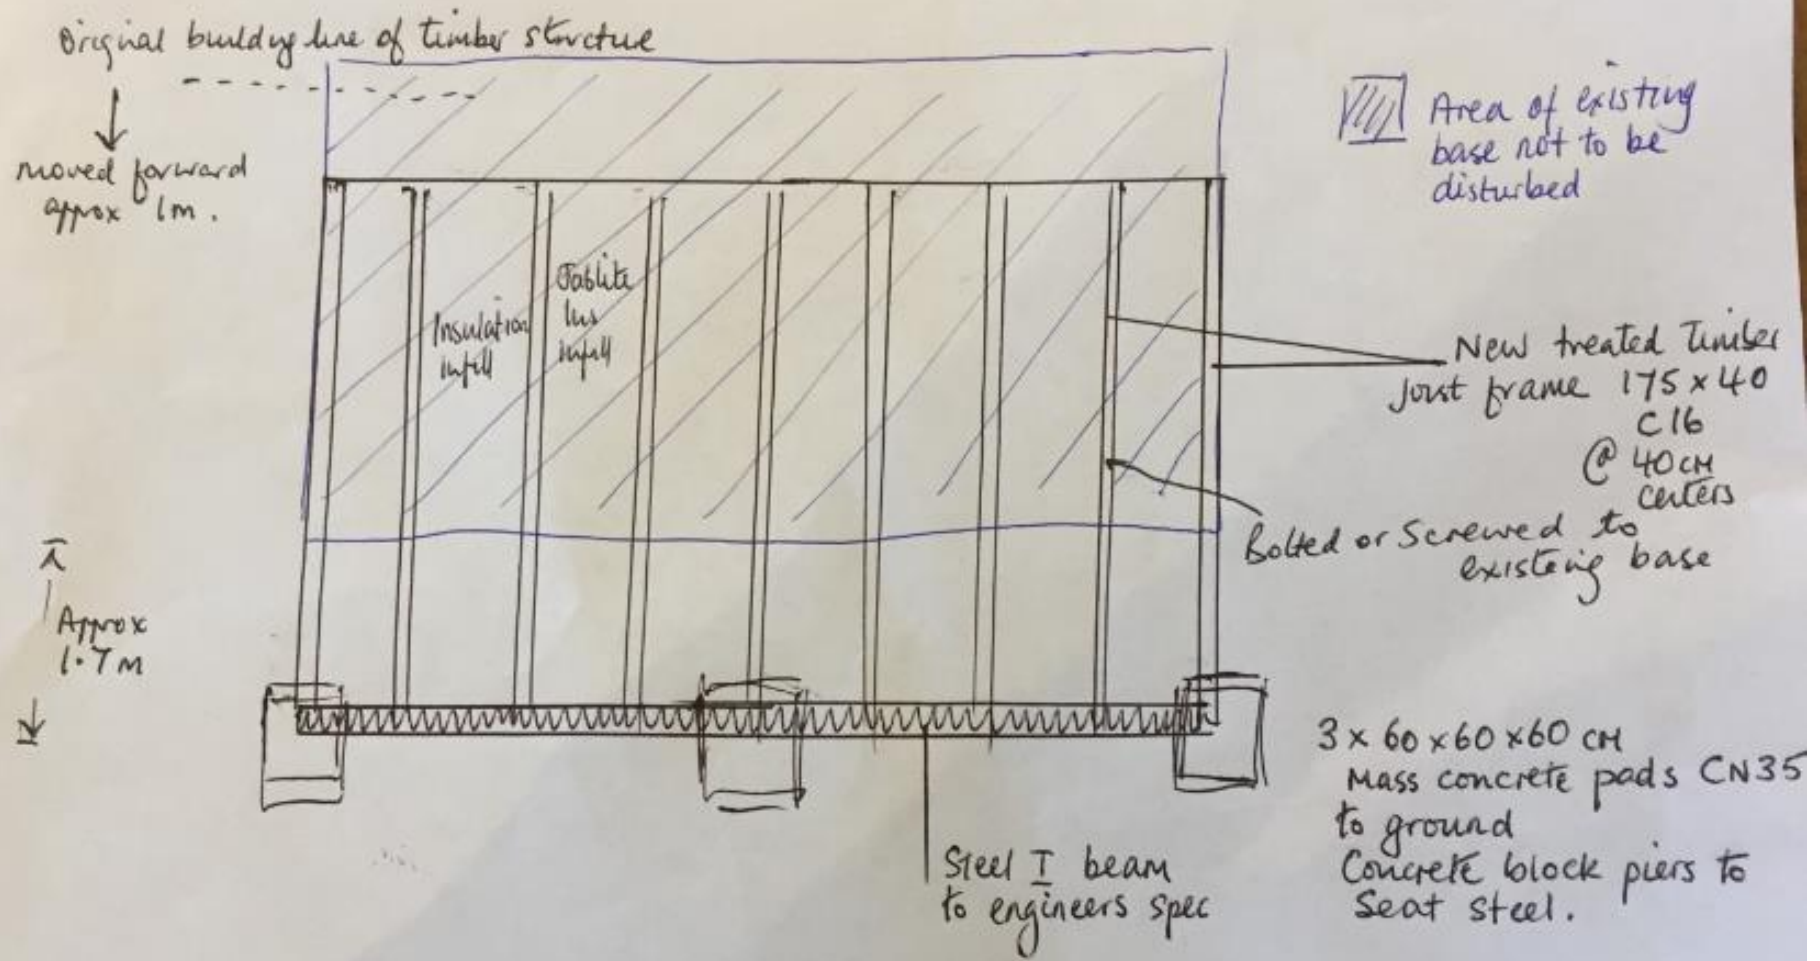
Downslope Hill Garden Study Plan View Sketch

- 4.4.2 Construction of the garden study and its foundations encroach within the theoretical RPA of two retained trees, T006 and T007. The structure will be moved 1 metre, south west, away from the rear boundary and extended approximately 1.7 metres, south west, beyond the existing foundation base. Where the extended footprint encroaches within the RPA of these trees a specialised foundation design has been produced by XUL Architecture, included in Appendix I. This design will provide for raised floor levels and will incorporate a ventilated air space beneath the underside of the slab.

The design also allows for these pads (3 in total, measuring 600 x 600 x 600 mm) to be adjusted if an important root (e.g. greater than 50 mm) is identified during the excavation phase. Otherwise, where necessary, linear root pruning may be carried out during excavation, as part of the access facilitation pruning (AFP) works. This excavation must be carried out using an Air-spade and hand tools (secateurs and handsaw etc.) or hand digging, if soil conditions preclude, and in accordance with item 5.8.2 below. Following this, prior to being backfilled, the foundation hole will be lined with a non-permeable geotextile membrane to prevent phytotoxic concrete adversely affecting the retained trees' roots. These operations will be supervised by the appointed Arboriculturalist. A diagrammatic representation of the affected area is shown on the attached drawing no. 7757-D-AIA Rev A.

5.8.2 Where it is shown that the construction of the garden study encroaches within the RPA of a retained tree, pad and beam foundations of the extended base have been designed to minimise the detrimental effect of the construction on the tree's roots. Any excavations within the RPA of an affected tree will only be undertaken following exploration of the existing root system with an air spade (or by hand digging, if soil conditions preclude) and the necessary root pruning undertaken to allow excavation without unnecessary pulling and tearing of the roots to be retained. This will ensure minimal damage to tree roots. Prior to being backfilled, the foundation hole will be lined with a non-permeable geotextile membrane to prevent phytotoxic concrete adversely affecting the retained trees' roots.
