## 234 Shaftesbury Avenue - Photographic Schedule, Rev A – November 2019

Pre –existing condition

As built condition

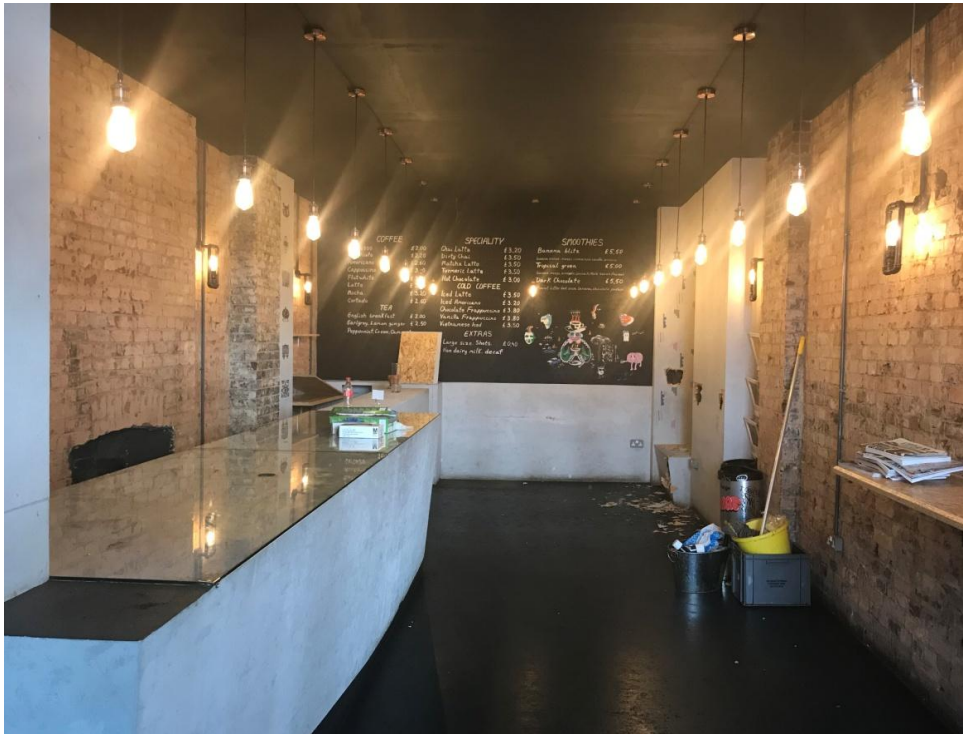
Fig 1 View looking into the shop unit from adjacent to the shopfront.

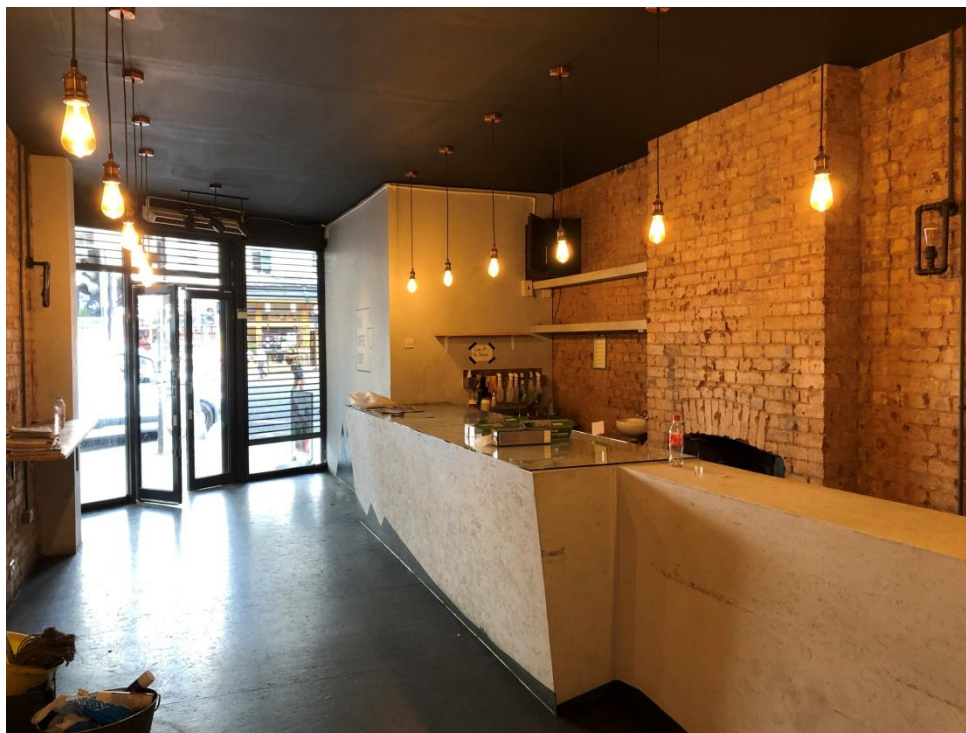
Fig 2 View looking towards the shopfront.

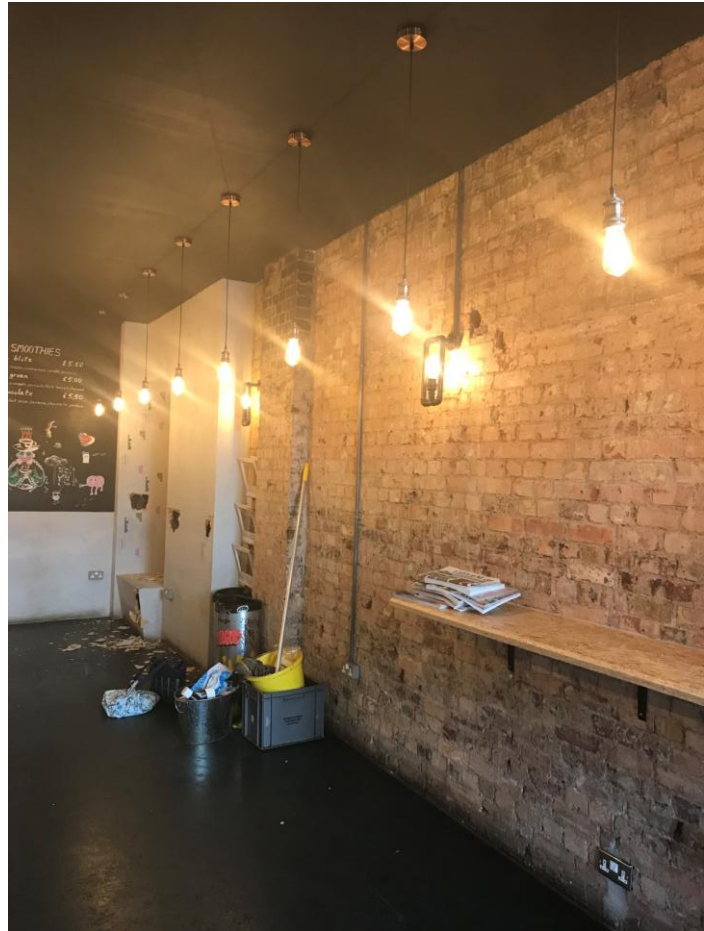
Fig 3 View of the southern party wall.

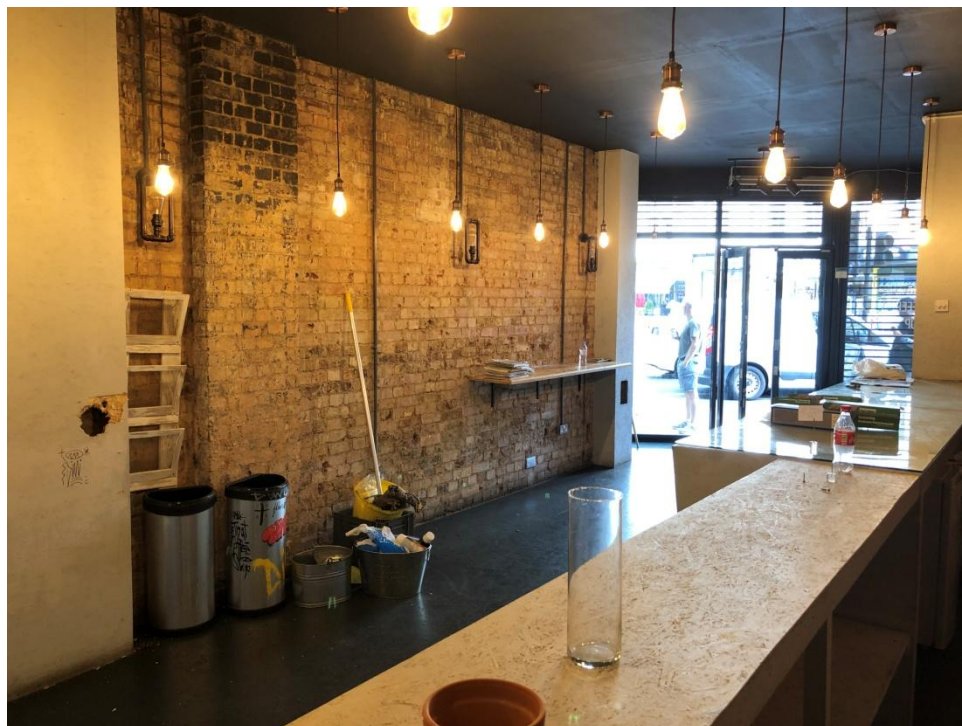
Fig 4 View of the southern party wall showing pre-existing lighting.

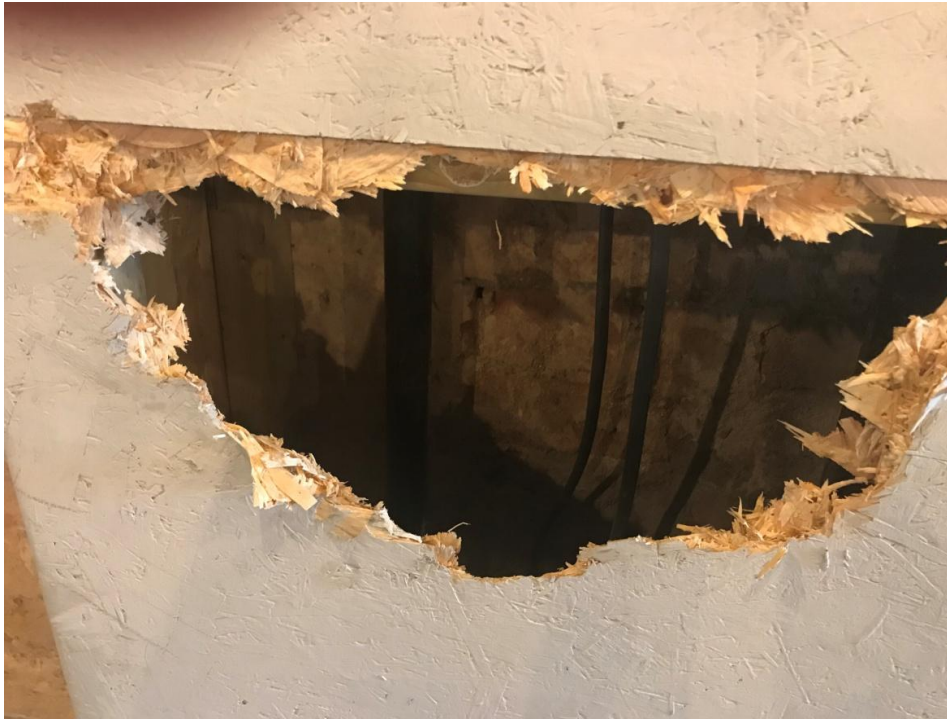
Fig 5 Modern sterling board boxing around existing pipework and cabling.

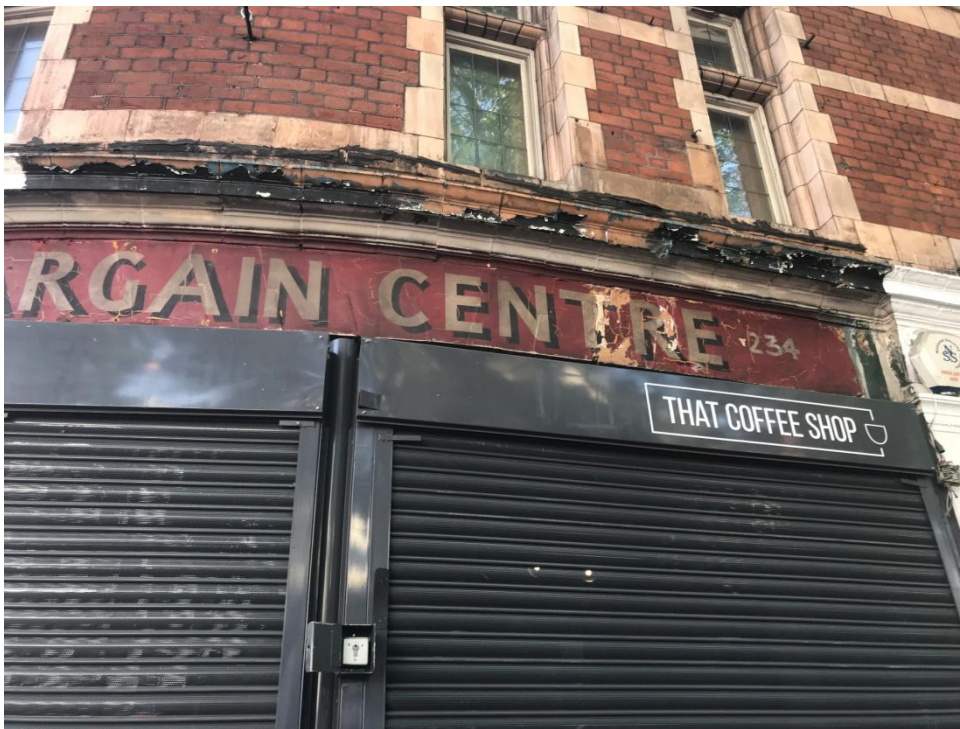
Fig 6 The pre-existing fascia and roller shutter.

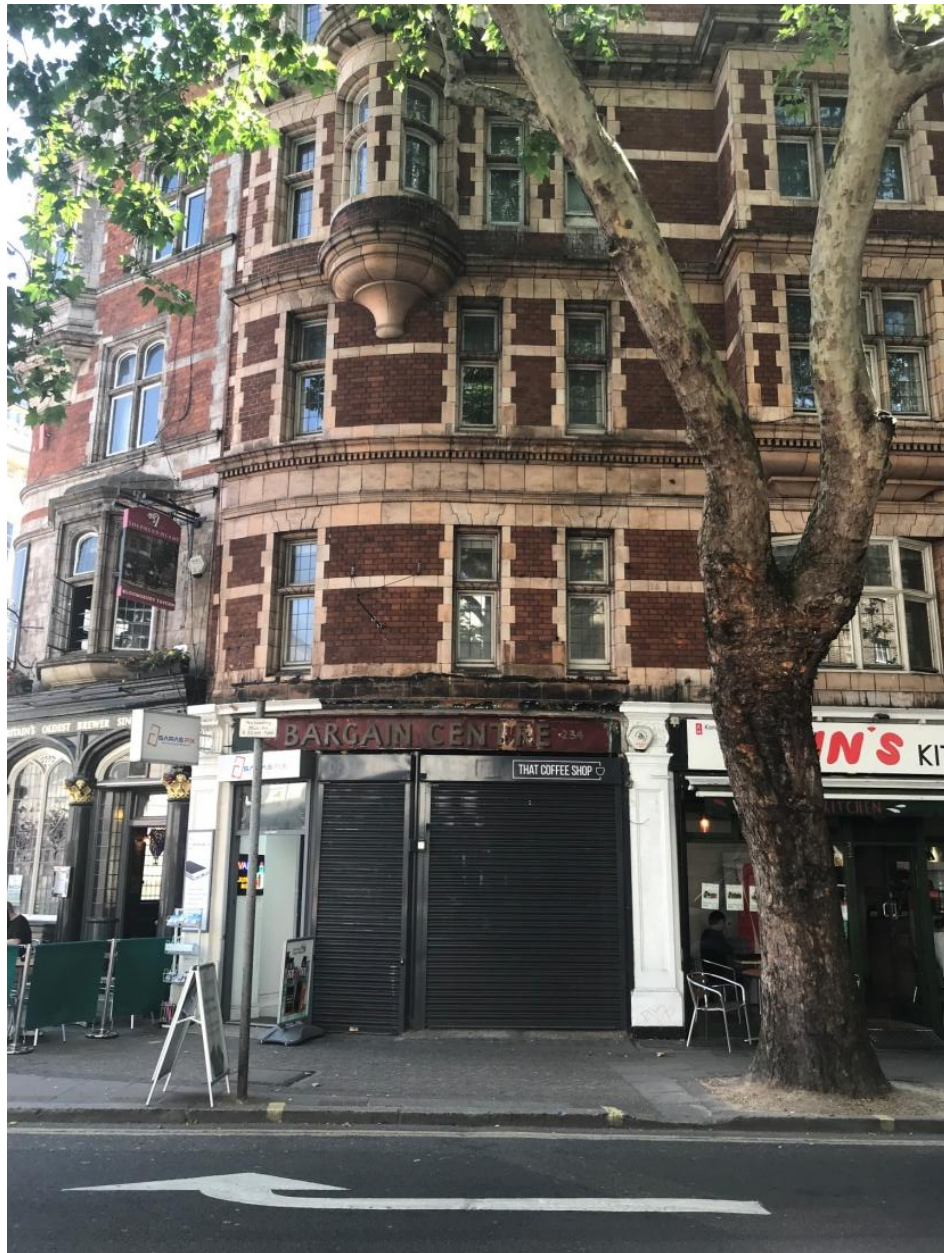
Fig 7 The pre existing front elevation of the listed building.

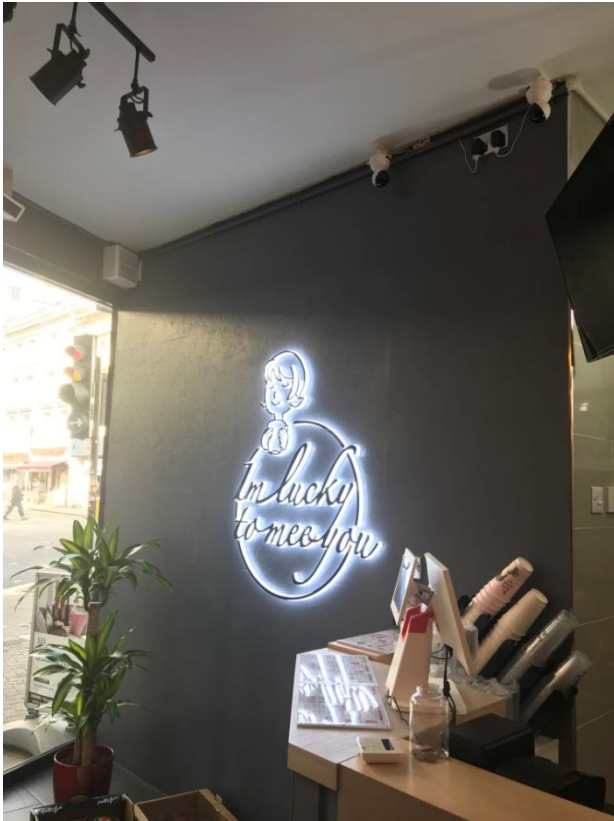
Fig 8 The modified Sterling board cladding adjacent to the entrance into the retail unit.

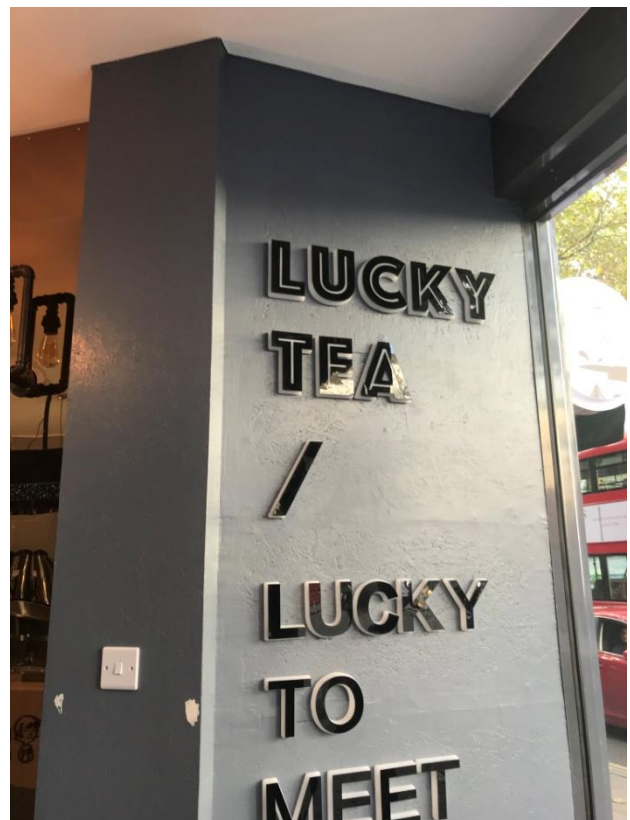
Fig 9 The modified and re-painted Sterling board on the opposite side of the entrance.

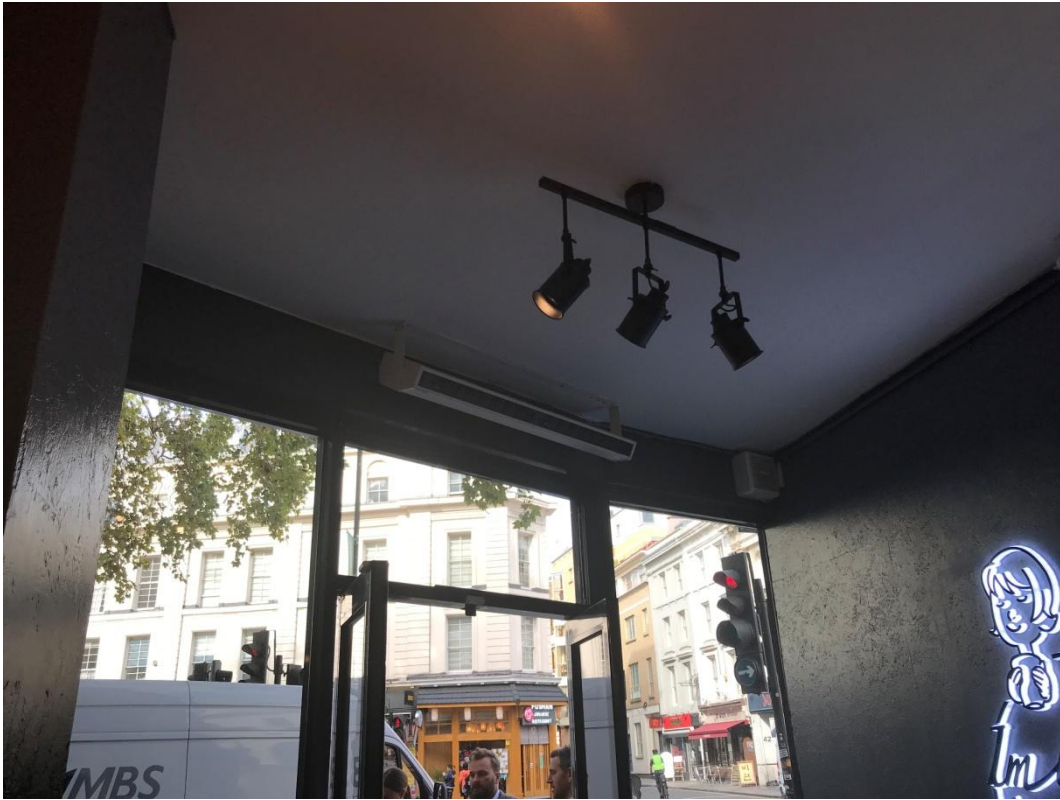
Fig 10 The AC cassette and extractor fan at high level behind the shopfront.

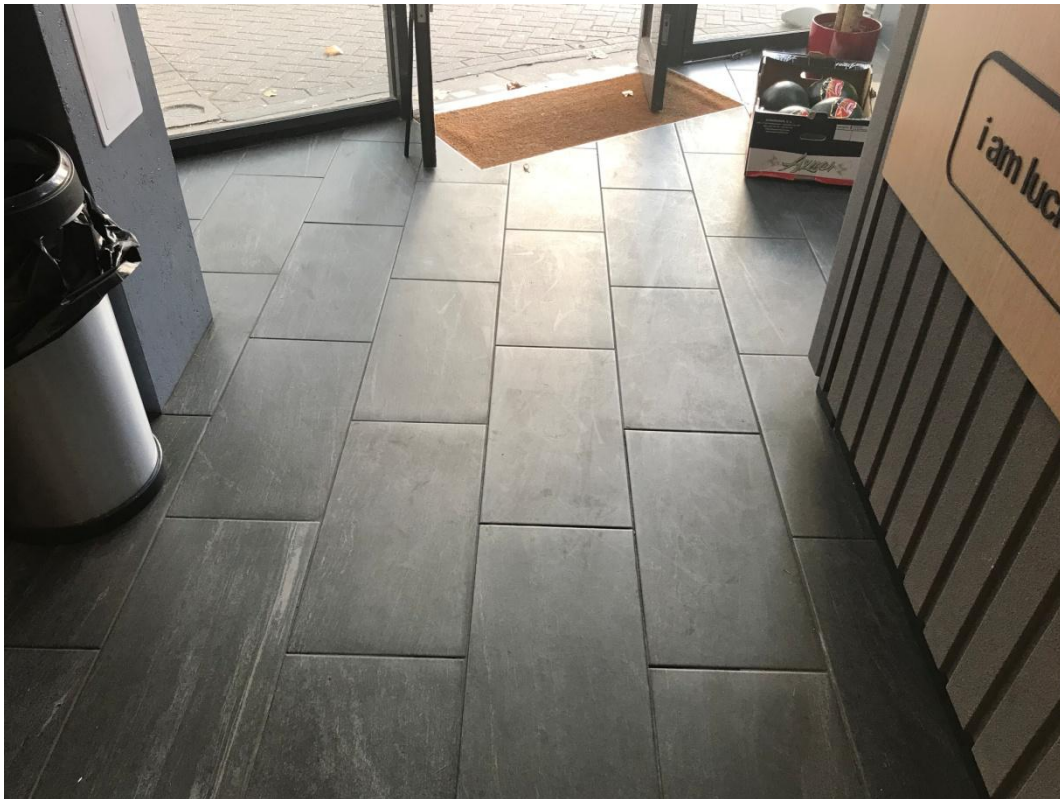
Fig 11 The tiled finish to the floor.

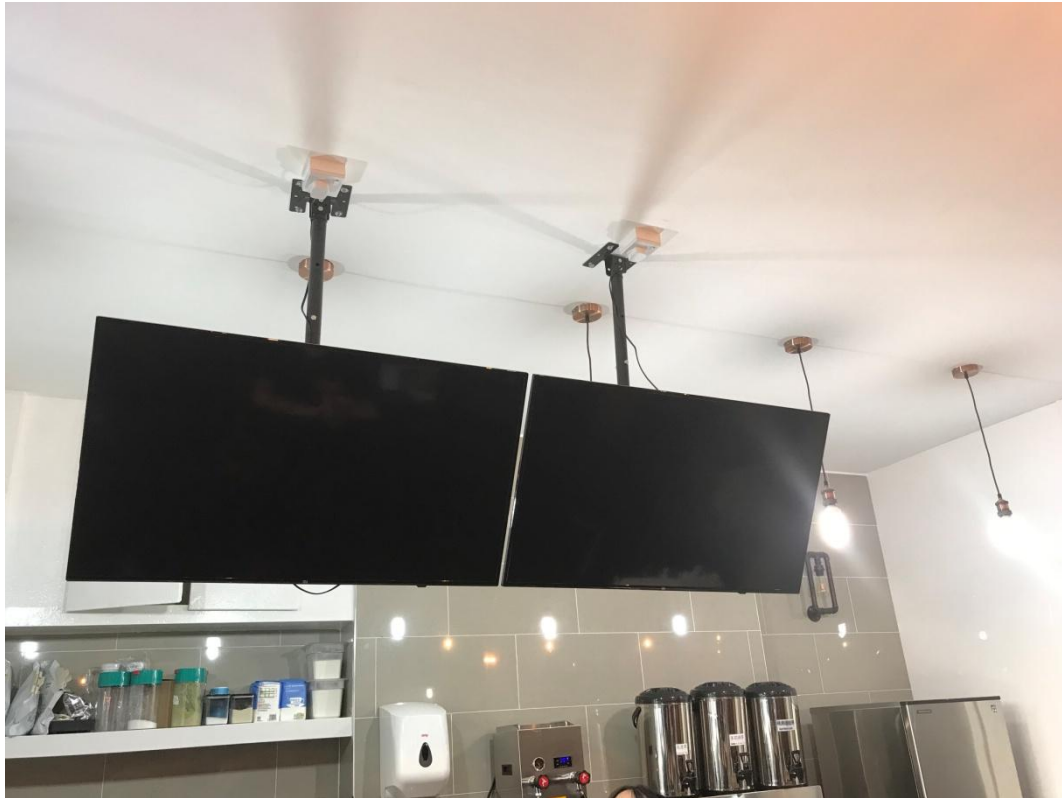
Fig 12 Installed televisions to the modern ceiling.

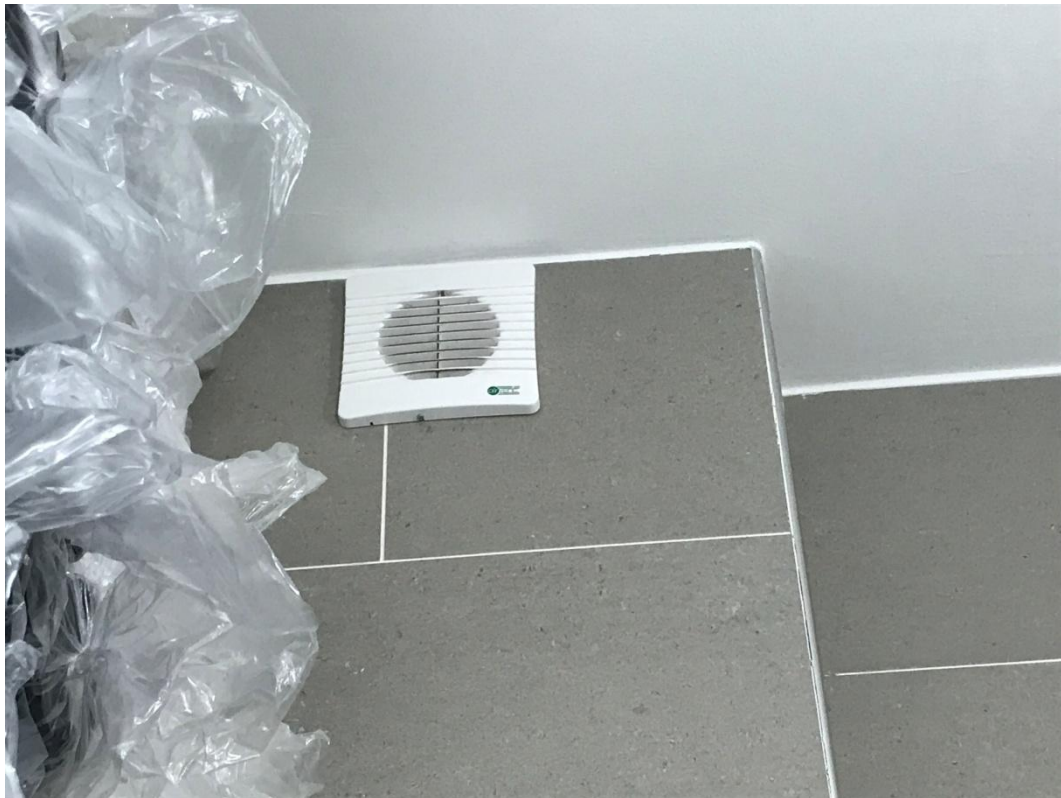
Fig 13 Extractor fan fitted at high level to the rear prep area/store room.

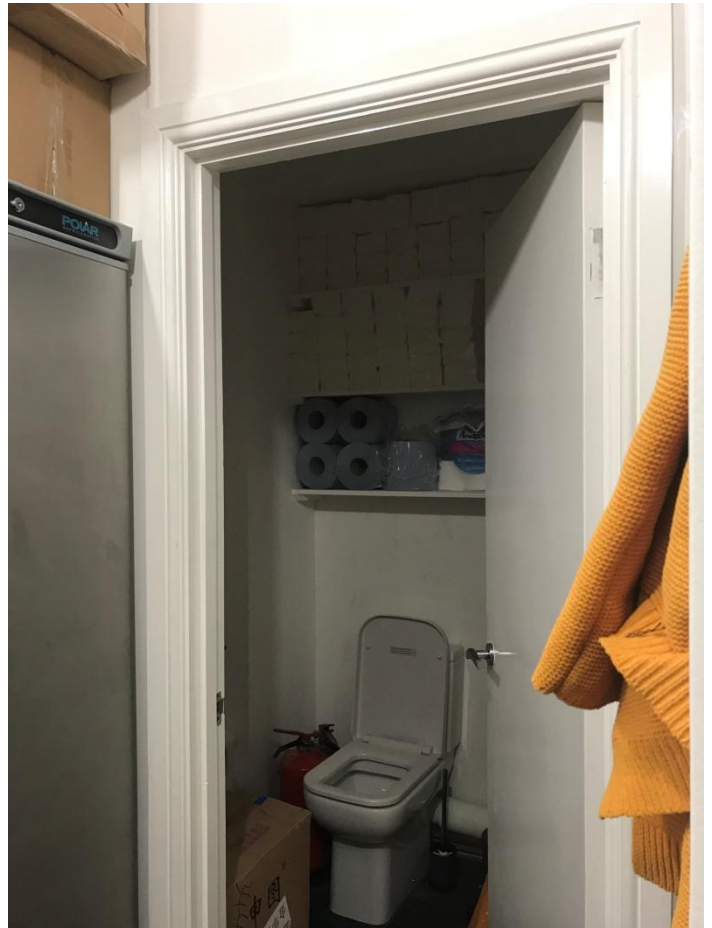
Fig 14 Modern partitions to form new WC at rear of retail unit.

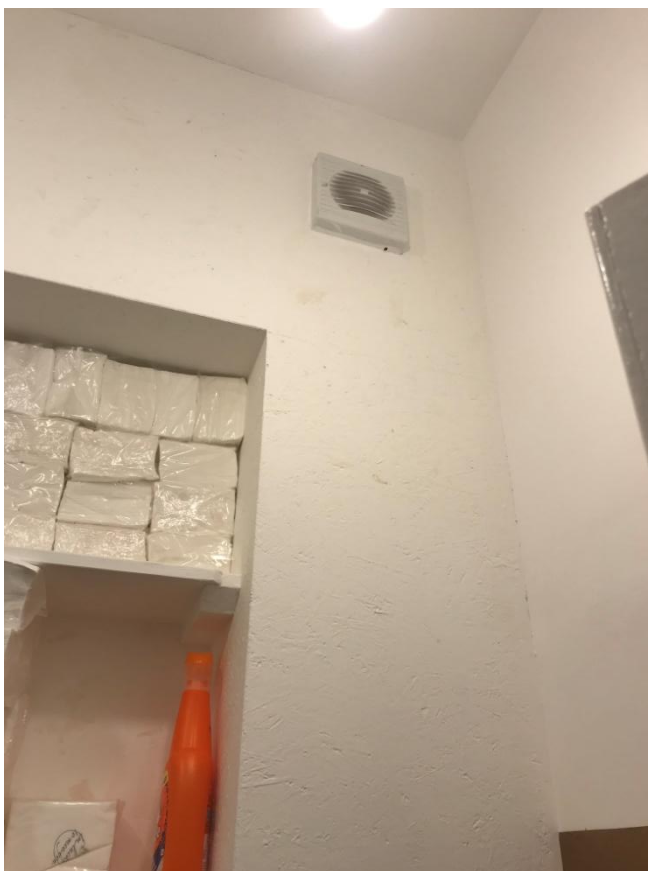
Fig 15 Extractor fan fitted at high level to new WC area.

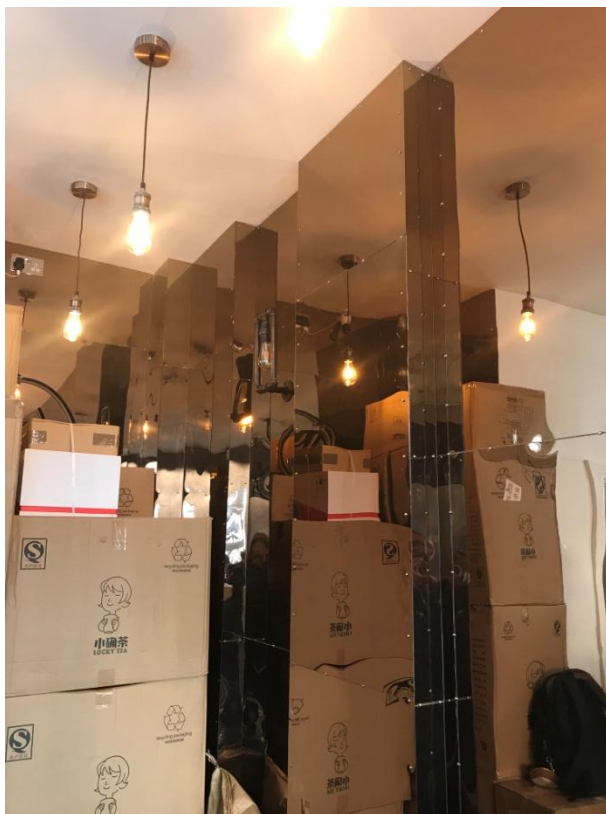
Fig 16 Mirror film applied to the modern Sterling board covered walls.

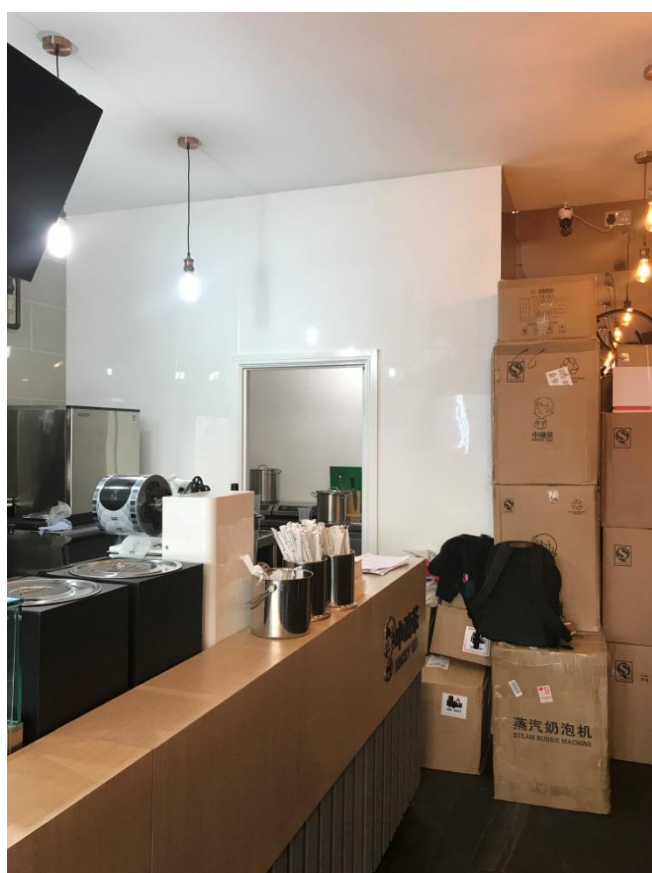
Fig 17 New partitions at rear of the retail unit.

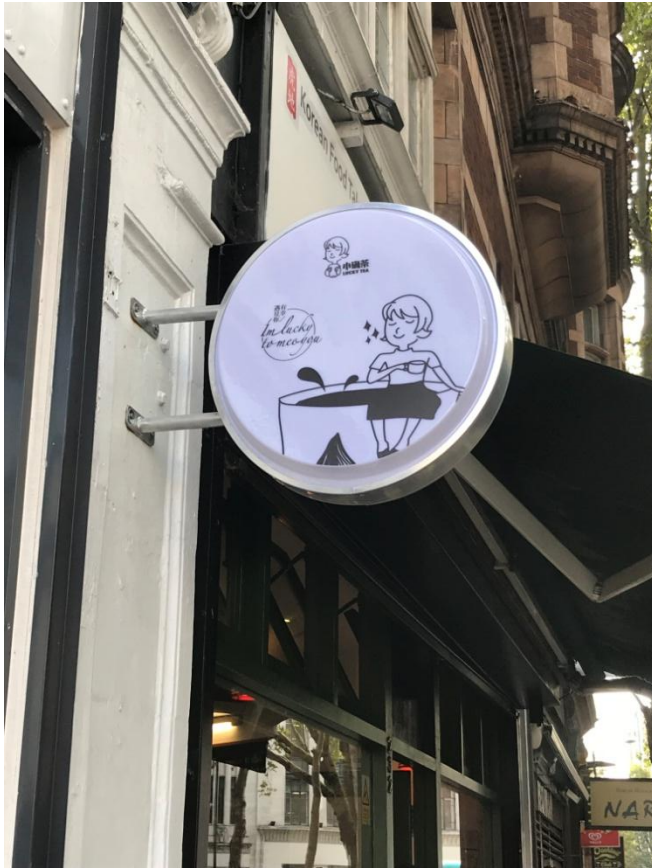
Fig 18 The installed acrylic fascia sign.

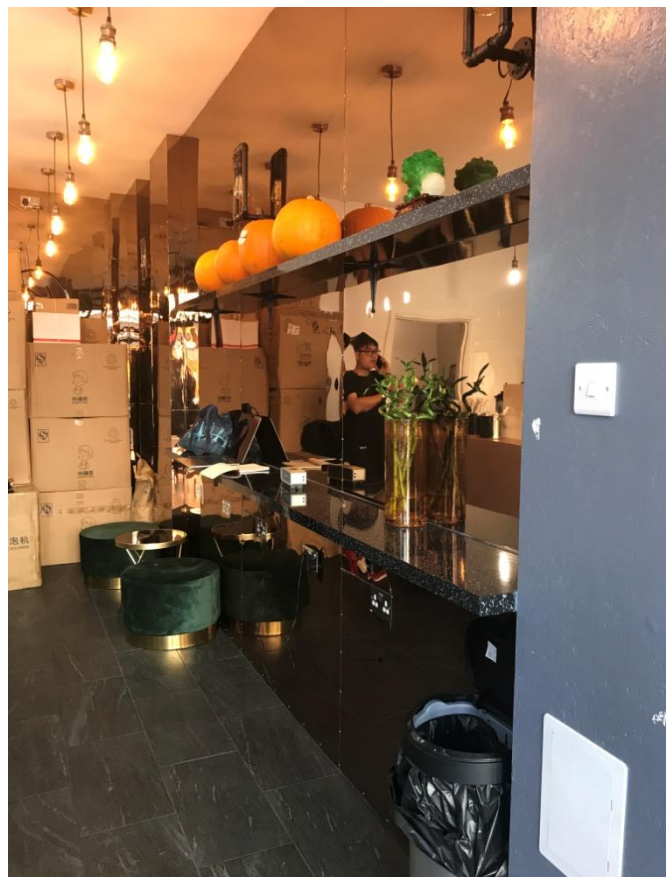
Fig 19 The southern internal party wall of the retail unit.

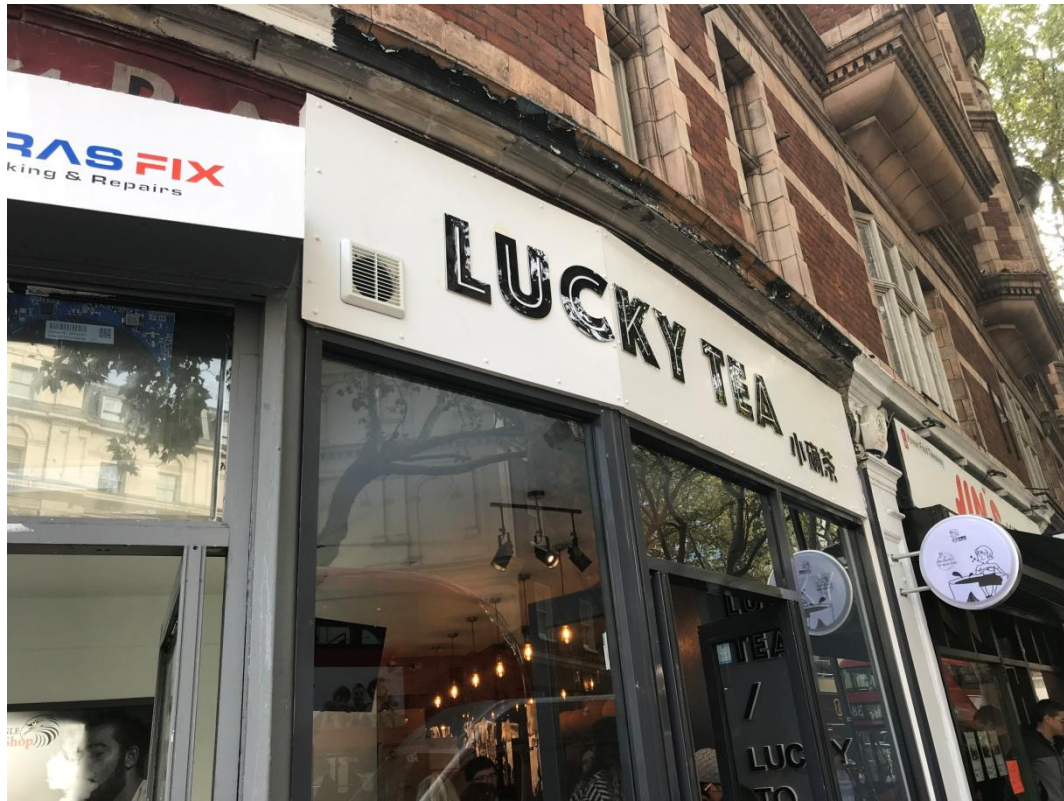
Fig 20 The 'as built' frontage to the retail unit.

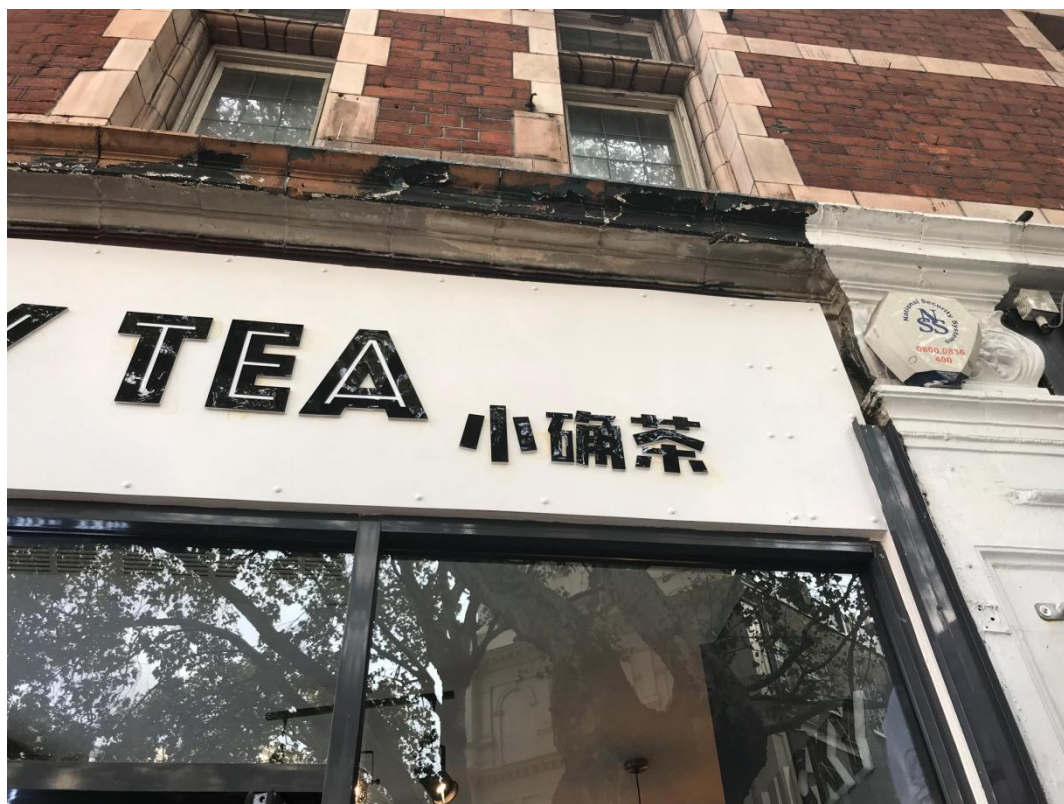
Fig 21 The installed fascia sign.
