ASSESSMENT OF CONDITION

**Front Garden Walls
at
48 Downshire Hill,
London.
NW3 1NX**

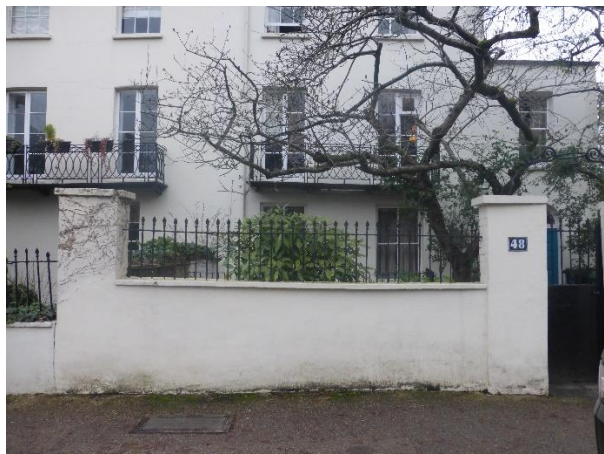
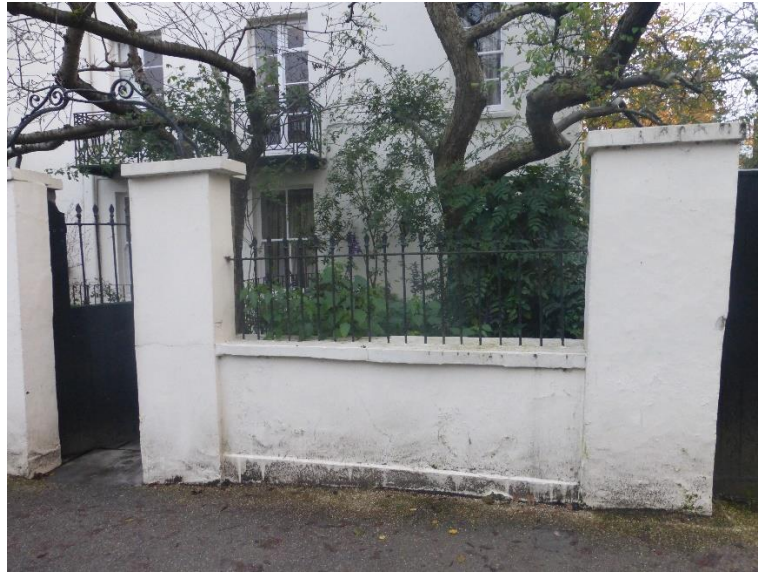
- 3.1 The main frontage wall has a number of vertical cracks to the renderwork face. These are a mix of category 1 and 2, mostly small minor cracks. Generally these can be filled and made good and monitored for reoccurrence.

- Fill and make good hairline cracks
- Cut out, fill and/or restitch brickwork to the boundary pier medium crack, repair render to match and make good.
- Remove loose render to the boundary pier, and patch repair to match existing render to make good. Approx area 0.3m² to the north east side face between railings and coping.
- Rake out loose and eroded pointing to the rear, garden, face of the frontage plinth wall and repoint with matching mortar and joint finish.
- Remove vegetation from the garden separating wall and carefully take down full length to higher ground level. Clean and set aside bricks for re-use.
- Rebuilt in matching 225mm thick brickwork, Flemish bond with matching mortar and joint. Supplement with good quality matching secondhand bricks to make up any deficiency.
- Reuse, and rebed existing copings.

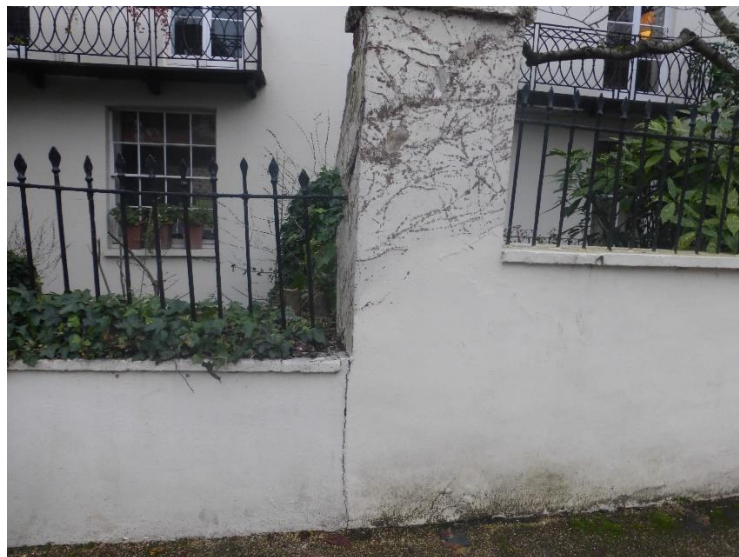
- 3.2 At the junction of the boundary pier and plinth wall to No 47, there is a wider vertical crack, Category 3, medium, which does require repair.

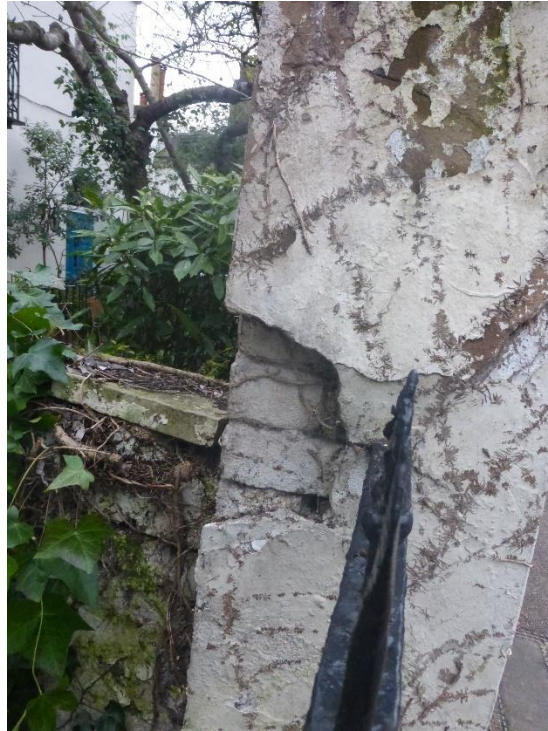
- 3.4 To the boundary pier in the frontage wall, a large patch of render to the north east face, approximately 1.5m above ground is missing and surrounding render 'hollow' and loose. Water can penetrate behind the render causing further deterioration. This requires repair.

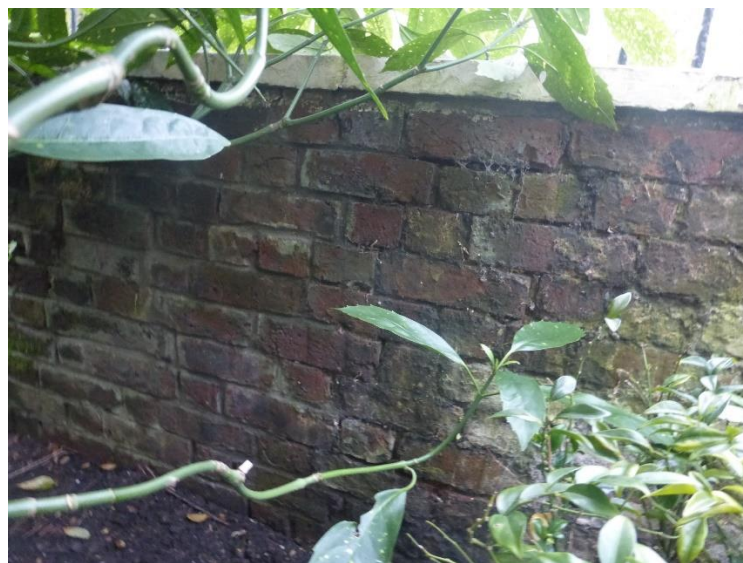
- 3.5 The frontage plinth all has face brickwork to the rear, garden, face. The pointing is in very poor condition, eroded, loose and missing and requires repointing to the entire length.

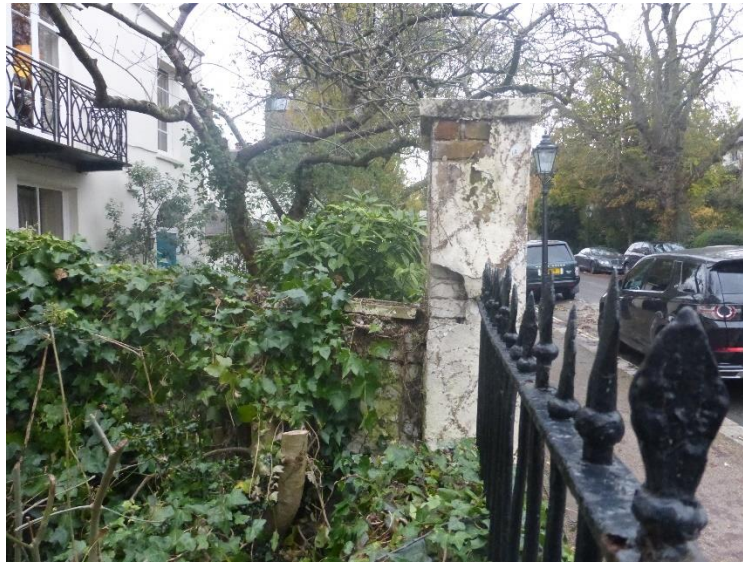
- 3.6 The most significant damage is to the front garden separating wall. A prior existing holly tree has been removed although part of the trunk remains.

The wall needs to be rebuilt above higher ground level.

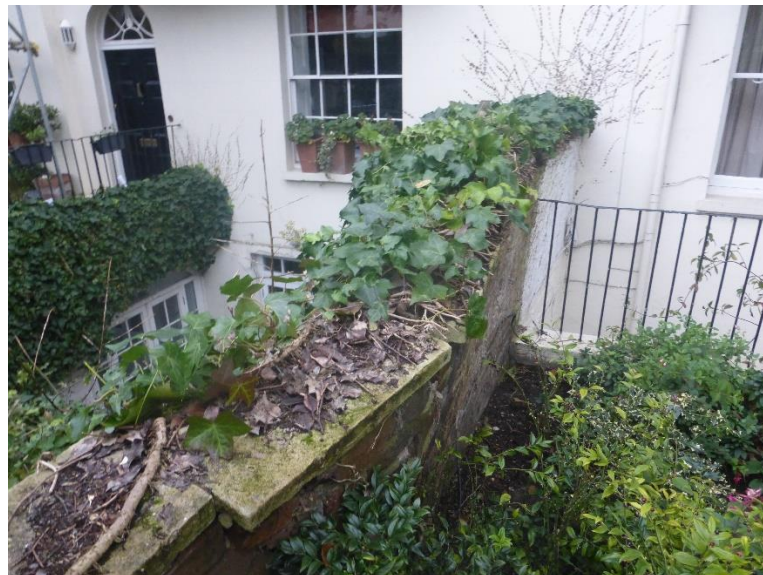
This clearly grew against the wall 'pushing' it over as it grew. A 2m length of the wall now has a significant bulge and is leaning approximately 100m from the vertical.

This puts it outside the middle third and is therefore unstable.

The mortar pointing to this wall is also in very poor condition, eroded and missing, adding to the instability.

It is likely on the creeping vegetation, which covers the wall on No 47's side, is preventing its collapse.
