## Condition Report

**The Hoo,  
17 Lyndhurst Gardens  
Hampstead  
London**

November 2019

SDA Consulting LLP  
Edward House  
Deva Centre  
Trinity Way  
Salford  
Manchester  
M3 7BE

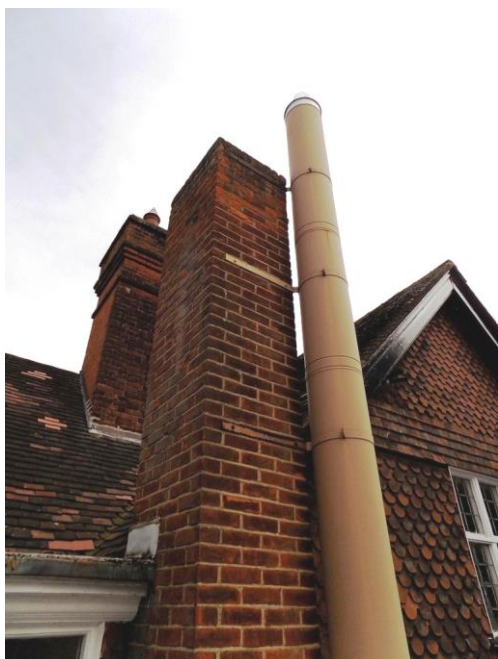
Chimney Stack 1

The chimney stacks are all generally plumb and appear to be free from significant cracking as a result of structural movement. There are varying amounts of spalled bricks to many of the chimney stacks, primarily at high level below the cappings and the decorative corbel courses. This is due to water run-off from the cappings and the corbels soaking the bricks and freeze thaw cycles causing spalling of the faces of the bricks. This appears to have been made worse to many of the stacks by later repointing with cement rich mortar that does not allow the wall to breathe and dry out naturally and which holds back moisture and traps it within the bricks, causing the bricks to spall when this freezes.

The spalled bricks will need to be replaced to match existing and the cement mortar pointing should be removed back to the original pointing and then repointing using a lime, rather than cement mortar that will allow the walls to dry out naturally.

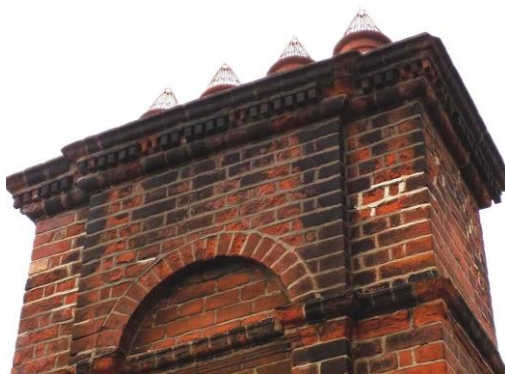
Spalling brick to chimney stack 4

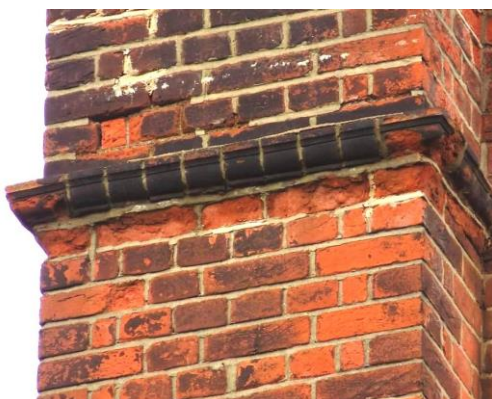
Spalling brick to chimney stack 4

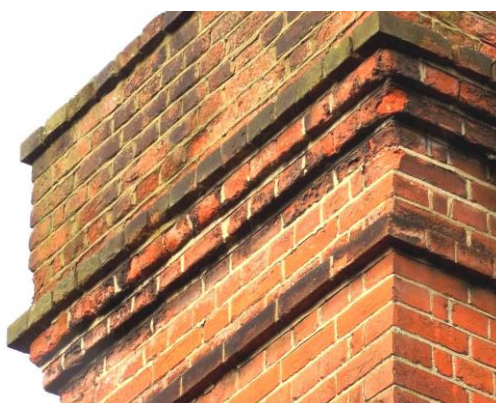
Spalling to chimney stack 6

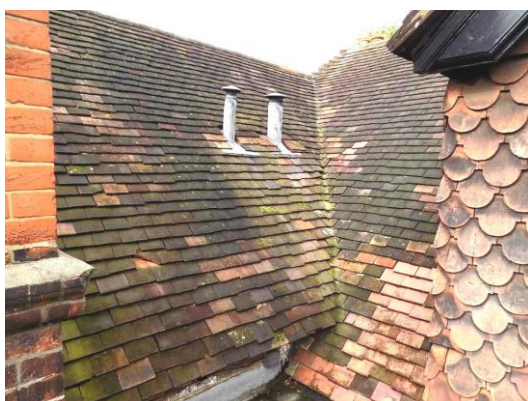
The majority of roofs are true to line and level with no significant deflection or distortion noted to the roof structures and ridge lines. The tiles themselves are generally well fixed although relatively extensive areas have clearly been patch repaired and partially retiled at various times in the past. The areas that have been patched and repaired are concentrated around valley gutters and chimney stacks and are thought to be due to damage caused by access onto the roofs to repair chimneys and other features rather than failure of the tile fixings themselves. This patch repair is most evident to the roofs around the south east terrace and the roofs around the chimneys and either side of valley/box gutters such as roofs 9 and 12-15.

Patched tiles to roofs 2 &amp; 18

A number of isolated tiles are broken, missing or slipped and a general overhaul of the tiled roofs will be required to refix loose and slipped tiles and replace broken and missing tiles. There is one area at the back of the dormer window to roof 6 where a coating has been applied as a poor quality patch repair and this should be retiled.

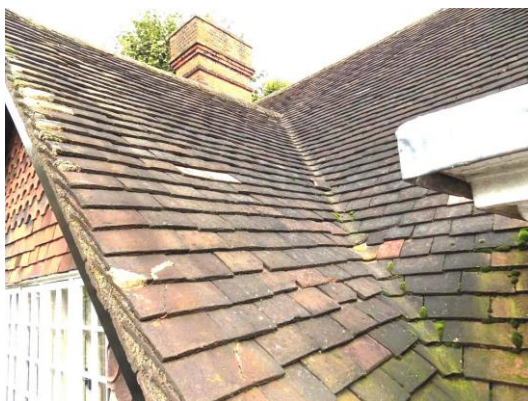
Broken and slipped tiles to roof 6

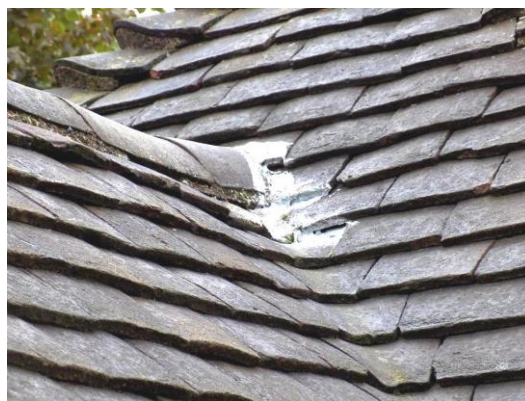
Coating patch to rear of roof 6 dormer

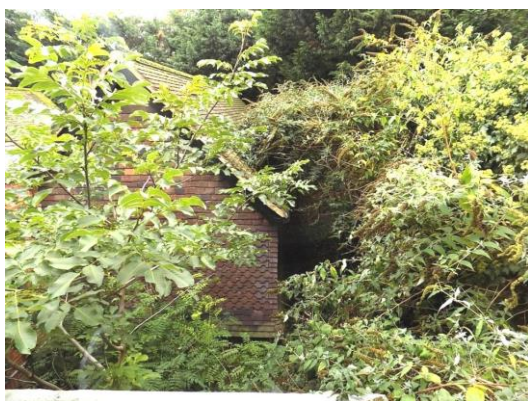
Trees growing into extension roof

The pitched tiled roofs to the extension are in reasonable condition, requiring isolated patch repair and the cutting back of trees and shrubs that are growing onto roof pitch 29. The aluminium framed and glazed roof 25 over the link conservatory is in fair condition but the opening lights have been patched with flashband and should ideally be repaired with lead if this area is to be retained as part of the refurbishment.

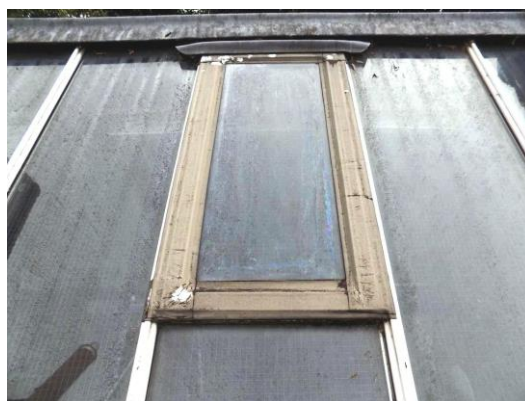
Flashband repair to glazed roof

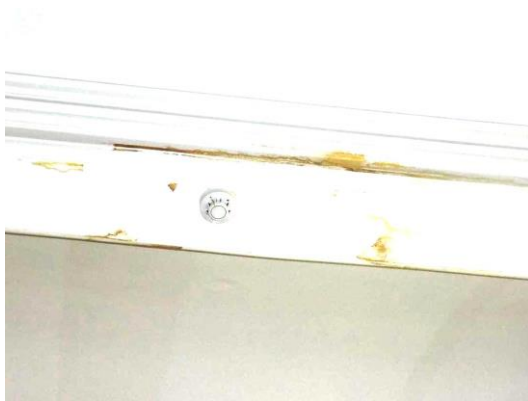
Damp staining was noted internally to the two storey ceiling in the main entrance hall and this coincides with the lead valley gutters between roofs 12 and 13. It is not clear if this is a current leak or is historic and access was not possible to view this gutter or the similar one between roofs 14 and 15 externally. The valley gutters will need to be checked and repaired as required.

Damp staining above entrance hall

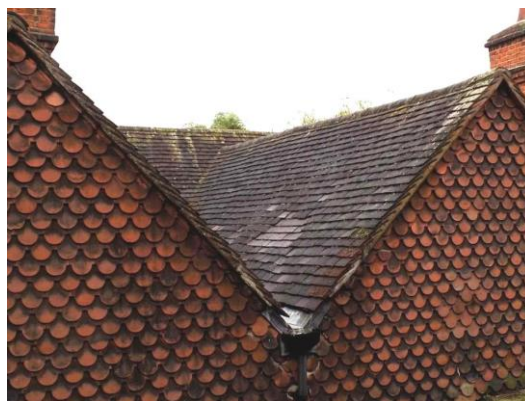
Valley gutter above staining

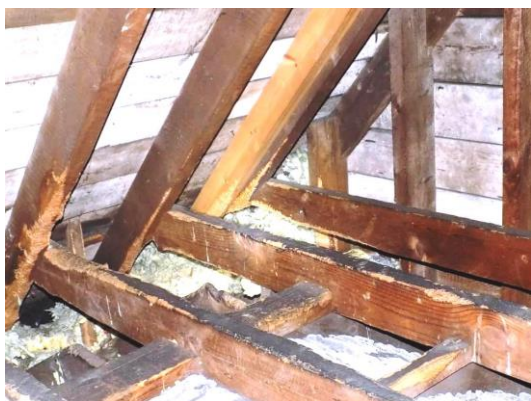
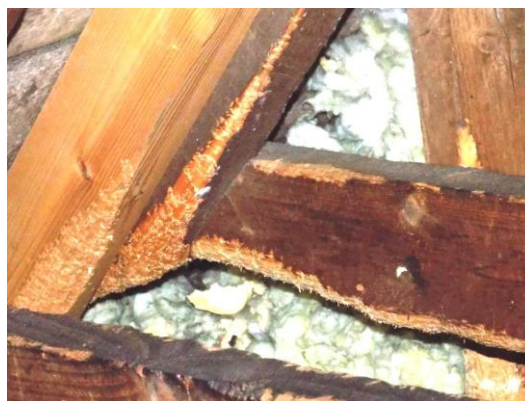
The timber roof structures and members are generally free from signs of deflection and movement, decay and insect attack but damage caused by squirrels gnawing at the timber joists and rafters is evident in roof 21. One rafter has been repaired and it is therefore assumed that this is a historic problem and the roof void has now been properly sealed but this needs to be confirmed to prevent further damage. Old wasp nests were also noted in the roof voids below roofs 5 and 19 but these are now dormant as they are only used once.

Squirrel damage in roof 21

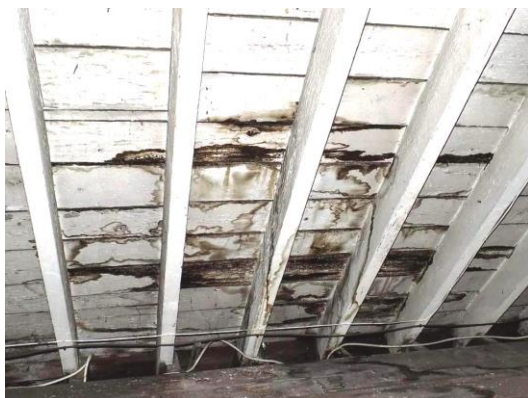
Damp staining was also evident in a number of areas, especially around chimney stacks and valley gutters. The damp staining in roof pitch 6/18 appears to coincide with chimney stack four and the raised flat roof nine. This flat roof is a later addition between the original roof pitches to accommodate the lift. The damp damage has caused some isolated decay but this is not structural and the staining is thought to be historic. This should however be checked during heavy rain.

Damp staining around chimney 4

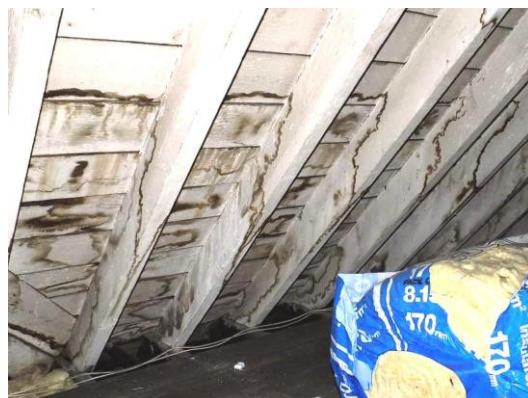
Damp staining below raised flat roof 9

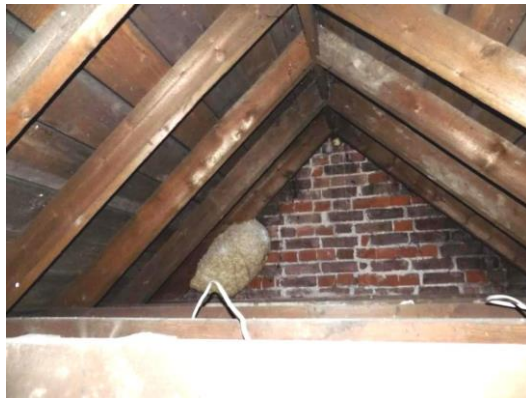
Old wasp nest to roof void 5

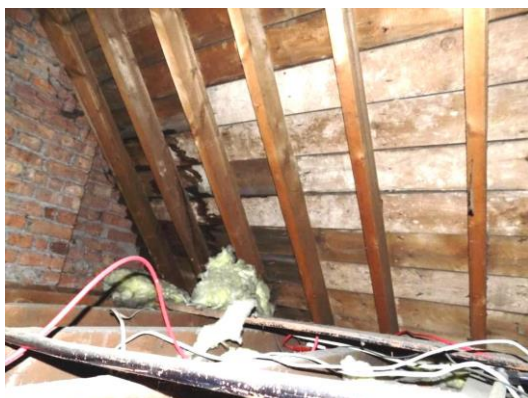
Damp staining was evident within roof void 15/16 again, around chimney stack six and the valley gutter to the west facing raised gable. There does not appear to be any decay to the roof timbers in these areas and the damp staining is probably historic but this should again be checked during heavy rain.

Damp stains to chimney to roof 15/16

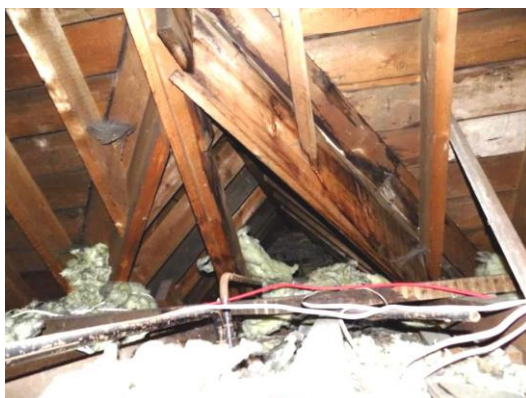
Damp stains to raised gable to roof 16

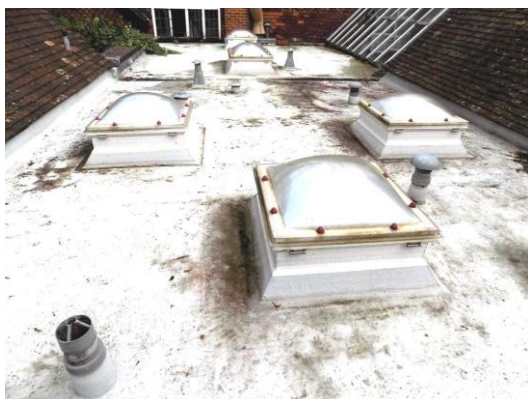
The liquid coating is a relatively poor quality patch repair for a historic building and appears to have been applied without repairing or preparing the substrate material. It will be very difficult to remove the coatings without damaging the underlying roofing and whilst most areas are free of leaks now, it is expected that re-covering of the roofs on a phased basis will be required. This will involve removing much of the original coverings below the coatings and replacement with new lead and asphalt, in keeping with the historic nature of the house. It will also allow increased insulation to be fitted although this will require careful design and detailing to the roofs and surrounding upstands to accommodate the increased thickness of insulation. This will be most evident to the flat roof over the former reception office to the north side of the house where the original leaded window cill heights are very low.

Coated flat roof to extension

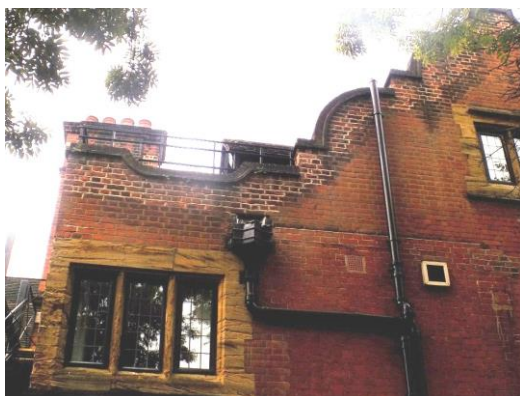
Cast iron rainwater goods

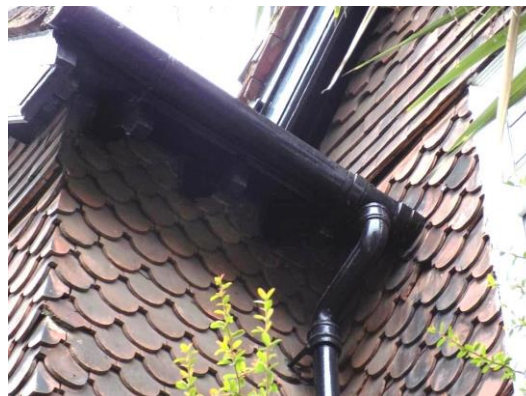
Replacement cast iron gutters and pipes

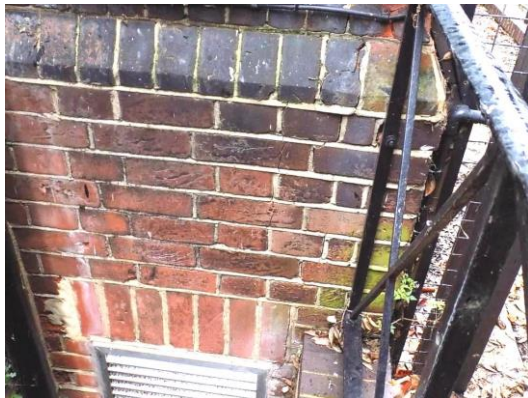
The external walls are generally in reasonable structural condition being largely free from significant cracking, bulging and evidence of structural movement. Isolated cracking was noted to the side of the large bay window to the south elevation, next to the glazed link and this appears to be due to the insertion of the louvred vent providing fresh air into the basement boiler room. Cracking was also noted where the external false porch has been added to the east elevation to form a store only accessible from the outside. This is minor and just requires repointing.

Cracking to side of south bay window

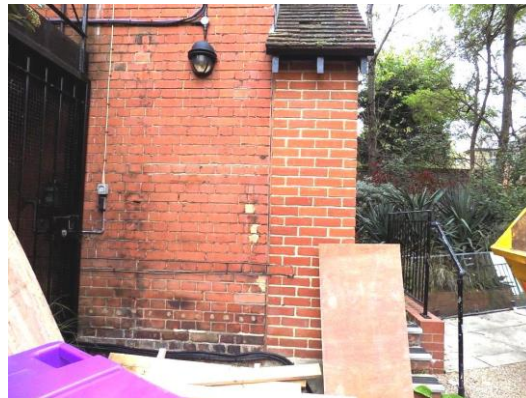
Added false porch to east elevation

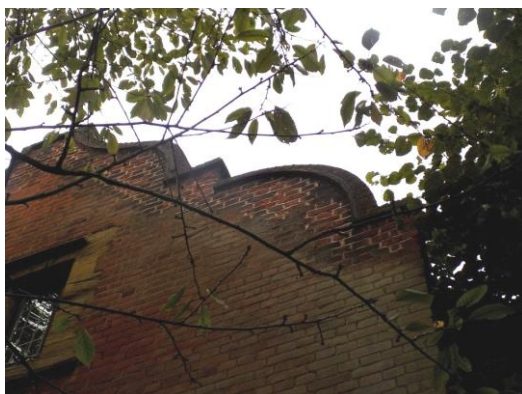
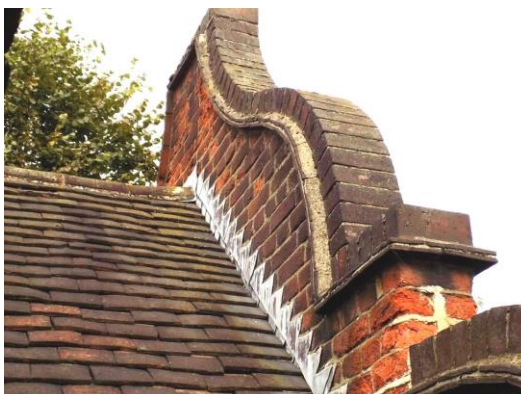
The mortar pointing to the raised dutch gable to the east elevation has been patch repointed to a relatively poor standard on both sides with poorly matched mortar. The brickwork has eroded and spalled due to a combination of water run-off from the brick on edge coping detail combined with hard cement-based pointing mortar trapping moisture into the bricks and freeze/thaw cycles. The top section of both sides of the raised gable wall and the brick on edge copings will need to be raked out, eroded bricks replaced and the walls repointed with a lime-based mortar which will allow the walls to dry out naturally. Eroded pointing was also noted to the parapet to the south east terrace and to the side elevation to the left of the main entrance door and these areas should also be repointed with a lime mortar.

Eroded pointing and spalling to east elevation

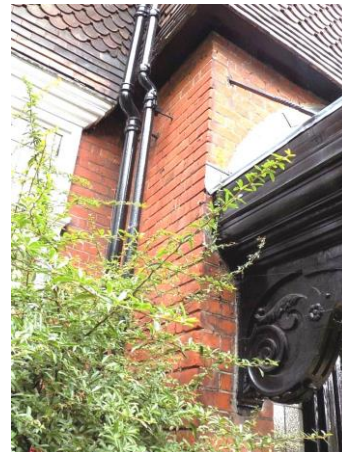
Eroded pointing to side of south door

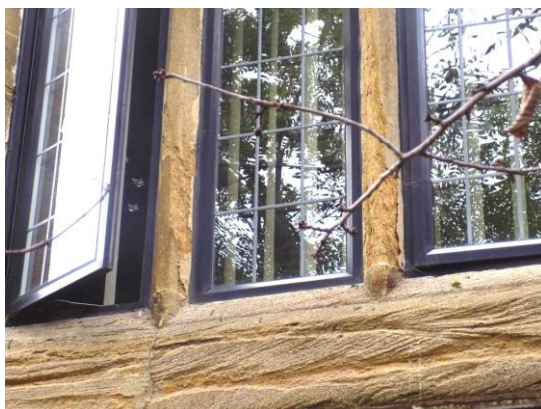
The windows to the east elevation and around the south east fire escape have stone surrounds and these have eroded and been redressed to remove loose and eroded stone. Poorly matched stone mortar repairs have also been carried out to some of the stone cills and mullions and these have accelerated some of the erosion to surrounding areas. The mullions and surrounds to a number of the windows are severely eroded and cracked and to a number of the mullions and surrounds the stone is beyond further repair and indent repairs or whole member replacement is now required with new matching stone.

Eroded stone mullions

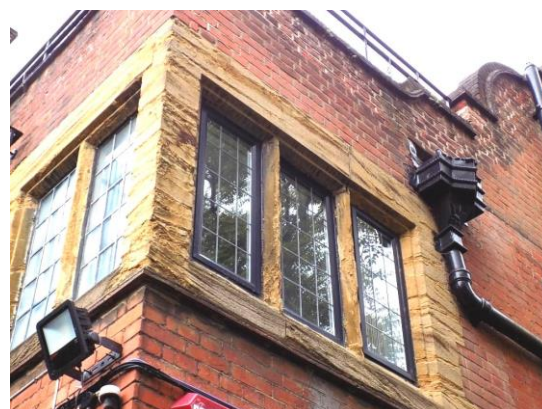
Eroded and redressed stone

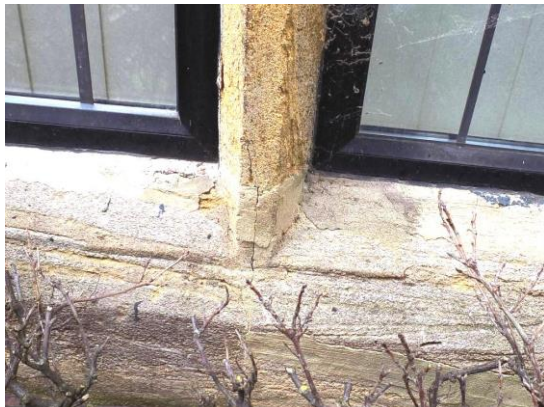
Poorly repaired cills and mullion

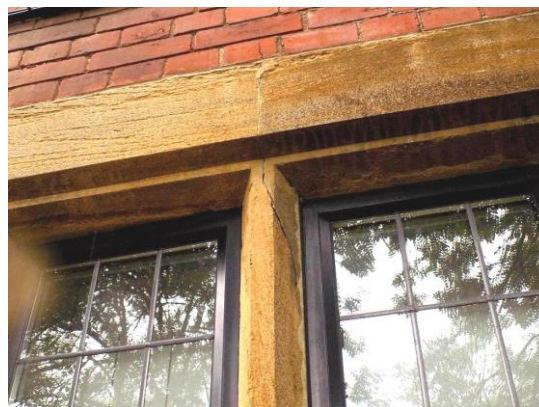
Cracked mullion

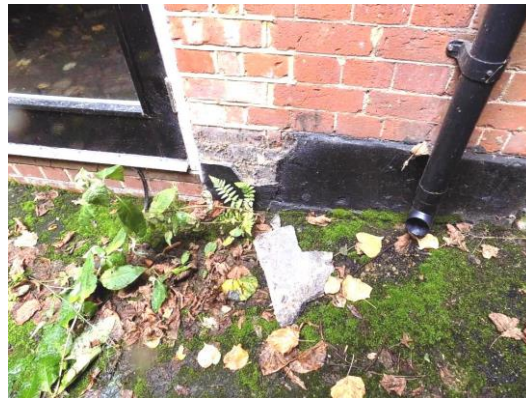
There are render and asphalt upstands at low level to the external walls to most of the north and east elevations of the original building, along with pointed-up drill holes above the plinths to some of the areas outside the IT room and office behind the original reception and to the east elevation walls. The floor level of the IT room and rear office behind the reception are 360mm lower than the external ground level and this changes to 270mm higher behind the reception and then approximately level for the remainder of the rear path to the north east corner. The upstand continues around the east elevation where the external ground level is again raised. The original building has an asphalt damp proof course and this is visible where it has extruded out to the large bay window to the front front elevation and it is assumed the injected damp proof course and render at the rear have been inserted to remedy the damp noted in some of the rear rooms. The render has failed in a number of areas and become detached from the wall.

Failed render plinth to north elevation

The injected damp proof course will not resolve this and high damp readings were noted in the areas where the floor level is lower than the ground level to the rear. The only solution to resolve the damp issue in these areas will be to reduce the external ground levels or where this is not practical to dig down and tank the walls externally outside or to tank internally with a waterproof render or membrane system.

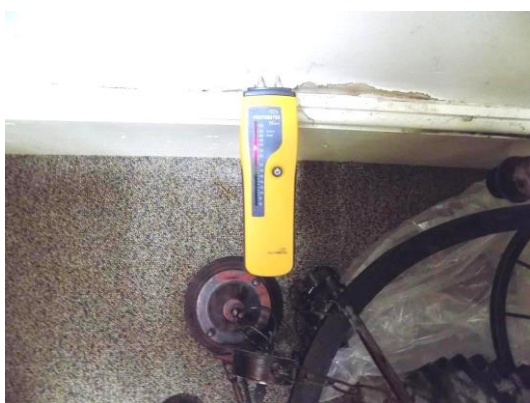
Damp reading in room next to IT room

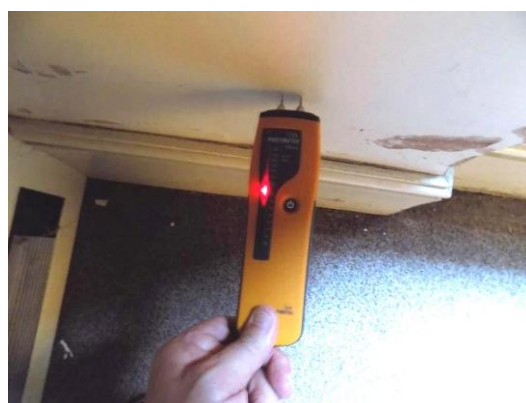
Damp reading to office behind reception

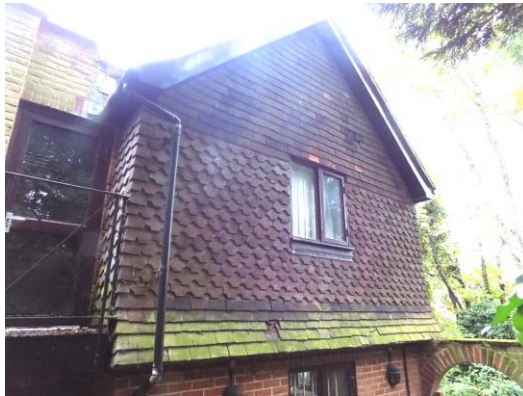
Missing tiles to extension

The tile hanging to the first floor walls and gables of both the original part of the house and the extension are generally well fixed with only isolated missing and broken tiles in need of patch replacement and slipped tiles in need of refixing. There are some poorly matched patch repairs to the west elevation where square tiles have been used to replace curved tiles and these should be made good with matching tiles.

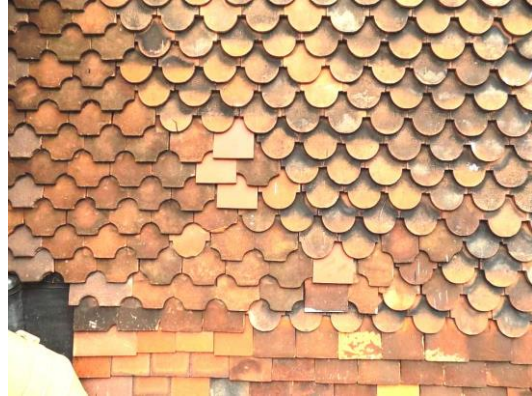
Patches of incorrect tiles

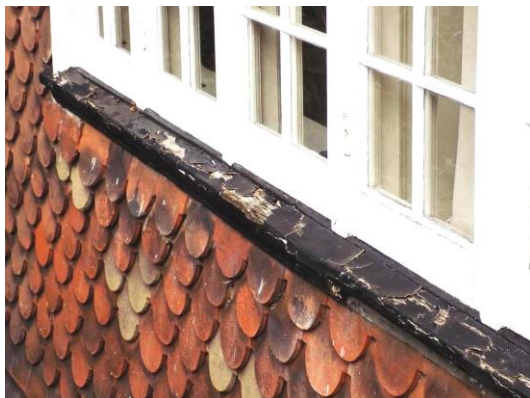
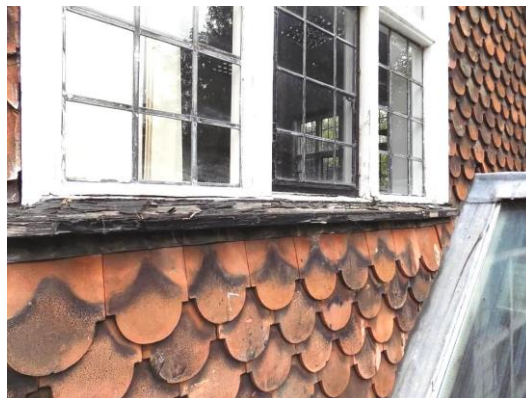
The timber windows to the original part of the house are only in fair condition with a number of severely decayed windows to the south and west sides of the house facing the prevailing weather in need of complete replacement. The worst affected windows are to the west elevation overlooking the flat roof of the extension and to the south and west sides of the extension where the windows are beyond repair and require complete replacement.

Decay to first floor west window

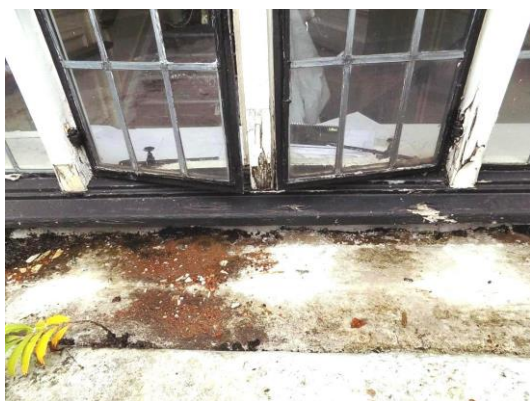
Decay to staircase window

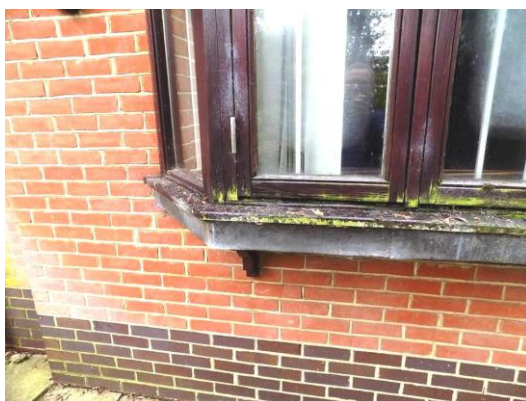
Decay to extension window

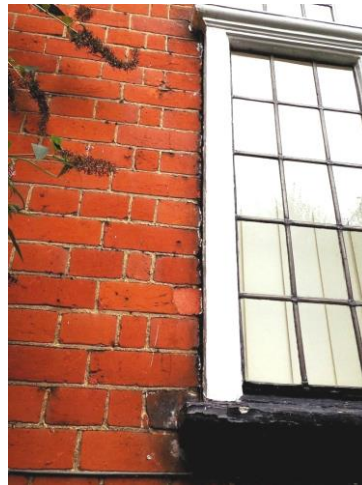
Missing frame sealant/pointing

Elsewhere, the timber windows require a programme of splice repair, renewal of glazing beads and putties and repainting and this should include perimeter frame seals/pointing where the window frames meet the brickwork. This is most evident to the windows and dormers facing west and south, including the large bay windows to the south elevation.

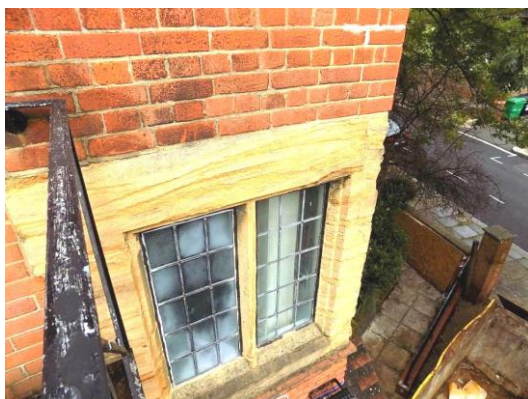
Wired glass has been added to the inside of the leaded windows near the fire escape in the south east corner of the building. This is to fire separate the rooms from the fire escape to ensure it is useable during an evacuation. The inner panes have caused dust and condensation to form between the panes and if the fire escape is not required in the refurbishment this can be removed.

Inner glass to windows to fire escape

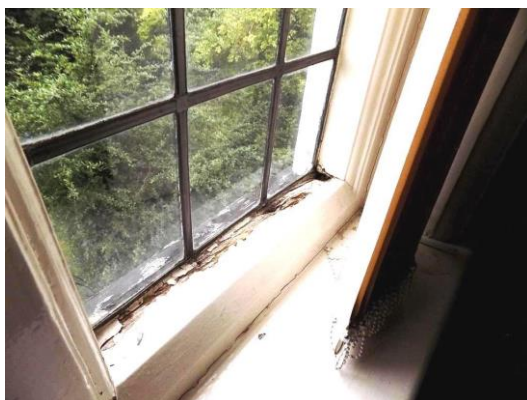
There are also signs of decay to some internal cills and frames due to a combination of long term water penetration through the lead comes and condensation. All damaged areas will require splice repair. Many of the windows have missing ironmongery such as catches and stays and many are very draughty, poor fitting and inoperable. The windows will require a phased programme of replacement, repair and overhauling and this will need to take account of the listing for any replacement windows and the use of specialist conservation contractors for the leaded lights, timber repair and restoration, draughtstripping and overhauling.

Internal decay to cill

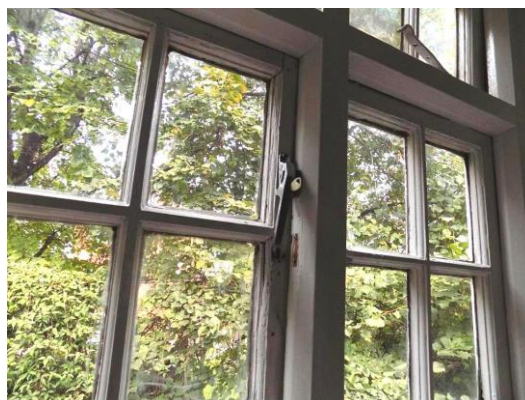
Defective window ironmongery

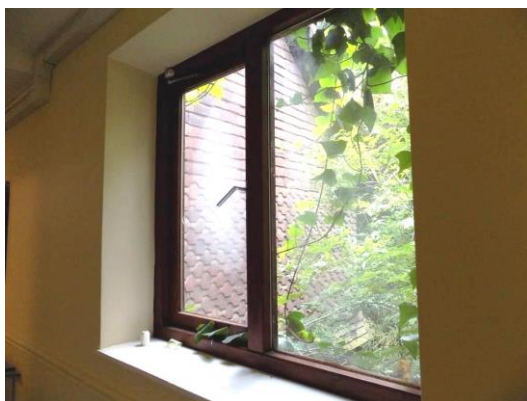
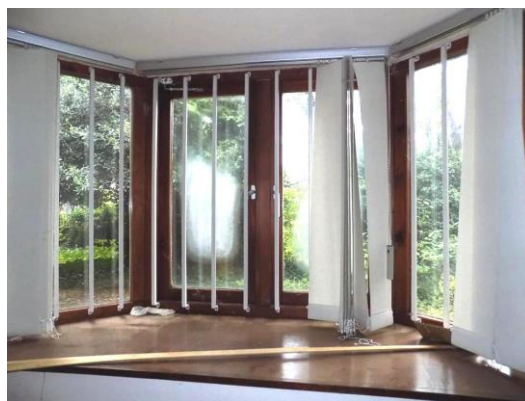
The hardwood windows to the extension are poor condition and many of the double glazed units have failed. The concealed mechanisms are broken or very difficult to operate. The windows are around thirty years old and the ironmongery is likely to be obsolete. The windows will be difficult and expensive to repair and as some are also decayed it is likely to be more cost effective to replace the windows.

Failed double glazed units to extension

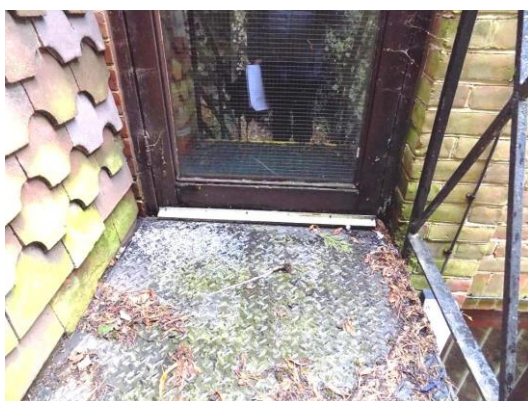
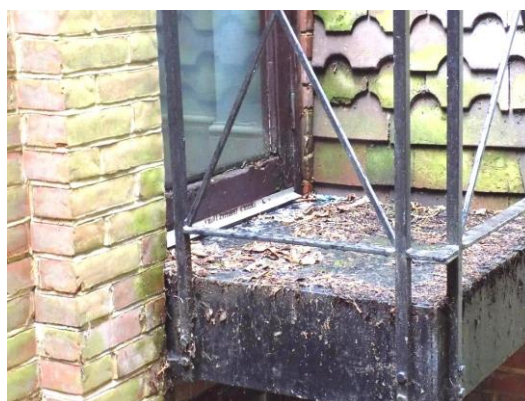
With the exception of the main entrance door, the external doors are generally low quality softwood either flush or glazed and fitted with commercial ironmongery such as panic bars and access control. Decay is also evident to a number of the doors especially the fire exist doors to the west elevation of the extension. It is anticipated that all the doors except the main entrance door will be unsuitable and will require replacement as part of the refurbishment.

Decay to fire door to extension

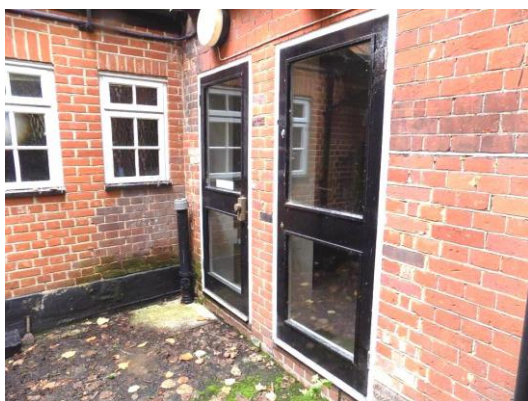
Poor quality fire doors

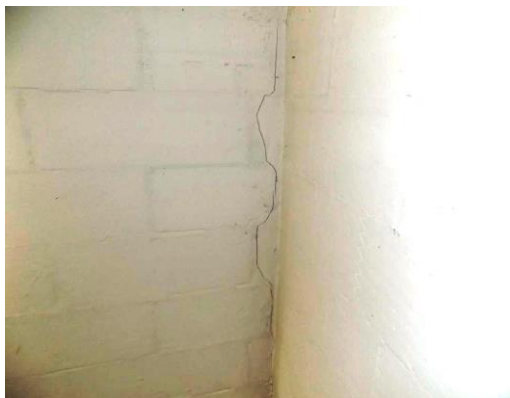
The internal walls are a mixture of solid masonry and timber stud partitions and are generally in satisfactory structural condition with isolated cracking noted to the internal walls in the extension as noted on the floor plans. This however appears to be due to shrinkage and thermal movement rather than foundation or other movement but will need to be monitored and further investigated as part of the refurbishment works.

Cracking to lower floor of extension

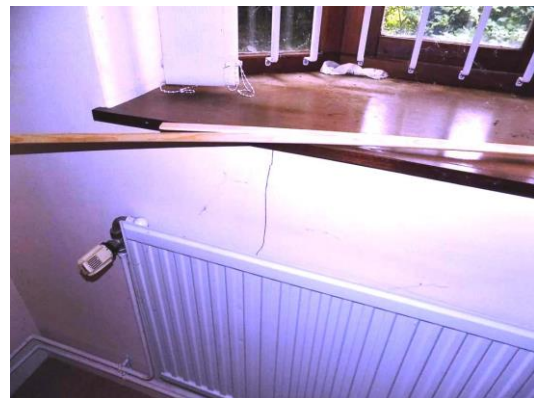
Cracking below south window in extension

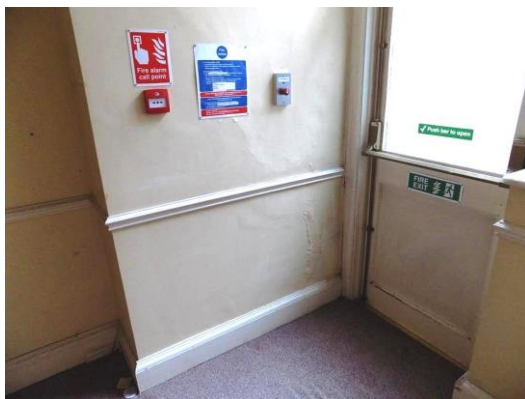
Dampness is evident in a number of areas and we have highlighted this on the floor plans. These are due to a combination of roof leaks below valley gutters and flat roofs and damp to some rooms where the floor is below external ground level to the rear elevation - see External Walls above. Damp readings were taken in these areas and these will require internal tanking.

Damp to office to north side

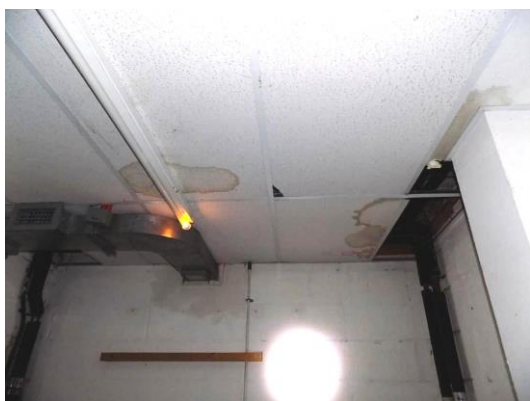
Damp was also noted in the lower floor of the extension but this appears to be due to water damage from the bathroom above that is being used by the contractors on site. We did not note any dampness in the lower ground floor area of the extension on the north side where the ground level is two metres above floor level so assume the tanking system in this area is sound. We assume all internal finishes and fittings will be replaced as part of the remodelling and refurbishment and have therefore not costed these items.

Damp to lower floor of extension

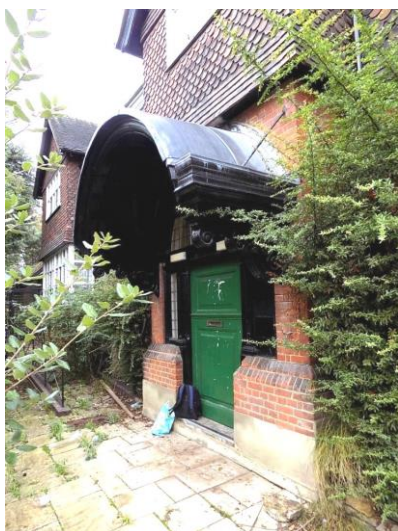
The pavings around the building are in serviceable condition but loose, broken and uneven flags will require rebedding and replacement. It is assumed that the hard paved areas will be replaced as part of the refurbishment works.

Paving to front door

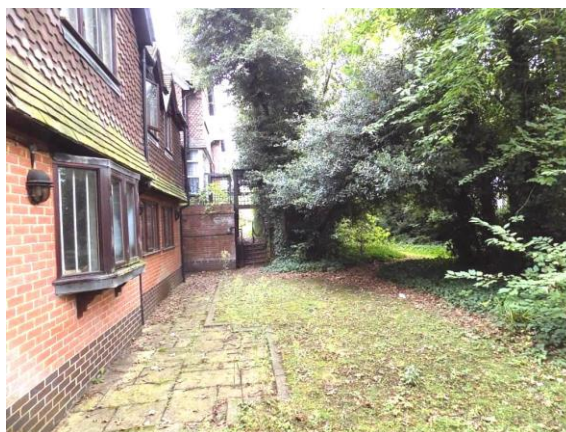
Paving to south side of extension

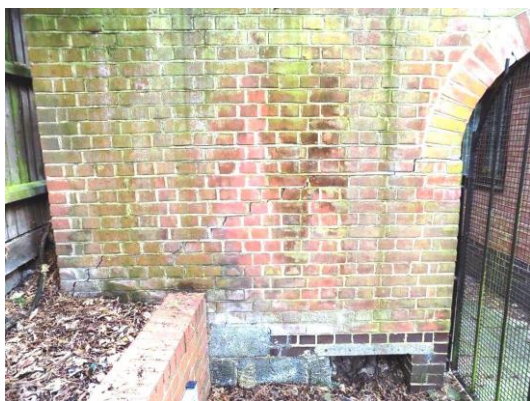
Cracking to wall to west boundary

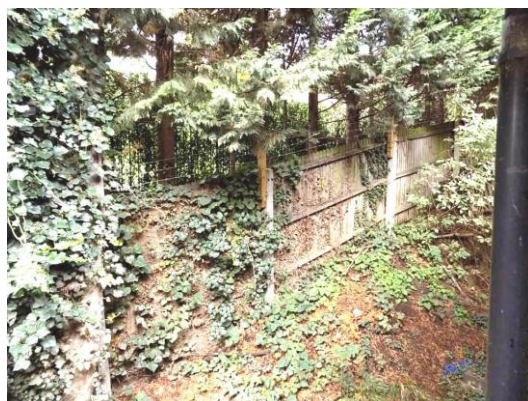
Fencing to west boundary

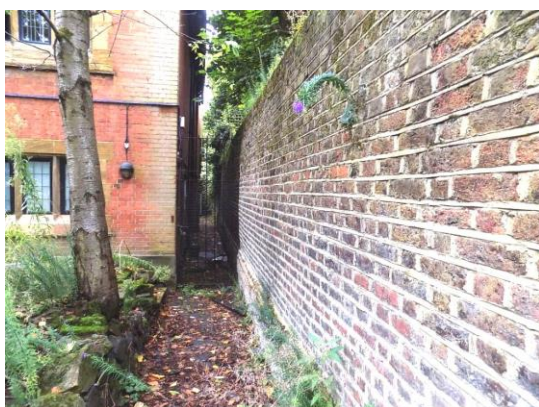
North boundary wall - east end

The large retaining wall to most of the north elevation is bulged in areas and large steel beams and braces have been inserted between the wall and external wall of the house around the chimney breast to chimney five. This appears to have restrained further movement in the retaining wall and the wall appears stable and well pointed at present but it would be sensible to monitor and measure the wall into the future, especially during and after the refurbishment works if any excavation or disturbance is planned to the north side of the site. There are minor areas of spalling brickwork approximately half way down the boundary that require repair and repointing and a large part of the wall was obscured by bushes and could not be viewed. This is the case around many of the external areas where bushes and trees are overgrown but we assume this will be cleared prior to the refurbishment work.

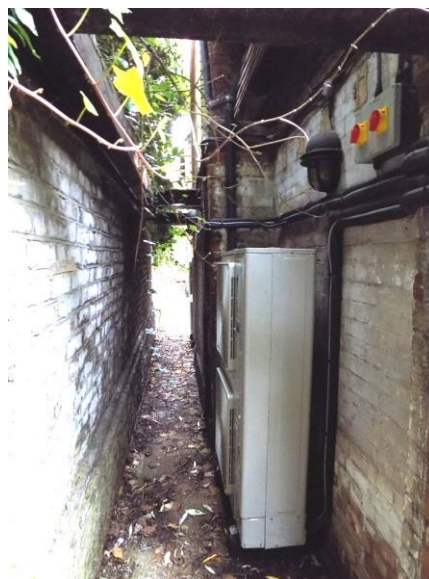
Steel beam and braces to north wall

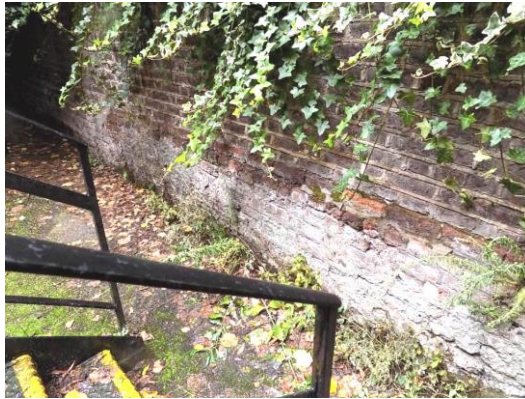
Spalling to north boundary wall

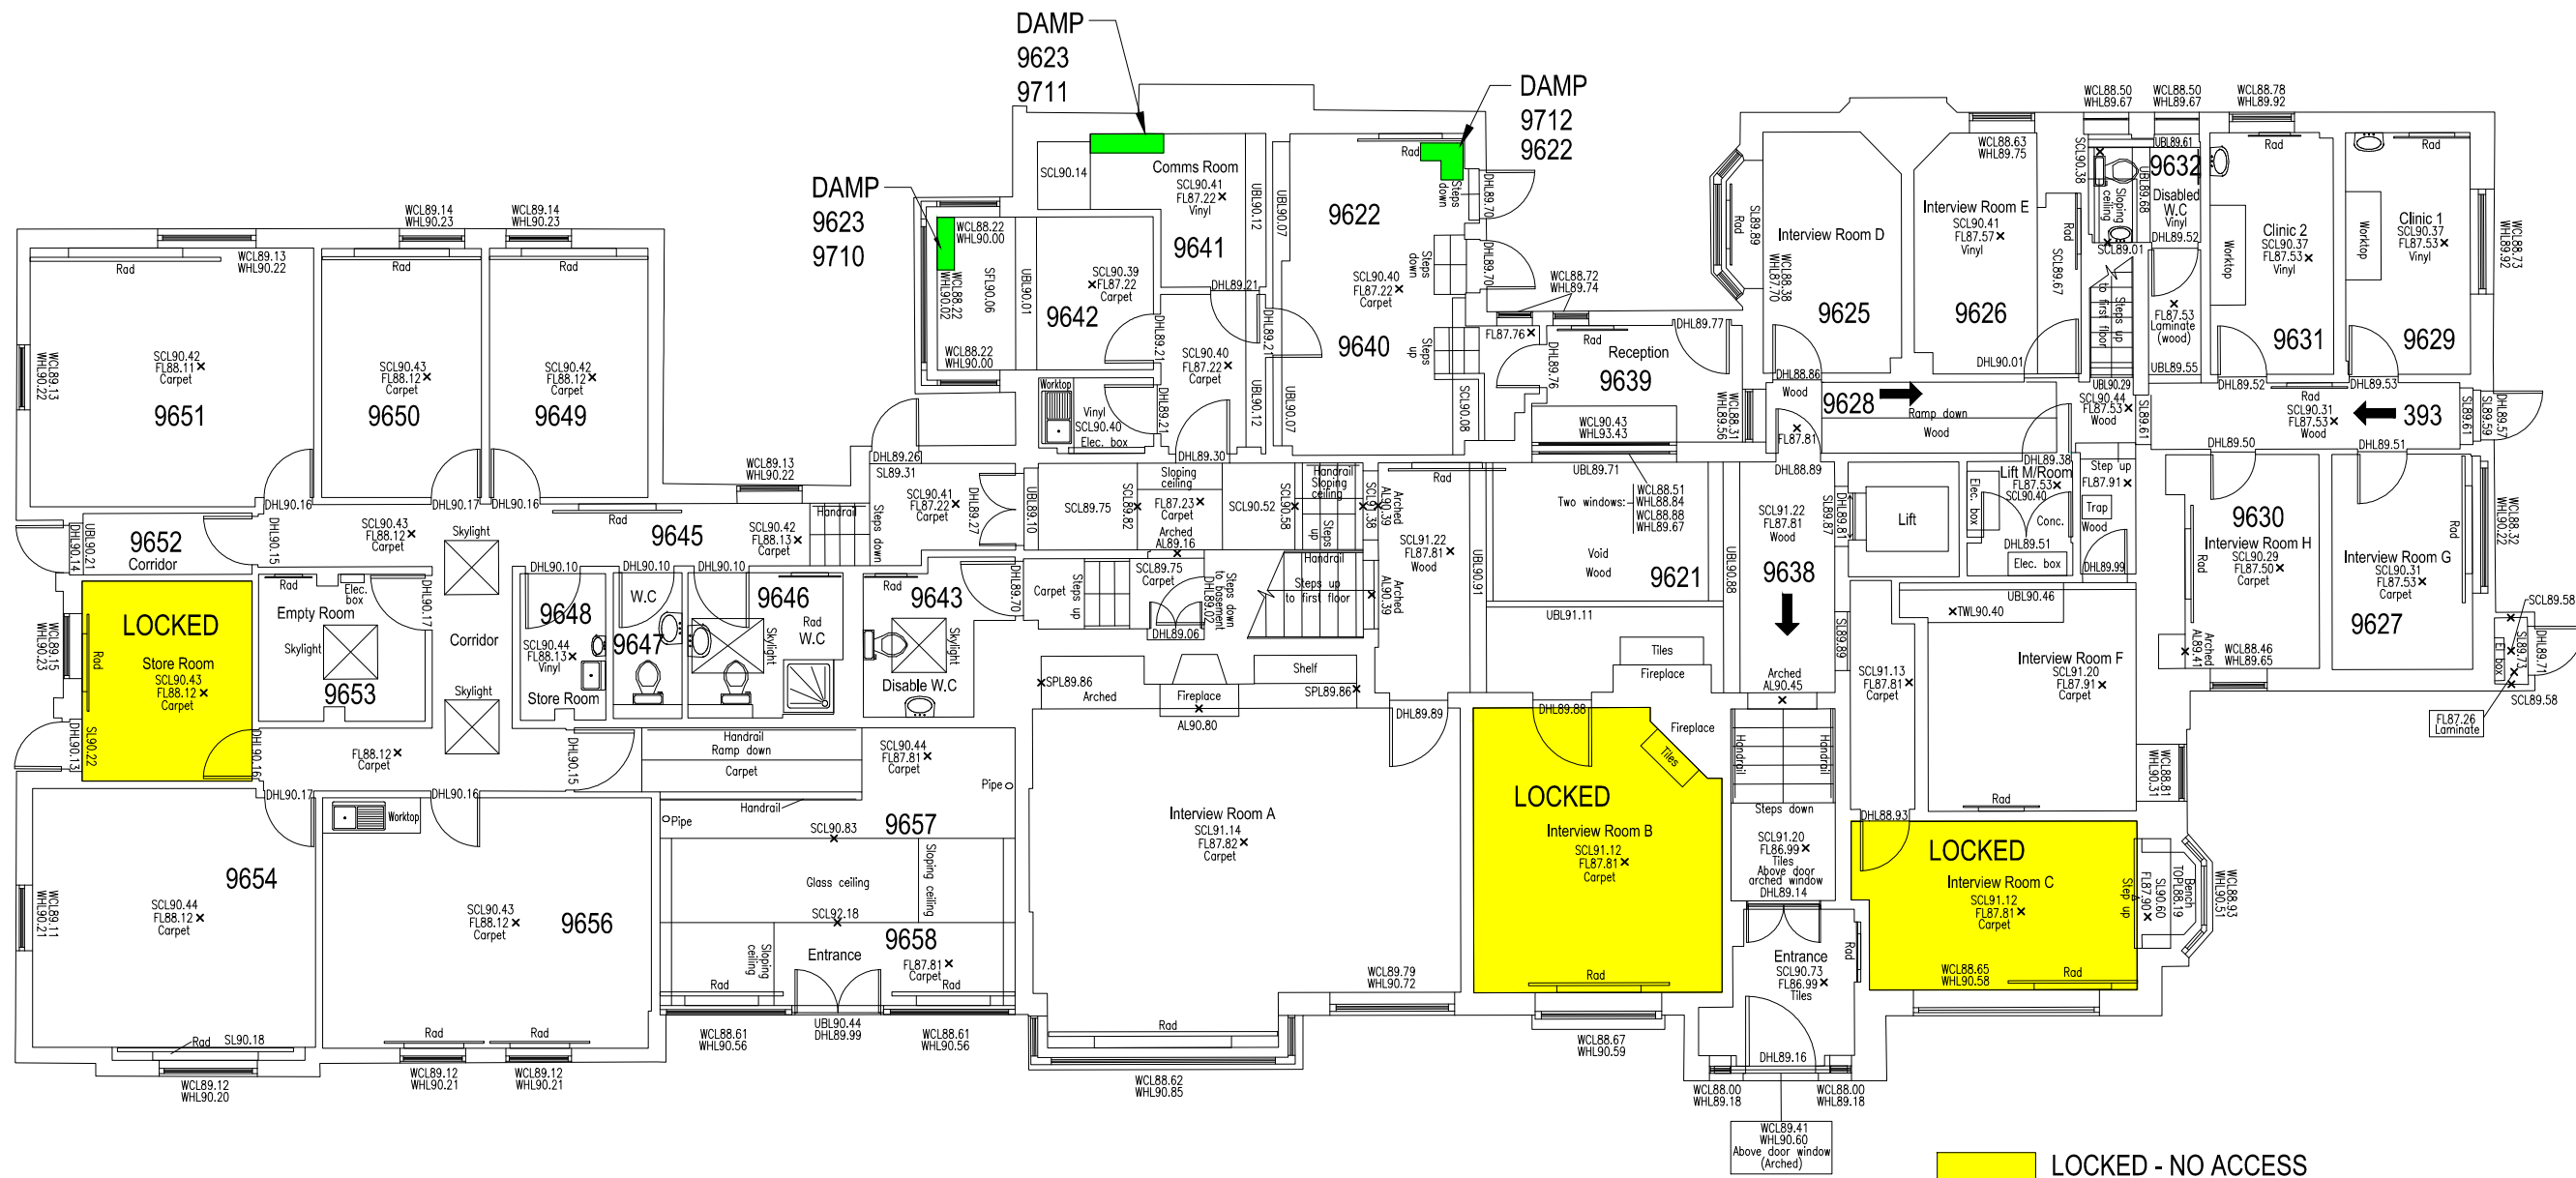
# GROUND FLOOR

LOCKED - NO ACCESS

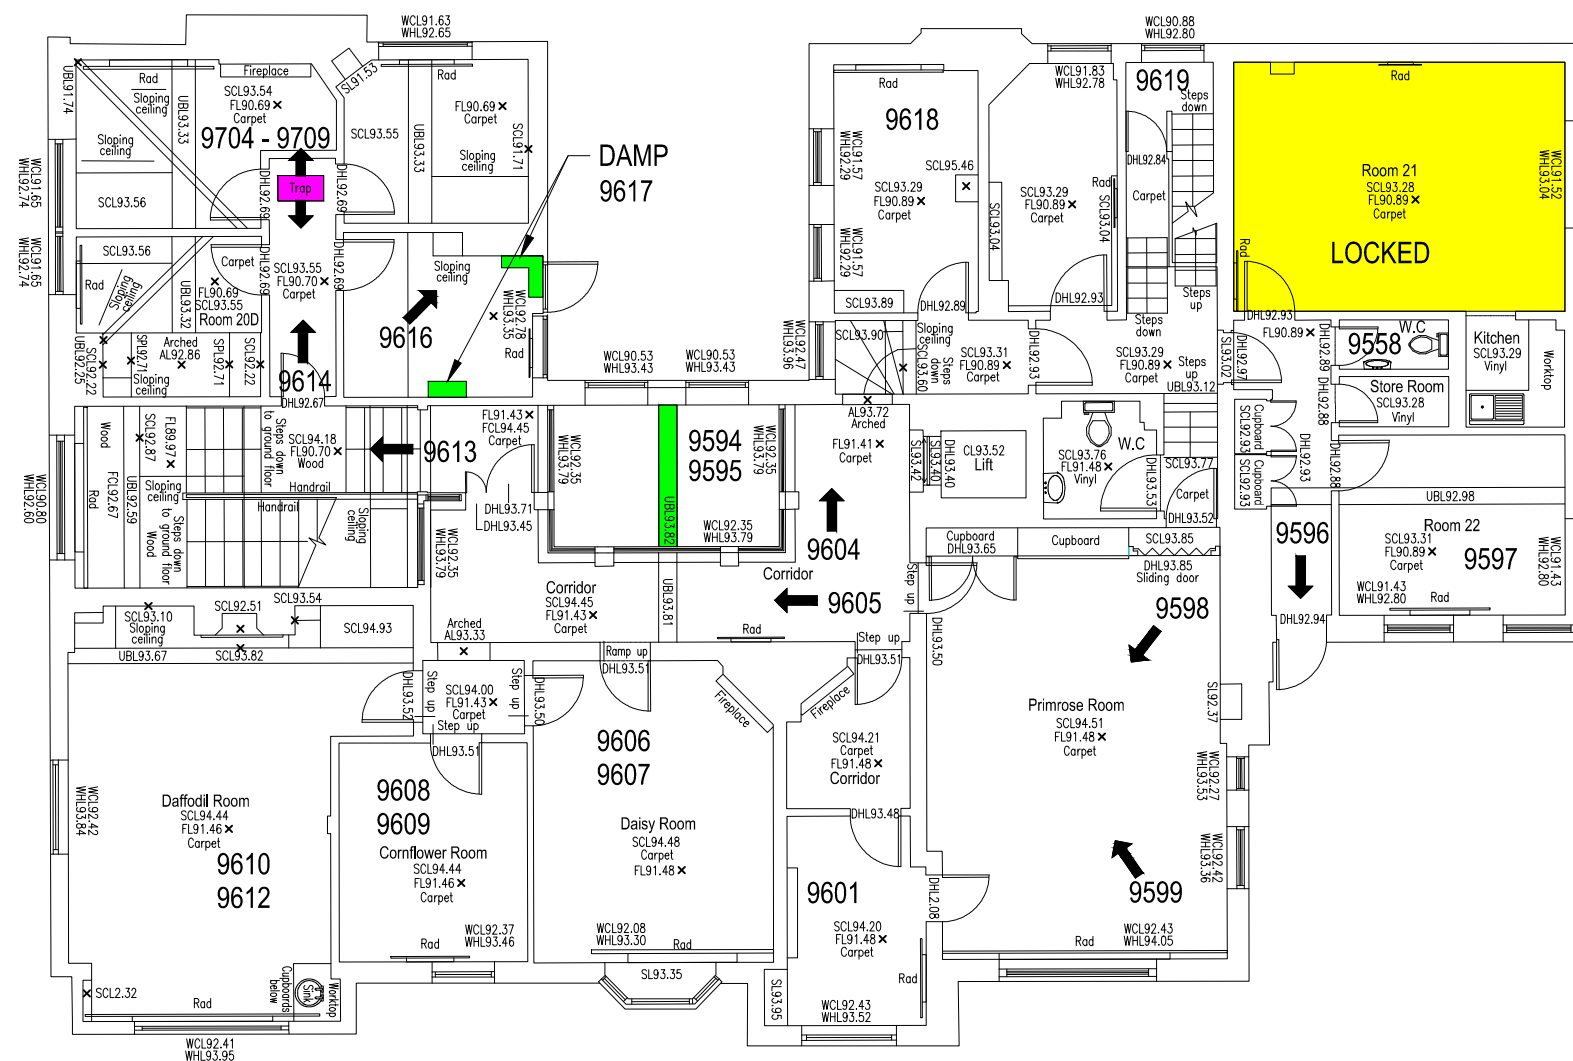
FIRST  
FLOOR

LOCKED - NO ACCESS
