TECHNICAL REPORT ON A SUBSIDENCE CLAIM

14 Lindfield Gardens Management Co Ltd  
14 Lindfield Gardens  
London  
NW3 6PU

TECHNICAL REPORT

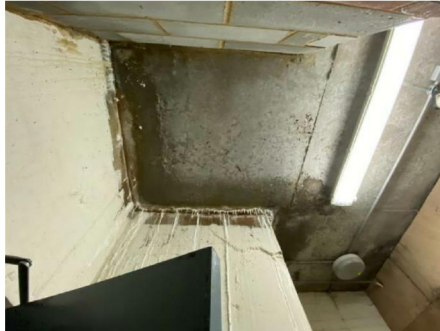
### BIN STORE

Water ingress to the bin store from the terrace above.

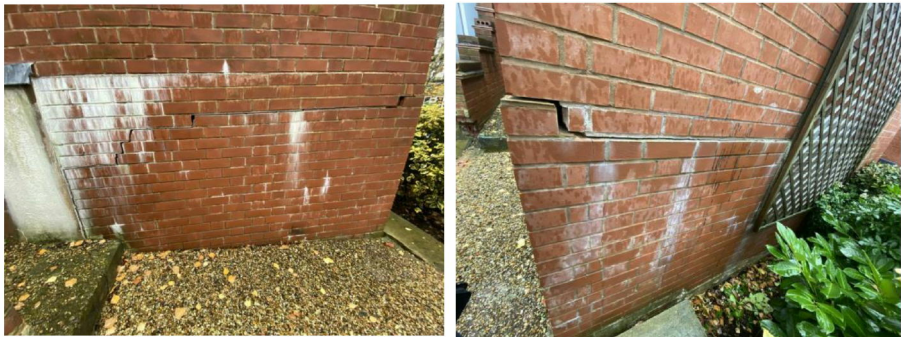
FRONT BOUNDARY RETAINING WALL

Outwards rotation of up to 20mm of boundary retaining wall.

TERRACE/BIN STORE STRUCTURE

Outwards rotation of lower section of masonry up to 15mm.

In structural terms the damage falls into Category 4 of Table 1, Building Research Establishment<sup>6</sup> Digest 251, which describes it as “severe”.

The pattern and nature of the cracks is indicative of an episode of subsidence. The cause of movement appears to be clay shrinkage.

The timing of the event, the presence of shrinkable clay beneath the foundations and the proximity of vegetation where there is damage indicates the shrinkage to be root induced. This is a commonly encountered problem and probably accounts for around 70% of subsidence claims notified to insurers.

The cause of the movement needs to be dealt with first. We have completed a Soil Risk Analysis (VISCAT Assessment) and we are satisfied that your Hawthorn Tree can be removed.

We will obtain a quotation for the recommended tree works. Whilst the trees are not subject of a Tree Preservation Order, they are located in a Conservation Area and therefore an application to the Council will be required.

Provided the tree management works are completed expeditiously, consideration may then be given to carrying out the appropriate repairs to the property.
