**19 Woodchurch Road London NW6**

**SUMMARY REPORT**

**London Borough of Camden**

Ref: E&M Summary Report **Revision A** 2019-11-19 - 19 Woodchurch Rd

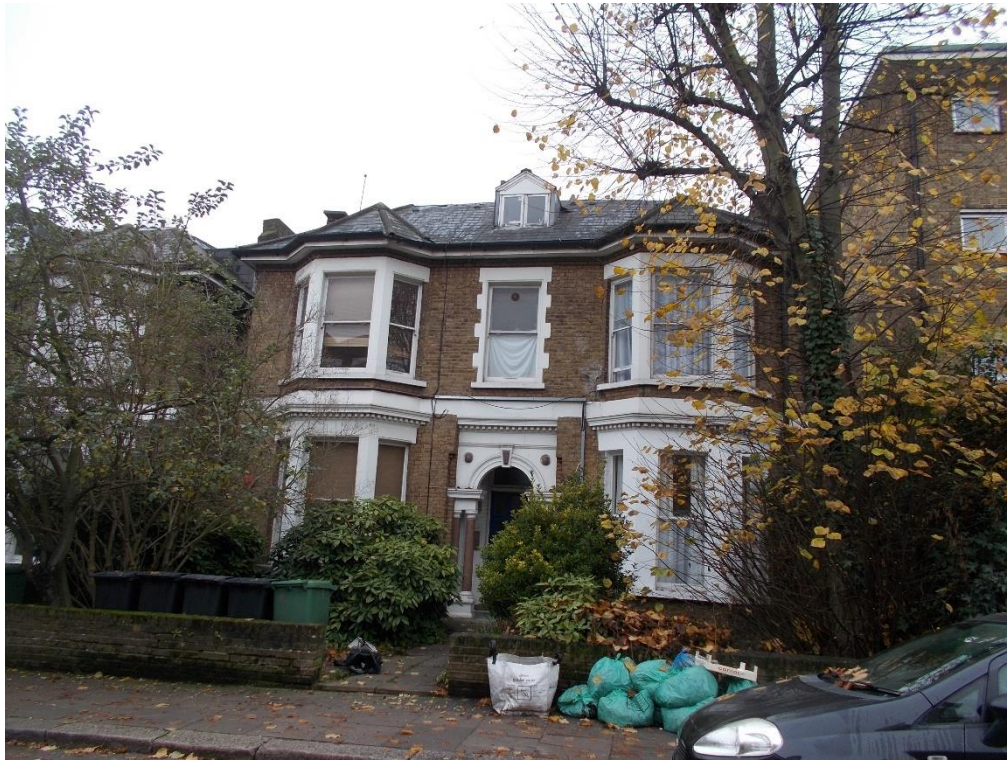
Photograph 01

- b) The building is a three-storey, including Loft Floor, detached house of Victorian architectural features (refer to Photographs 01 to 03 in Appendix B); the building is believed to have been constructed during that era.

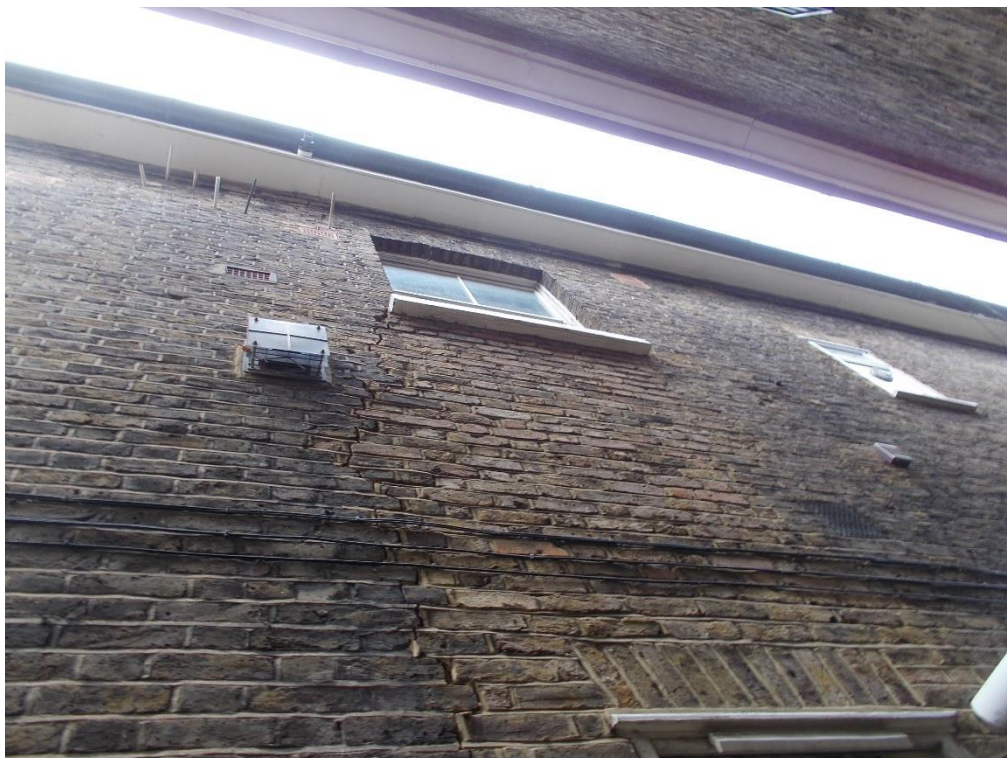
Photograph 04

- e) Externally, cracks of up to approximately 10mm maximum width were evident to the left-hand flank wall (full-height vertical crack) and the middle of the rear façade at 1<sup>st</sup> Floor level (refer to Photographs 04 to 06).

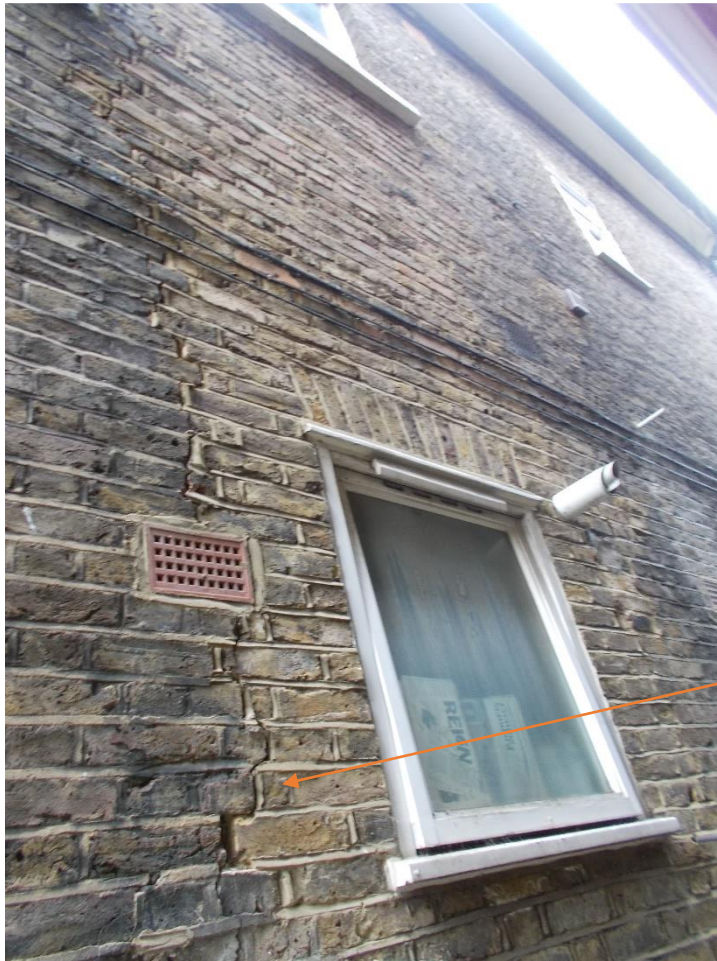
Photograph 05

Possible  
location of  
crack

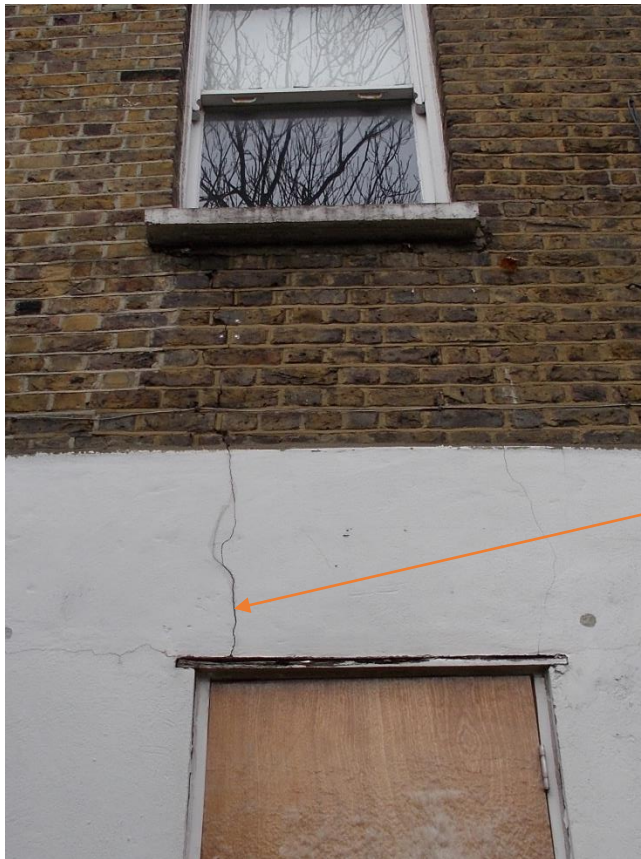
Photograph 07 (Rear Façade)

- f) A selection of some other external cracks is shown in the Photographs 07-08.
- g) Internally the cracks of greatest magnitude were evident within the 1<sup>st</sup> Floor Flat 4, adjacent to the kitchen window to the flank wall of 10mm maximum width (refer to Photograph 09). Also evident within the 1<sup>st</sup> Floor common hall, there is a full height vertical crack of approximately 6mm maximum width to the right-hand partition wall and also within the common hall/stairs an approximately 5mm maximum wide crack below the 1<sup>st</sup> Floor window front bay (refer to Photographs 10 and 11).

Possible  
location of  
crack

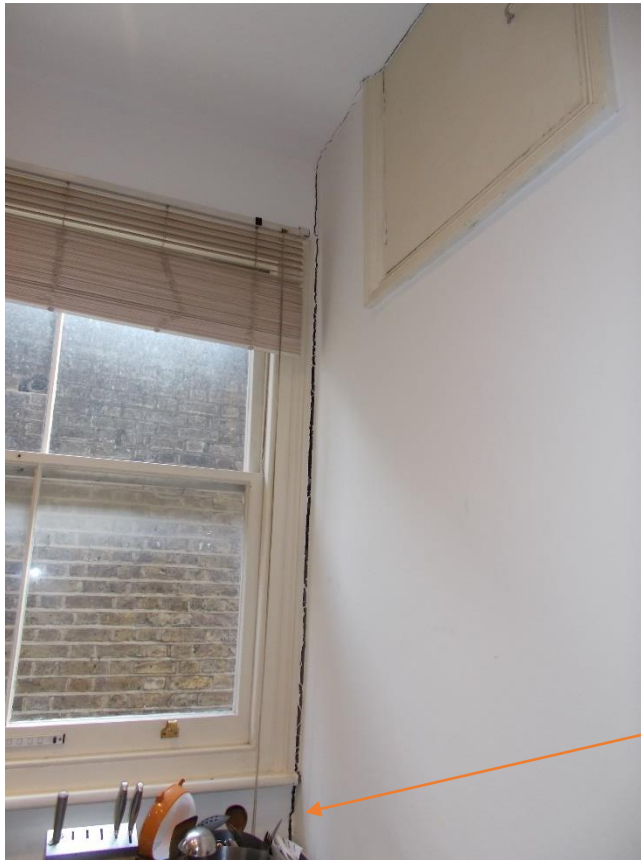
Photograph 09

Possible  
location of  
crack

- 3.9. We also understand that consideration is being given to replacing the existing windows. It was noted that there is a significant crack to the rear jamb of Flat 3's window in the kitchen, which is located to the left-hand flank wall. Therefore, we recommend that this window is not replaced until remedial works to the crack, and the property as a whole, are undertaken. With regards to window to Flat 4's rear bedroom, we recommend that the gap between the soffit of the cill and the brickwork is also made good before the window is replaced.

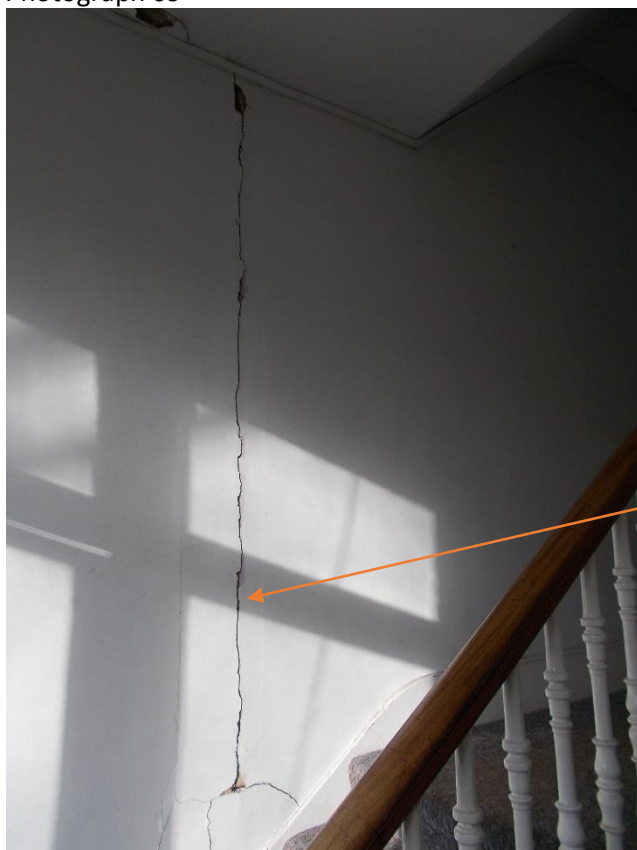
Photograph 10 (Common Hall/Stairs)

Possible  
location of  
crack

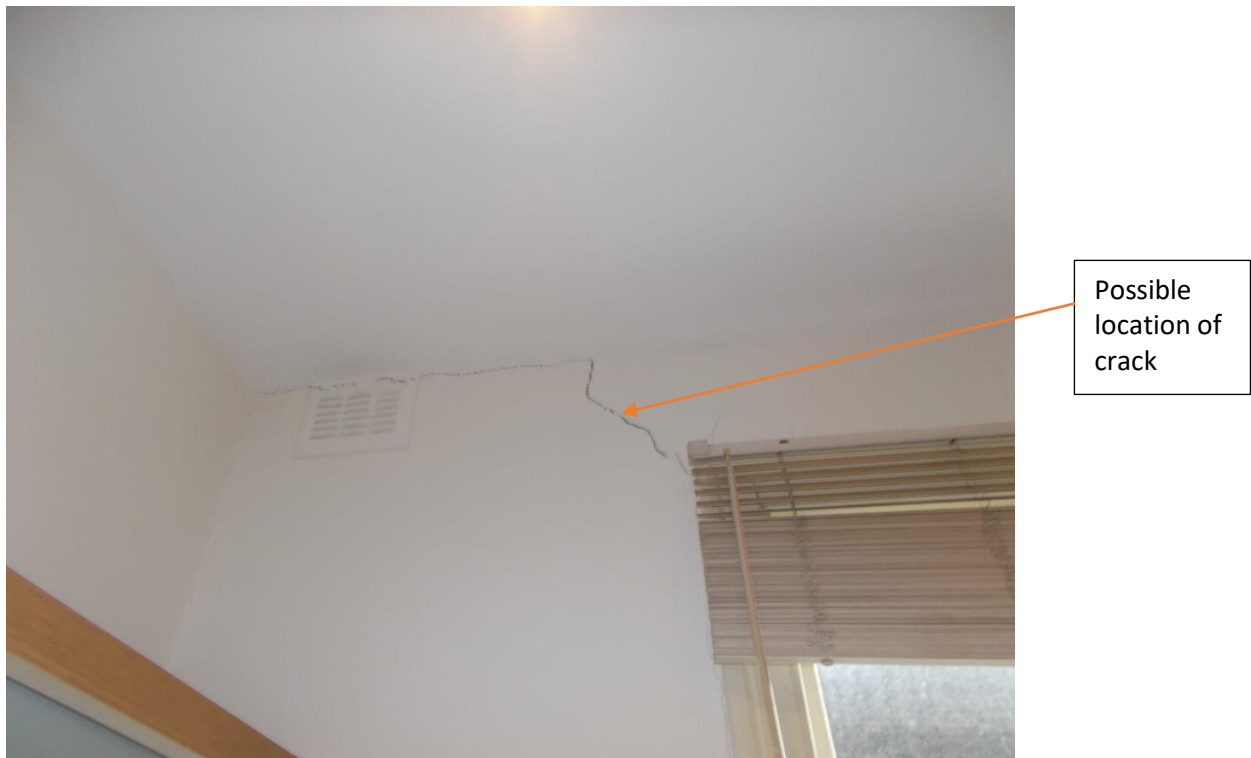
Photograph 12 (Flat 4 Kitchen)

- h) A selection of other internal cracks are shown in the Photographs 12-17.
- i) Please note that both Flats 1 and 5 were recently redecorated and the cracks were filled.
