Vulnerability analysis [continued]

Vulnerability analysis of existing fire doors.

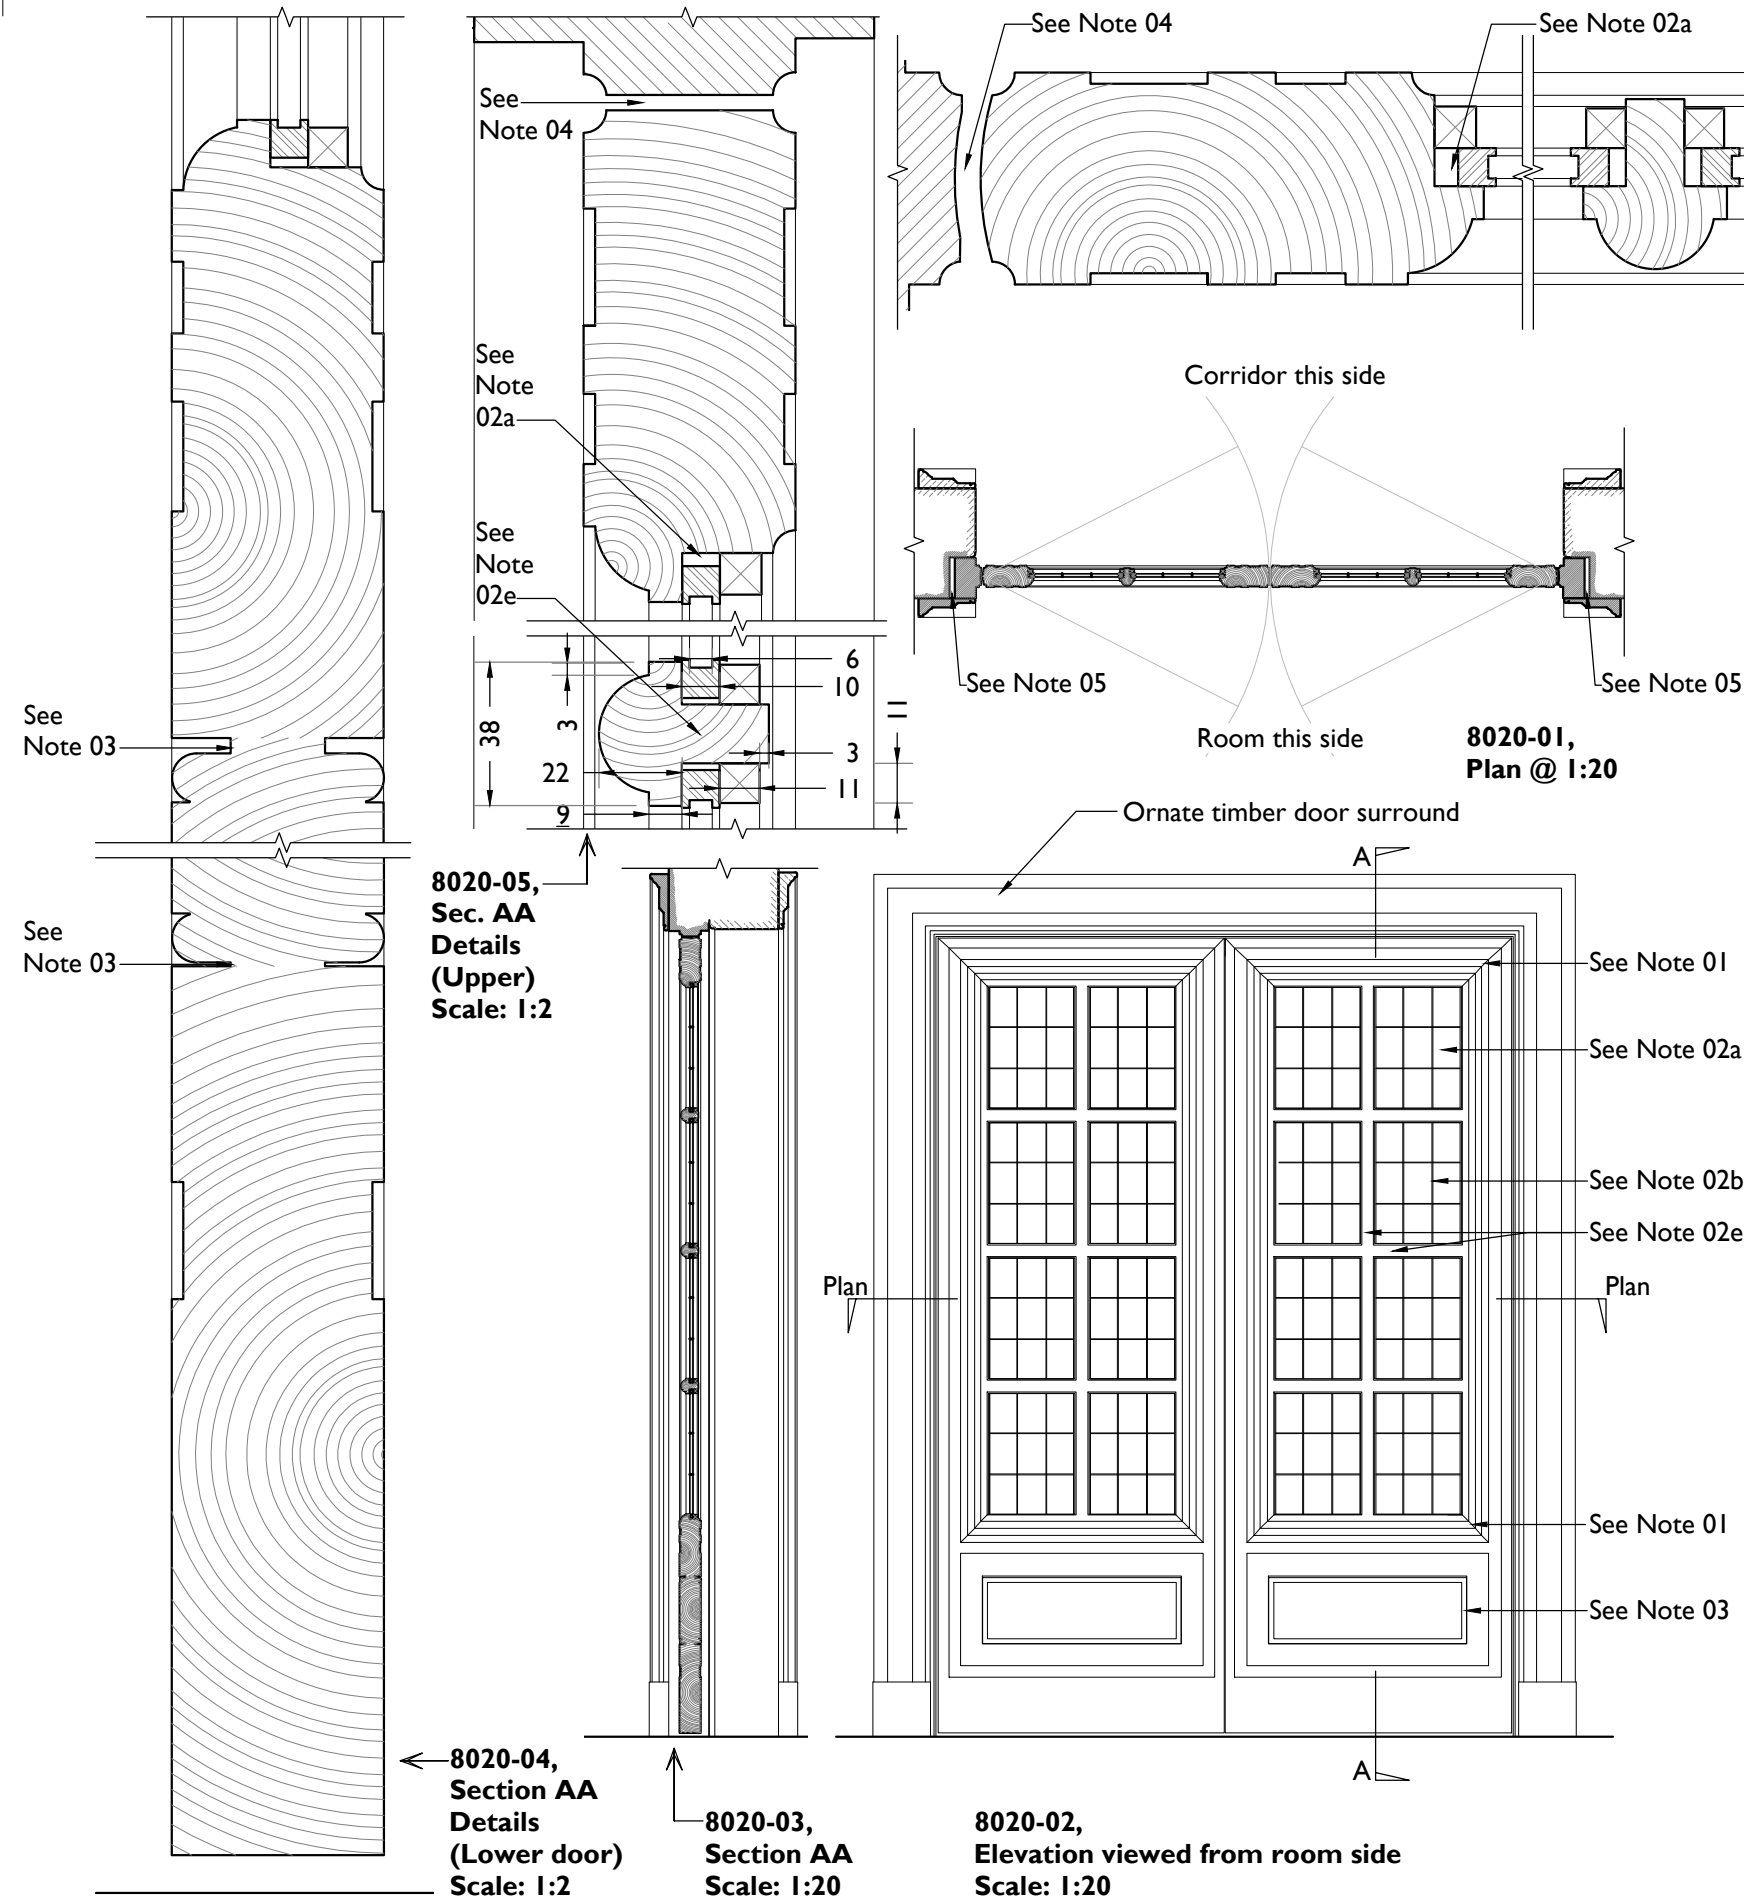
Existing doors often have perimeter gaps which exceed 4mm. Many of the existing doors have deformed to varying degrees over time. In some cases they have warped. This means that they do not have consistent perimeter gaps or frame contact. Therefore it is not possible to install intumescent strips and smoke seals in such a way that they can be depended on to perform to prescribed standards.

Note 05: Frame Perimeter

Existing door frames have a tolerance gap around them, between the compartment wall structure and the outer edge of the frame. This gap is, in many cases, covered only by a timber architrave. It is therefore unable to resist the passage of fire, smoke and gas and compromises the integrity of the entire doorway.

Note 01: Construction

Door joints are held together with animal glue which melts at a low temperature. When exposed to fire the glue will melt quickly increasing the likelihood of rapid structural failure. Even moderate failure of the glued joints could result in distortion of the doors, thus increasing the gaps between the door and frame, rendering any fire resisting properties ineffectual.

Note 02: Glazing

Many of the existing doors possess large areas of glazing. This existing glazing is not suitable for resisting fire for the following reasons:

- It is not fire resistant or insulating glass. This means that it will break at temperatures between 150 - 200°C.
- Many of the glazing units are composed of small panes of glass supported in a lightweight copper frame. The thin copper strips are likely to expand and distort under extremes of temperature thus contributing to glass breaking and structural failure of the unit.

- The glazed units are loosely fixed into the mullions and transoms of the door with thin battens. They have gaps around them and are not bedded with sealant. Thus fire, smoke and high temperature gas can pass through the unsealed gap between the glazed unit and the timber supports.

- Once the glazing breaks, this allows significantly more air to pass through the door which will feed the fire.
- The mullions and transoms of the glazed door will burn quickly due to their large exposed surface area and comparatively small cross sectional area.

Note 03: Raised and fielded panels

Panels are fixed into a groove routed into the inner edge of the supporting members. At this point the the panel is at its thinnest and most vulnerable to fire penetration. Further, the existing panel is not sealed into the groove with an intumescent sealant. Therefore fire, smoke and high temperature gas can pass through the unsealed gap.

Note 04: Seals

To form an effective fire barrier, doors must fit in their frames such that a consistent gap is formed which does not exceed 4mm. If the gap is greater than this, the intumescent fire seal (which expands on contact with fire) will not fill the perimeter gap, which will in turn compromise the door's fire resistance.

For doors which also require perimeter smoke seals, a consistent contact seal is of critical importance to resist the passage of smoke effectively. [Continued...]

The majority of existing doors require upgrade to a 30 minute fire resistance although there are several instances where doors require 60 minute fire resistance. All existing doors have been surveyed, with detailed photographs and measurements taken.

Methods of upgrading these existing doors have been considered. This includes the application of clear fireproof paint, and bonded intumescent cards along with other intumescent seals.

The use of intumescent paint is not a particularly good long term solution. This is because the finish can be readily removed during redecoration or damaged thus compromising the fire strategy in the future. It is also of limited use on glazed doors where the main issue is the quantity and type of glazing.

An applied intumescent card is a more robust option but this would change the appearance of the door unless veneers are applied carefully. It cannot be used on mouldings and profiled timber. Therefore, it is not a practical solution for the doors on this project.

Glazed doors would require the installation of secondary fireproof / insulating glazing if the existing panels were to be retained. This would entail the removal of existing framed copper glazing and changing the existing rebate depth and stop beads before reinstallation with intumescent bedding to the units. It is not possible to increase the depth of the rebates as they are already slight (see 8020-05). The glass units could be replaced with replicas but this does not solve issues with the door structure.

In all cases International Fire Consultants (a fire door specialist) have advised that the upgrade of the existing doors would achieve, at best, a maximum of 20 minutes fire resistance due to the nature of the door construction and their use of animal-based glues which have a poor fire resistance.

Gaps between the existing doors and the door liner / frame are comparatively large in some cases making it difficult to form a discreet and effective smoke seal with even, friction free contact around the perimeter. Use of standard intumescent strip, which works with a typical 3 mm +/- 1 mm gap, would not be effective in many cases.
