SUBSIDENCE ENGINEER'S REPORT

Client Name	Plum Underwriting
Reference	PLUM-1567
Name of Insured	Mr Simon Kilgour
Policy Number	ALH/105514
Risk Address	13 Wilmot Place, London, NW1 9JP

GHG Reference	L/2019/58972/S/RK
Date of Report	31 December 2019

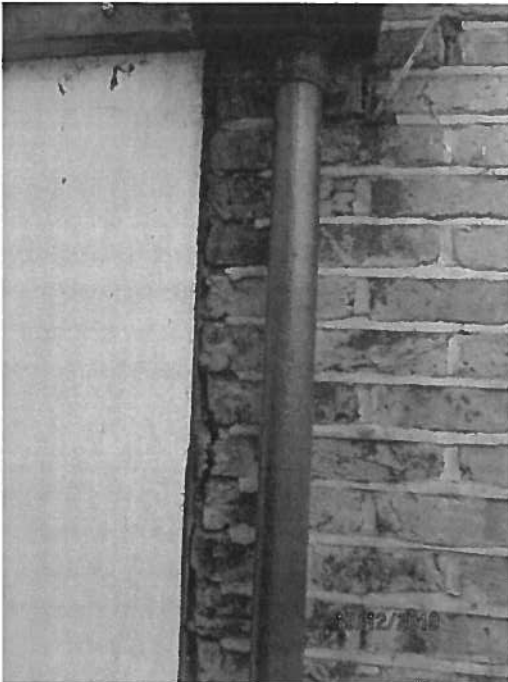
This photograph shows vertical cracking at the junction between the rear extension and main house, with water staining to the brickwork at high level.

There is a tapering vertical crack up to 15mm in width at the junction between the right hand flank wall of the rear extension and the right hand flank wall of the original building. At high level, the cracking steps up diagonally towards the rear through the extension brickwork. The brickwork in this area is stained green due to water leaking from the rainwater hopper.

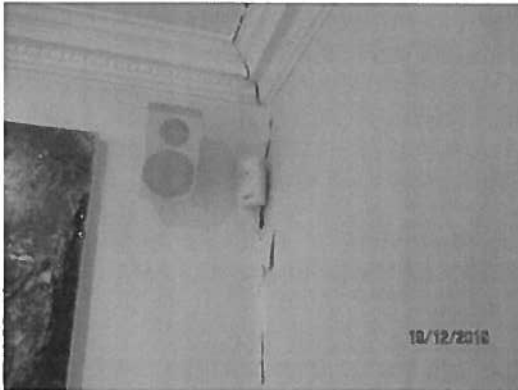
This photograph shows tapering cracking at the junction between the right hand flank wall of the lounge extension and the rear wall of the main house.

A tapering vertical crack up to 15mm in width was noted at the junction between the right hand wall of the extension and the rear wall of the main house, which connects to the cracking along the wall/ceiling junction.
