## TECHNICAL REPORT ON A SUBSIDENCE CLAIM

Mourne House  
11-13 Maresfield Gardens  
London, NW3 5SL

**SUBSIDENCE CLAIM**

DATE 22 October 2019

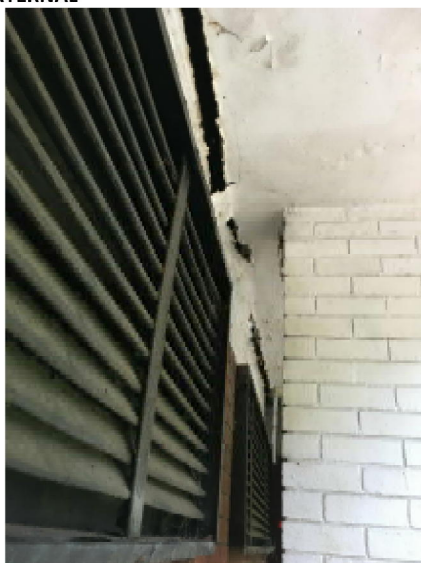
Beneath staircase

Staircase to the left hand side is showing movement away from the main building <60mm.  
Staircase to the right hand side is showing some minor (historic) movement <3mm.

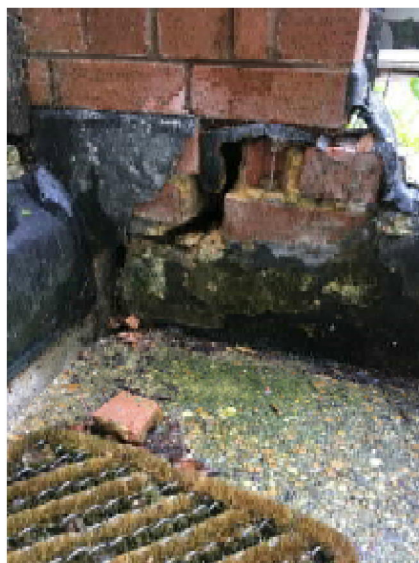
Top of staircase

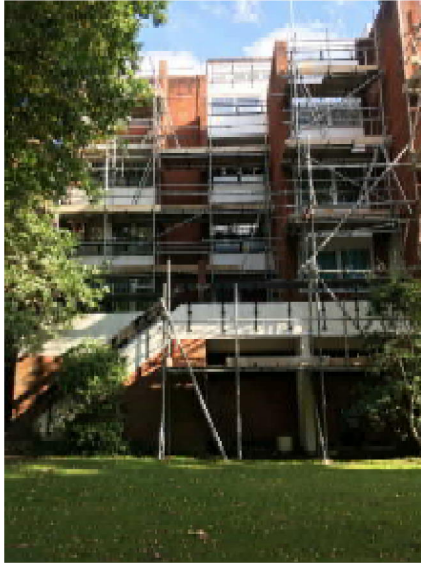
The pattern and nature of the cracks is indicative of an episode of subsidence. The cause of movement appears to be clay shrinkage.

The timing of the event, the presence of shrinkable clay beneath the foundations and the proximity of vegetation where there is damage indicates the shrinkage to be root induced. This is a commonly encountered problem and probably accounts for around 70% of subsidence claims notified to insurers.

Rear elevation showing staircase

Although the cause of the movement needs to be dealt with, we note the involvement of commercial third party trees which are potentially subject to a Preservation Order. Unfortunately, current legislation requires certain investigations to be carried out to support an application for the tree works.

Typically, these investigations would involve trial pit(s) to determine the depth and type of footings, boreholes to determine the nature of the subsoil/influence of any roots and monitoring to establish the rate and pattern of movement. The monitoring data provided must be sufficient to show a pattern of movement consistent with the influence of the vegetation and therefore it may be necessary to carry out the monitoring for up to a 12 month period.

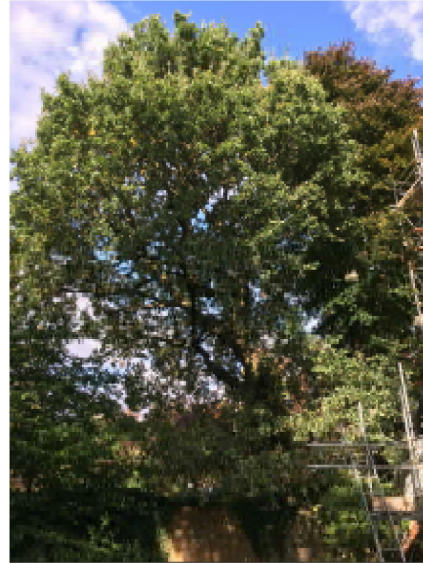
Nearby vegetation

It will also be necessary to obtain a specialist Arboricultural Report.

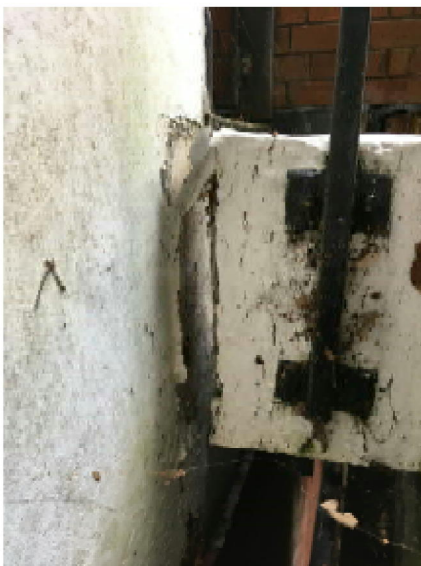
In structural terms the damage falls into Category 5 of Table 1, Building Research Establishment<sup>7</sup> Digest 251, which describes it as “**very severe**”.

Junction of staircase and main building

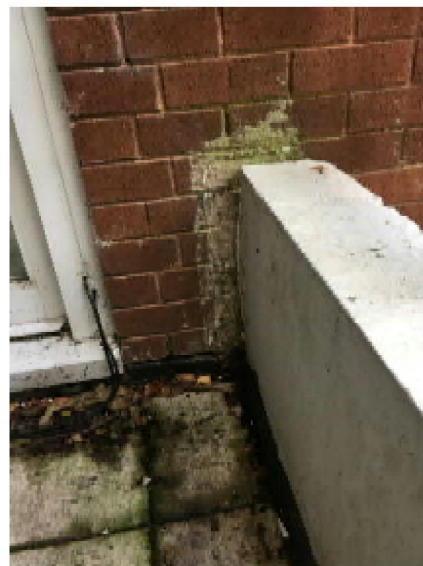
Dwarf wall on landing of staircase

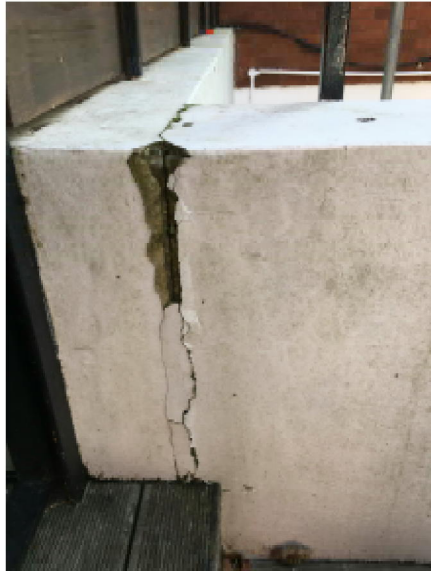
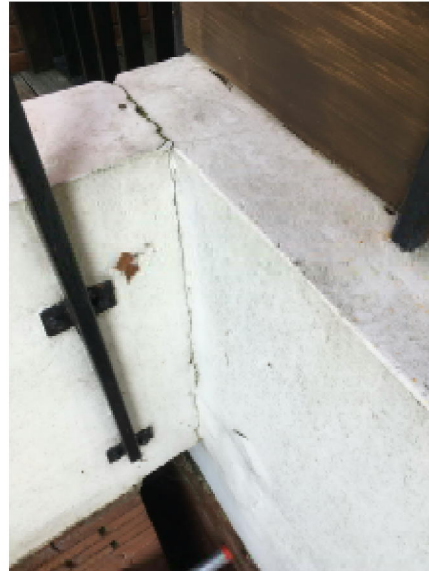
Historic movement to other staircase

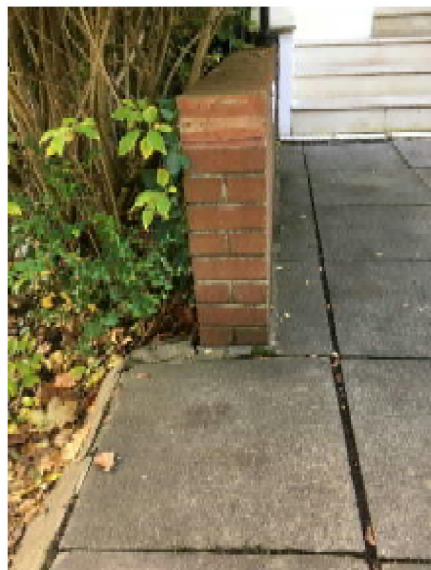
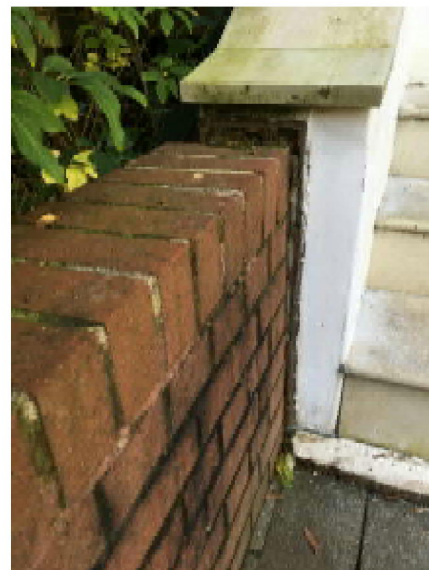
Path leading to front steps at entrance 12-23 Mourne House has dropped and dwarf wall has rotated outwards (to be dealt with under a separate claim).

Rotation of dwarf wall at entrance
