**TECHNICAL REPORT ON A SUBSIDENCE CLAIM**

Ms J Rickards  
22 Ivor Street  
London  
NW1 9PJ

**SUBSIDENCE CLAIM**

DATE 30th December 2019

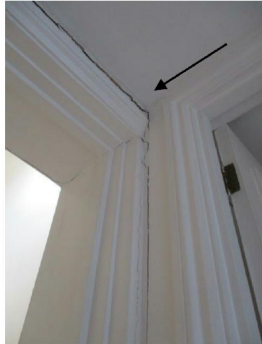
Cracking in 2nd floor rear bedroom on rear addition junction

**2nd Floor Rear Bedroom and En-Suite** - 6mm tapering separation around wall / ceiling junction on rear addition junction, wall / ceiling and vertical junction cracking around en-suite partition.

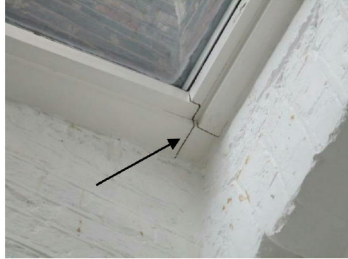
**Kitchen** - 3mm horizontal crack above door to hall on rear addition junction, 1mm vertical crack down left hand flank on boxing junction, door to hallway catching on frame, unrelated water ingress through glass roof on rear left hand corner.

Cracking to glazed roof in kitchen around rear addition junction

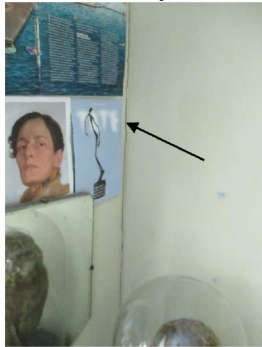
**1st Floor Rear Bedroom** - 3mm vertical crack down rear right hand corner, 1mm vertical crack below left hand side of window, 8mm gap between floor and skirting on rear wall.

Cracking in 1st floor rear bedroom around rear addition junction

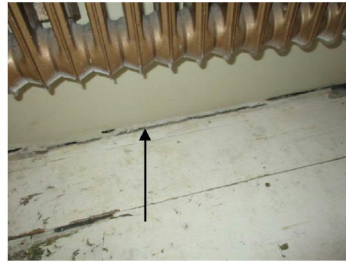
Gap between skirting and rear wall in 1st floor rear bedroom

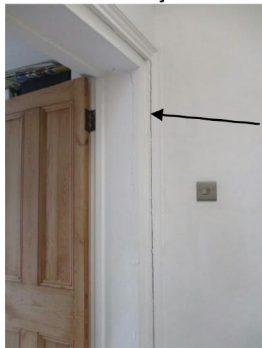
**2nd Floor Landing** - 3mm tapering cracking around rear bedroom door frame, cracking along stair stringer on rear addition junction to stairs to loft.

Cracking on 2nd floor landing on rear addition junction

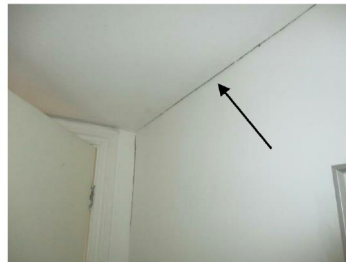
Cracking in 2nd floor rear bedroom ensuite on rear addition junction

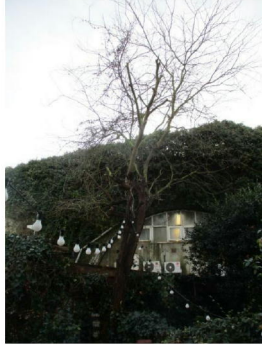
Type	Height	Distance	Ownership
Honey Locust	11 m	7 m	Owners

View of insured's Honey Locust tree to rear

The cause of the movement needs to be dealt with first. We have completed a Soil Risk Analysis (VISCAT Assessment) and we are satisfied that your Honey Locust tree can be removed.

We recommend the tree works and will undertake statutory checks for Preservation Orders or whether the tree is in a Conservation Area. The cost of the actual tree work however is not covered as part of the claim.
