Arboricultural Appraisal Report

Subsidence Damage Investigation at:

38 Steele's Road
Hampstead
London
NW3 4RG

CLIENT:	Crawford & Company
CLIENT REF:	[REDACTED]
MWA REF:	[REDACTED]
MWA CONSULTANT:	Mark Johnson (FdSc; MArborA)
REPORT DATE:	01/11/2019

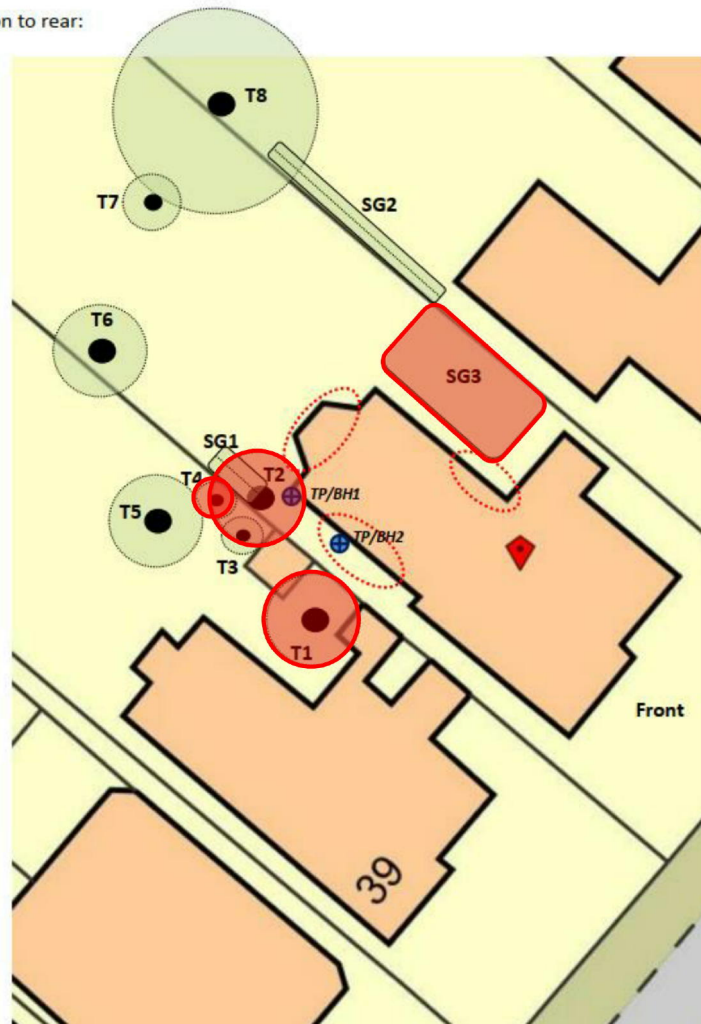
Site Plan

Approximate areas of damage

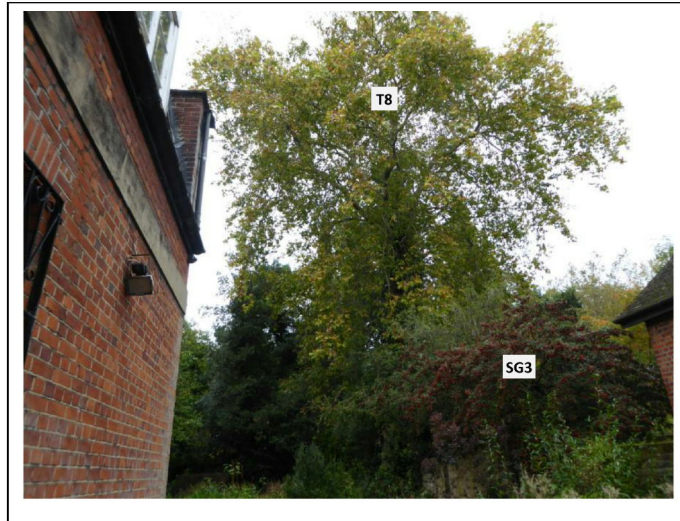
With respect to the further damage, of the remaining vegetation T5 and T8 are considered to be most significant. Whilst no roots from T8 have been identified these are likely to be present based on the trees height and proximity. The continuing movement in the building suggests the reduction of T8 has not been sufficient to mitigate its influence and on this basis removal is now recommended together with T5.

View of T8 and SG3

If an arboricultural solution is to be implemented to mitigate the influence of the trees considered to be responsible for the damage we recommend that T5 and T8 are removed

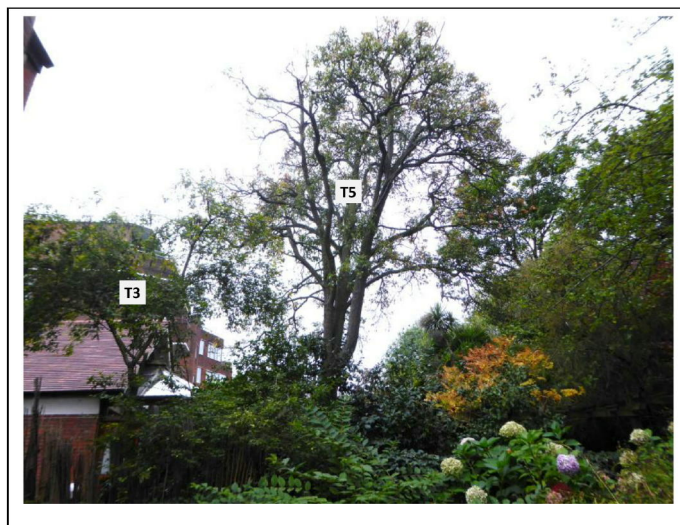
View of T3 and T5

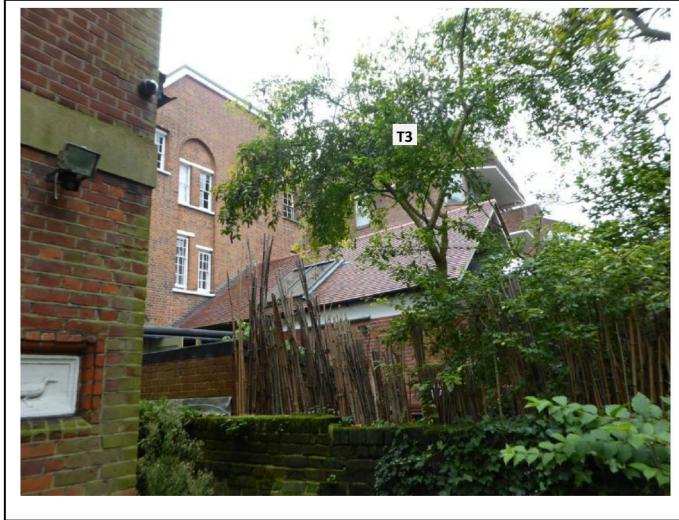
View of T3

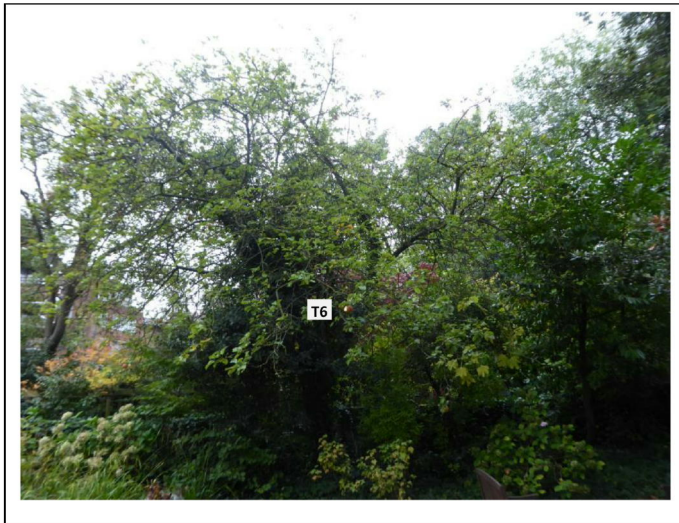
View of T6
