Arboricultural Appraisal Report

Subsidence Damage Investigation at:

16 Belsize Park Gardens
London
NW3 4LD

CLIENT:	Crawford & Company
CLIENT REF:	[REDACTED]
MWA REF:	[REDACTED]
MWA CONSULTANT:	Steve Swinburne
REPORT DATE:	02/12/2019

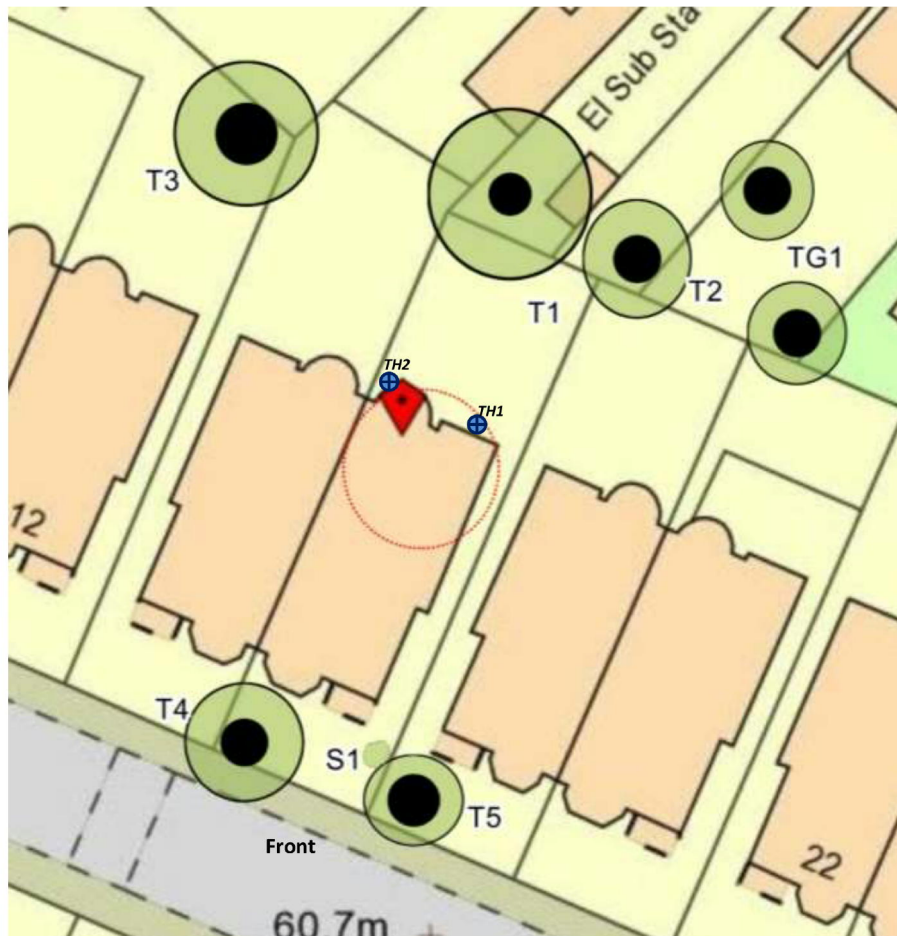
Site Plan

Approximate areas of damage

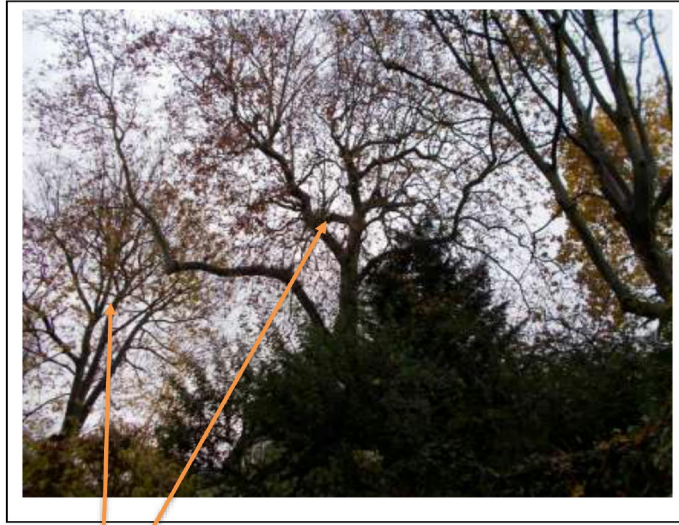
Platanus roots were observed to a depth of 500mm in TH1 and 1.3m in TH2 the origin of which will be T1, thus confirming its influence on the soils below the foundations.

Based on the technical reports currently available, engineering opinion and our own site assessment we conclude the damage is consistent with shrinkage of the clay subsoil related to moisture abstraction by vegetation. Having considered the information currently available, it is our opinion that T1 is the principal cause of the current subsidence damage with a likely contribution from T2.

View of T3 & T1

If an arboricultural solution is to be implemented to mitigate the influence of the implicated trees we recommend that T1 is removed. The roots of T2 have the potential to extend to the building although given that no Acer roots have been identified we recommend T2 is reduced in height by 1.5m – 2.0m and the radius by ~ 1.0m – 1.5m and managed on a biennial cycle.

Consideration has been given to pruning alone as a means of mitigating the vegetative influence of T1, however in this case, this is not considered to offer a viable long-term solution due to the proximity of the responsible vegetation.

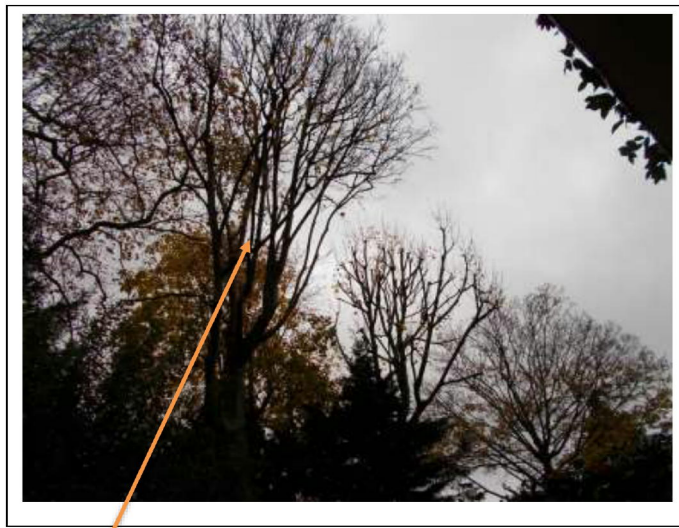
View of T2

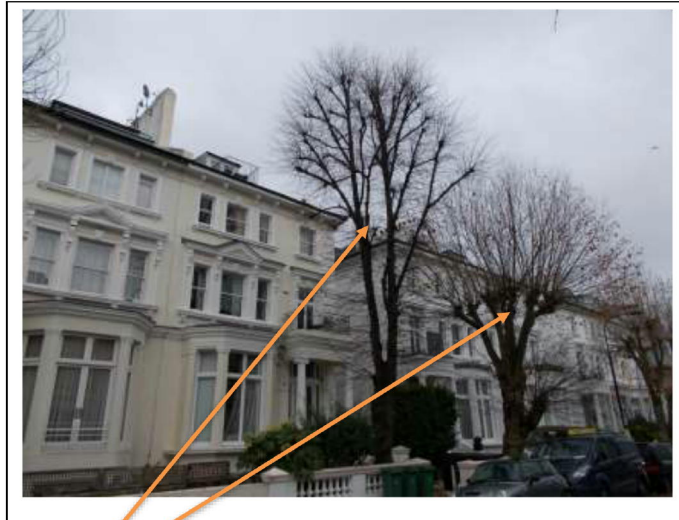
Other vegetation recorded presents a potential future risk to building stability and management is therefore recommended.

View of T4 & T5
