TECHNICAL REPORT ON A SUBSIDENCE CLAIM

16 Belsize Park Gardens Ltd
16 Belsize Park Gardens
London
NW3 4LD

SUBSIDENCE CLAIM

DATE 08 May 2019

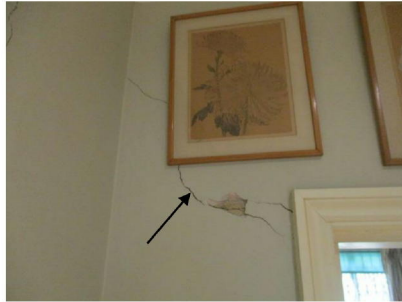
Cracking in basement flat hallway

Basement Flat - Entrance Hallway - 2mm diagonal crack to right hand side of arch to lobby area, wall / ceiling junction cracking along right hand flank, cracking to ceiling, hairline vertical crack above arch to rear section, 1mm horizontal crack to en-suite partition, 3mm diagonal cracking above both sides of rear bedroom door.

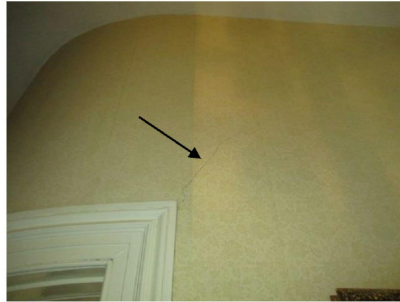
Cracking in flat 1 hallway

Hallway - 2mm diagonal crack above door to lounge, cracking to ceiling, cracking down left hand side of door to rear right hand reception.

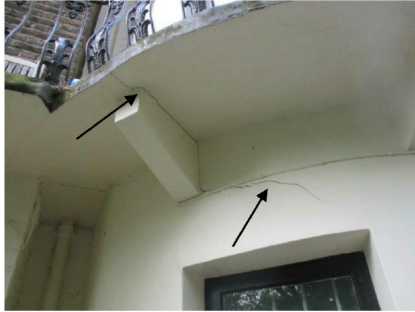
Cracking to rear bay

Rear Elevation - 5mm diagonal cracking above right hand side of basement bay window, 4mm vertical crack above left hand side of basement bay window, 2mm diagonal crack above right hand side of 1st floor bay window.

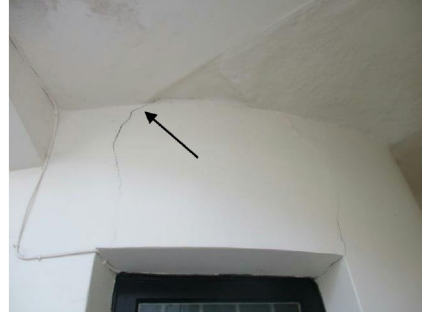
Cracking to rear bay

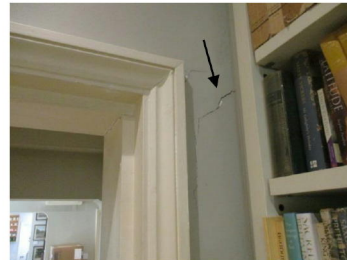
Rear Bedroom - Mirrored cracking above door to hallway, cracking to ceiling.

Cracking in basement flat rear bedroom
