ARBORICULTURAL ASSESSMENT REPORT

For:	Client:	Questgates
	Insurer:	AXA Commercial
Site:	Policyholder:	Renate Marie Charlotte Prince
	Risk Address:	60 Fitzjohns Avenue, London, NW3 5LT
Refs:	PRI Ref:	
	Client Ref:	
	Insurer Ref:

Arborist Name:	Will Hinde	Date:	10/10/2019
QC:	Margaret MacQueen	Date:	12/11/2019

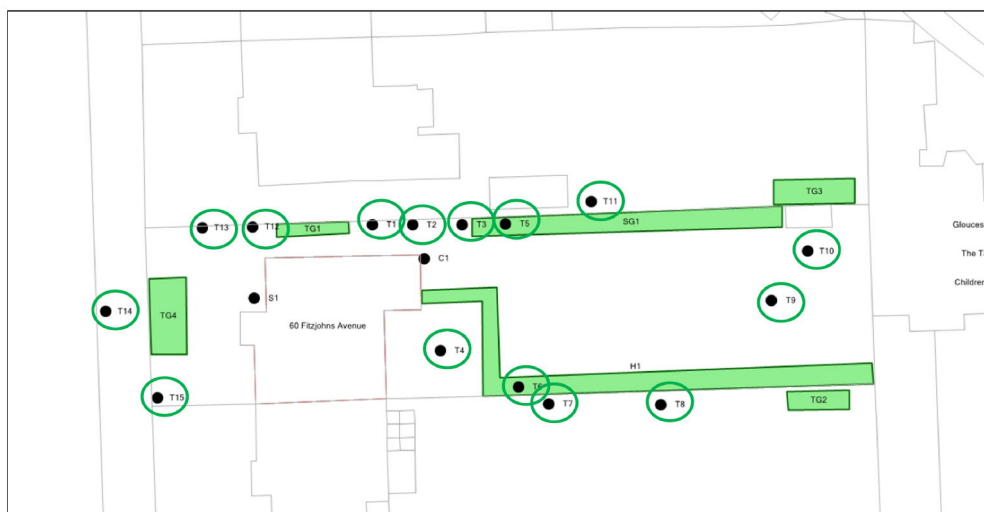
7.0 APPENDIX 2: SITE PLAN

Tree No:	Species	Works Required
T1	Horse Chestnut	Fell and treat stump.
T2	Birch (Silver)	Fell and treat stump.
T4	Acer	Fell and treat stump.
