## Arboricultural Appraisal Report

### Subsidence Damage Investigation at:

9 Willoughby Road  
London  
NW3 1RT

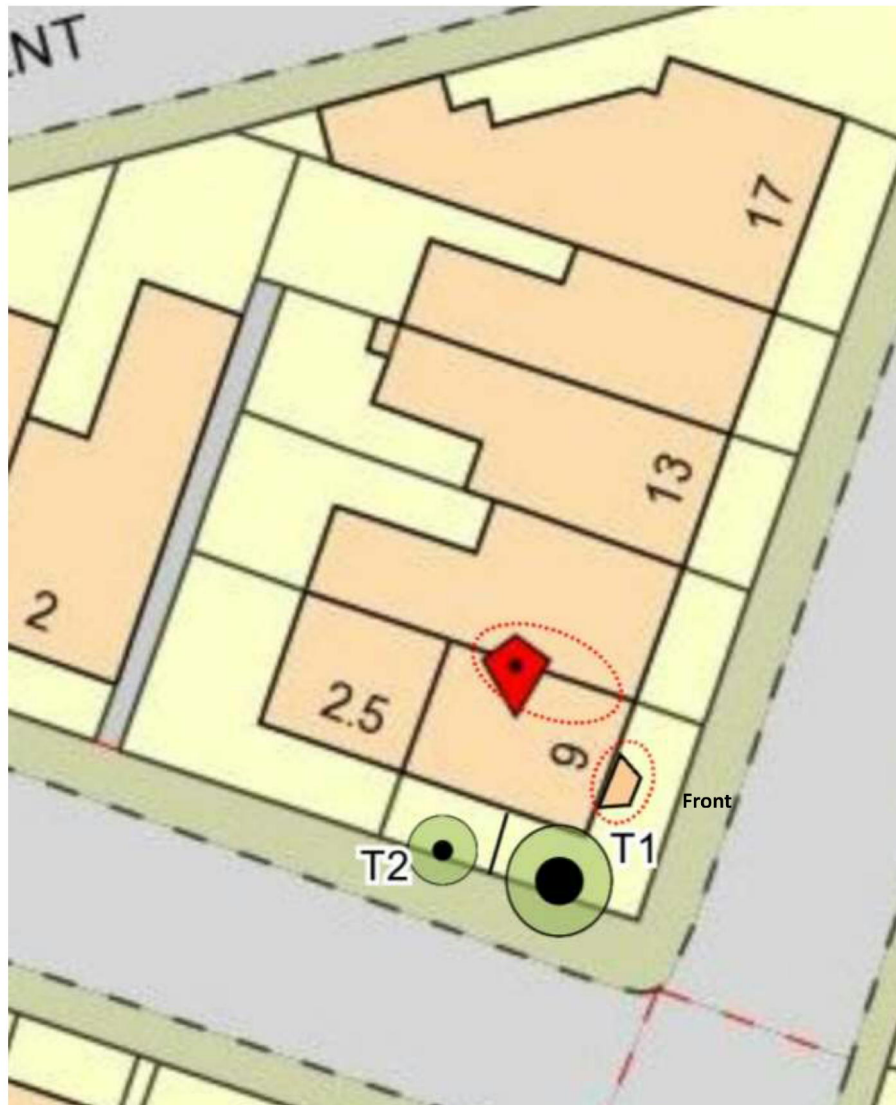
Site Plan

Approximate areas of damage

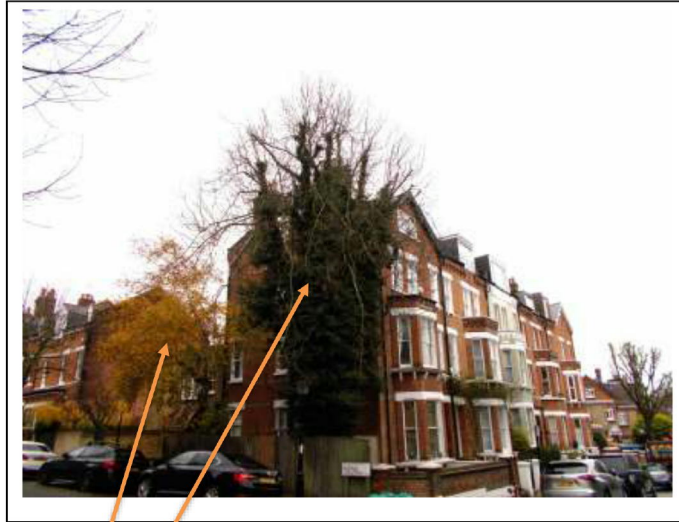
The vegetation considered to be most significant in relation to the current damage is T1.

| Tree No. | Species | Ht (m) | Dia (mm) | Crown Spread (m) | Dist. to building (m) | Age Classification | Ownership |
|---|---|---|---|---|---|---|---|
| T1 | Ash | 16* | 650* | 12* | 2.5 | Younger than Property | Policyholder |

View of T2 and T1

| Tree No. | Species | Ht (m) | Dia (mm) | Crown Spread (m) | Dist. to building (m) | Age Classification | Ownership |
|---|---|---|---|---|---|---|---|
| Recommendation | | Remove (fell) to near ground level and treat stump to inhibit regrowth. | | | | | |

| Tree No. | Species | Ht (m) | Dia (mm) | Crown Spread (m) | Dist. to building (m) | Age Classification | Ownership |
|---|---|---|---|---|---|---|---|
| Recommendation | | Reduce height by 2m and crown radius by 1m leaving balanced crown. Prune on a triennial cycle to maintain at broadly reduced dimensions. | | | | | |

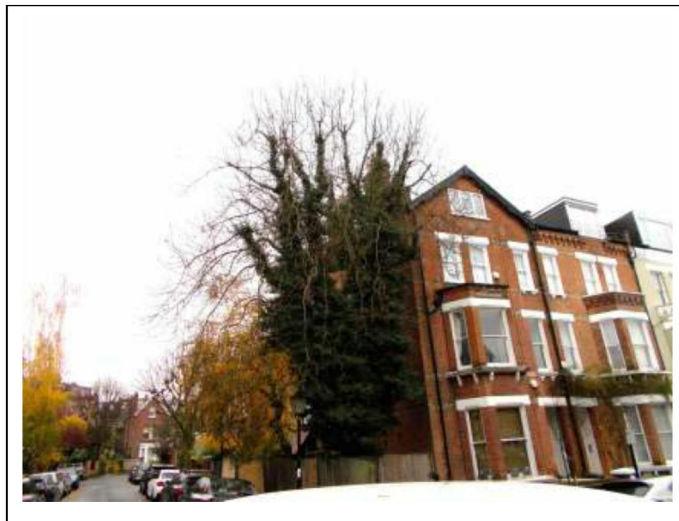
Alternative view of T1 and T2
