TECHNICAL REPORT ON A SUBSIDENCE CLAIM

Mark Longden & Others  
9 Willoughby Road  
London  
NW3 1RT

SUBSIDENCE CLAIM

DATE 14th November 2019

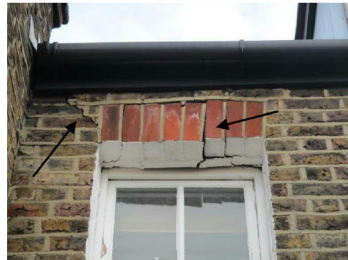
Cracking to rear elevation

**Rear Elevation** - 10mm cracking and movement to brick arch above flat D landing window, 9mm stepped crack below window.

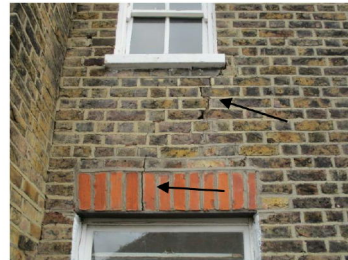
Cracking to rear elevation

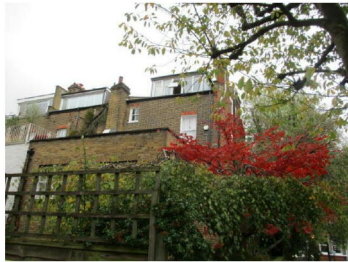
View of rear of property

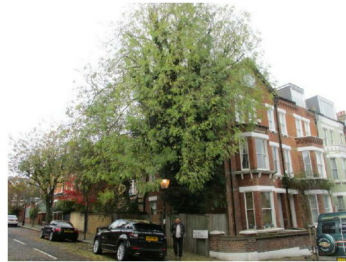
The timing of the event, the presence of shrinkable clay beneath the foundations and the proximity of vegetation where there is damage indicates the shrinkage to be root induced. This is a commonly encountered problem and probably accounts for around 70% of subsidence claims notified to insurers.

View of trees to left hand side of property

The cause of the movement needs to be dealt with first. We have completed a Soil Risk Analysis (VISCAT Assessment) and we are satisfied that your ash and silver birch trees can be removed.

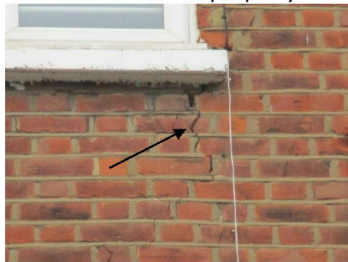
**Front Elevation** - Stepped crack below right hand side of top floor window.

Cracking to front elevation

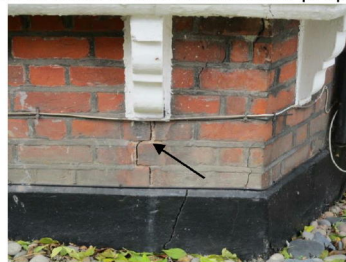
**Front Bay** - 7mm vertical crack below right hand side of ground floor middle window, tapering separation down left hand side bay junction at ground floor level, vertical cracking to lintel above 1st floor left hand window.

Cracking to front bay

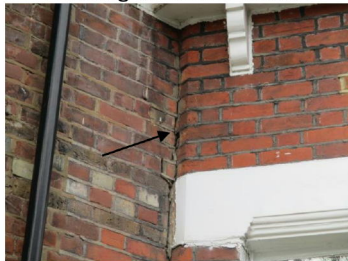
Cracking to front bay

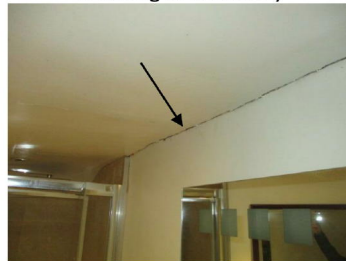
**Bathroom** - 5mm tapering separation along right hand party wall.

Cracking in flat D bathroom

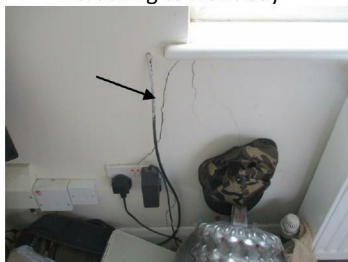
**Front Bedroom** - 2mm diagonal cracking above and below front window, cracking to ceiling.

Cracking in flat D front bedroom

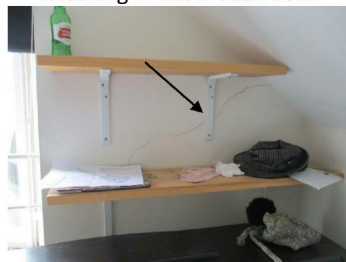
Cracking in flat D front bedroom
