## Survey Report for Dampness

Survey Address: 23 Gloucester Crescent London NW1

Date 15 December 2019

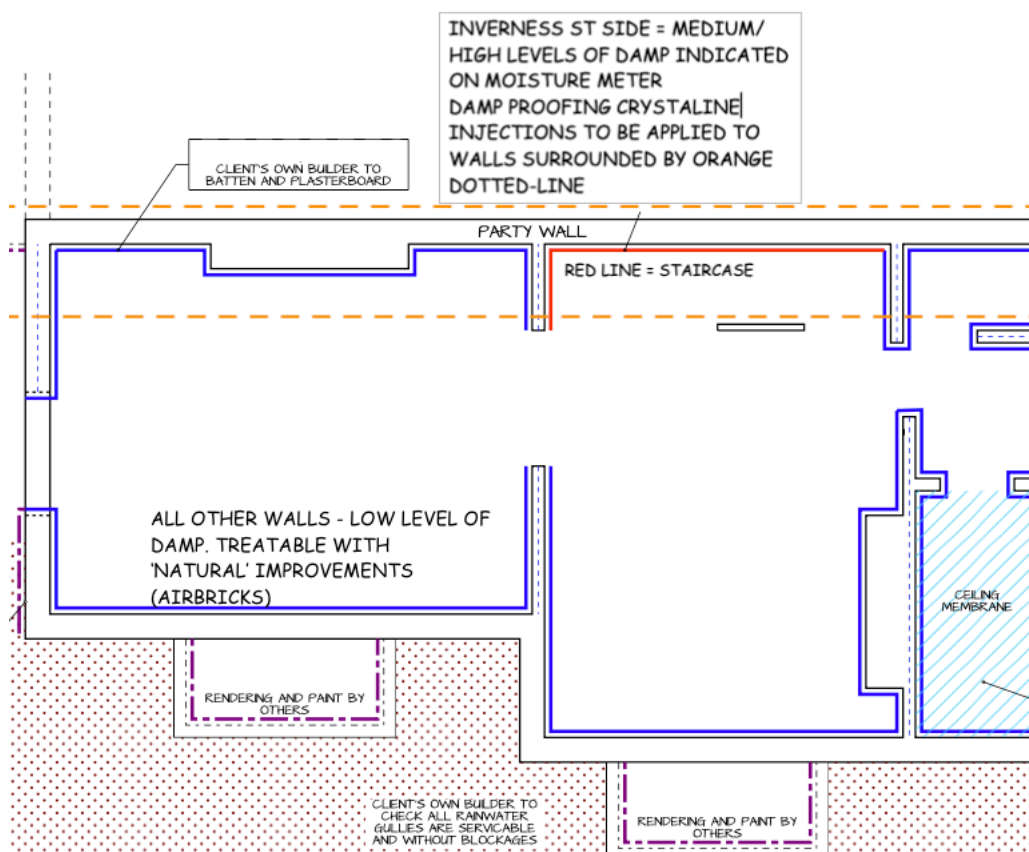
## 4. Readings & Site Drawing

Dampness was noted across all the wall on the eastern-side of the property – forming the party wall with 41 Inverness Street.

Walls to the perimeter of the house on the western side into the front garden area and northern and southern sides measured lower readings for pervasive damp.

All of what we would regard as 'abnormal' readings were investigated and from the evidence available to us at the time of our inspection we have concluded that damp is present in those walls referred to on the previous page.

We would propose using a course of DPC injections comprising Permaguard Damp Proofing cream at the low points of the affected wall backing onto Inverness St.

On the other basement walls we would look to improve air flow and manage condensation through the installation of Air Bricks.
