Addendum Report

On behalf of **Sheilas Wheels**

Report Date: 20 Jan 2020

Risk Address: 59 Hillway, London, N6 6AD

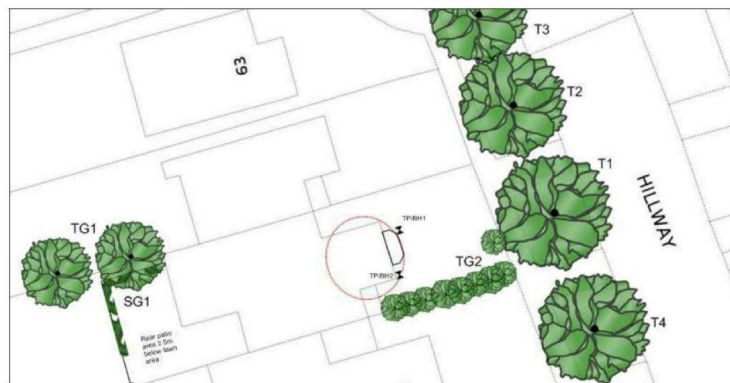
The site slopes down from right to left and there is an upward slope to the front elevation. There is a row of mature Lime trees along Hillway under the control of Holly Lodge Estates and approximately 10m from the front elevation – see site plan below.

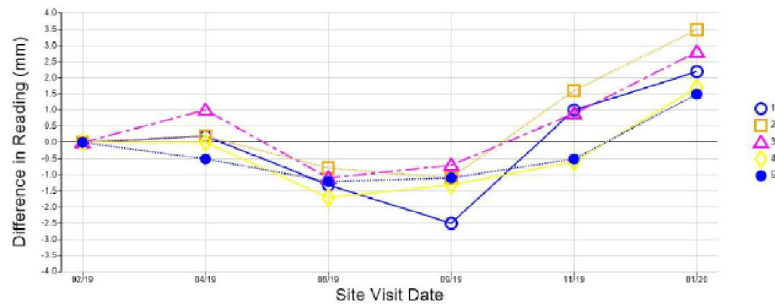
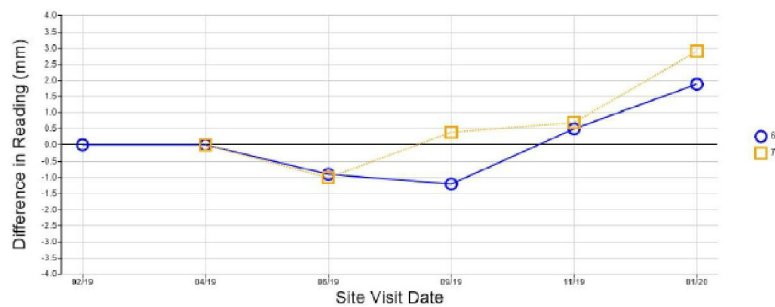
Despite the pruning work the level monitoring continues to show pronounced seasonal movement with the building moving down, as the soil is desiccated and shrinks through the action of the Lime tree and then recovering over the winter period (after leaf fall).

The subsequent level monitoring (following the pruning work) continues to show a clear pattern of seasonal movement suggesting the pruning work has been ineffective.

Given the circumstances and the failure of the pruning work to effectively mitigate the nuisance and damage caused by the Lime tree we consider the only effective solution is to fell the tree.

If this application to fell is refused, we would have to look at an engineering solution to stabilise the property either by the construction of a root barrier or through underpinning. While quotations for this work have not been obtained, it is envisaged these costs would be in the region of £30,000.
