Arboricultural Consultancy for Sheilas Wheels

Insured	Mr John Alderton	Address	59 Hillway, London, N6 6AD		
Client	Subsidence Management Services	Contact	Steven Vertefeuille	Claim No.	
ES Ref		Consultant	Andrew Cayley	Contact No.	
Report Date	08/10/2018

5. Technical Synopsis

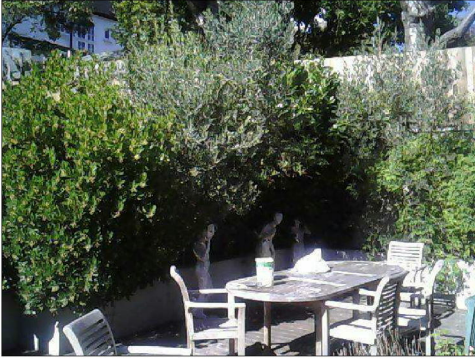
SG1 - Mixed species shrubs

Tree No.	Species	Age Cat	Approx. Height (m)	Distance to Building (m) *	Ownership	Action	Requirement
SG1	Mixed species shrubs: Species include: Arbutus, Olive, Ceanothus, Laurel and Jasmine. In planter.	1	3.2	1.9	C - Insured	No action	No works.
T2	Lime	1	15	14.5	F - Commercial Third Party	Action to avoid future risk	Re-prune back to point of previous reduction and maintain thereafter by re-pruning on a strict 2-3 year cycle.
T3	Lime	1	14.5	18.8	F - Commercial Third Party	Action to avoid future risk	Re-prune back to point of previous reduction and maintain thereafter by re-pruning on a strict 2-3 year cycle.
T4	Lime	1	12.3	17	F - Commercial Third Party	Action to avoid future risk	Do not allow to exceed current dimensions by way of regular pruning.
TG1	Cherry (Wild)	2	7.5	2.9	A - Third Party 61 Hillway London N6 6AD	Action to avoid future risk	Do not allow to exceed current dimensions by way of regular pruning. Trees set 2.5m above insured property ground level. Note: closest tree to the insured property appears to be declining.

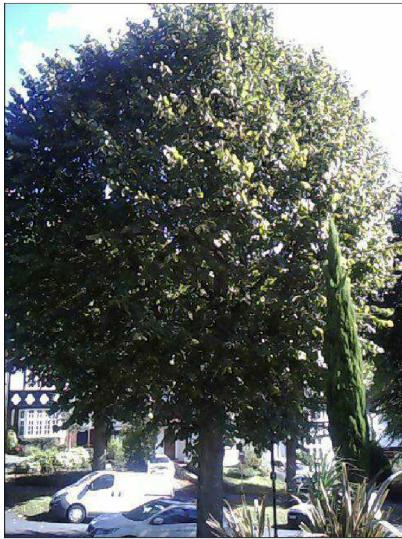
T1 - Lime

Our survey of the site identified T1 (Lime) and TG2 (Cypress (Italian)), given their position relative to the damage it is our opinion that the Tilia spp and Cupressaceae spp. roots identified within TP/BH1 / TP/BH2 will emanate from this vegetation.

Based on our observations on site and with due regards to species profile, T1 (Lime) is considered the dominant feature, the source of the Tilia spp roots identified and accordingly we have identified it as the principal cause of the subsidence damage.

Removal of T1 and a short section of TG2 will offer the most certain and reliable arboricultural solution likely to restore long-term stability.

Tree No.	Species	Age Cat	Approx. Height (m)	Distance to Building (m) *	Ownership	Action	Requirement
T1	Lime	1	15	13	F - Commercial Third Party	Remove	Remove close to ground level; do not treat stump due to translocation risk. Where such a risk exists, we advise that any emergent regrowth is removed annually.
TG2	Cypress (Italian)	1	6.5	2.2	C - Insured	Maintain as detailed	Remove the closest x 3 trees to the subject property close to ground level. Do not allow remaining trees to exceed current dimensions by way of regular pruning.

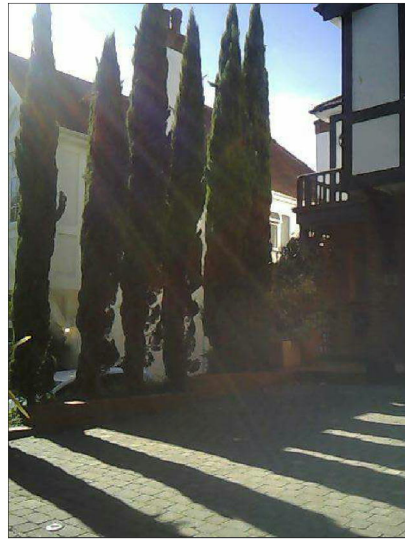
TG2 - Cypress (Italian)

Given the recovery of functionally active Cupressaceae spp roots, components of TG2 cannot be discounted as contributing to the overall level of soil drying proximate to the area of damage and is therefore also considered to retain a contributory influence, albeit in a limited / secondary capacity when compared to T1 (Lime).
