From: Tom Rosenthal [REDACTED]
Sent: 25 January 2020 07:52
To: Planning [REDACTED]
Subject: Submitted objection // Ref 2020/0048/T

Instruction

to assess the possible role of trees in subsidence damage at the adjacent
property, Mourne House, 11-13 Maresfield Gardens, reported in September
2019.

Site visit 18 January

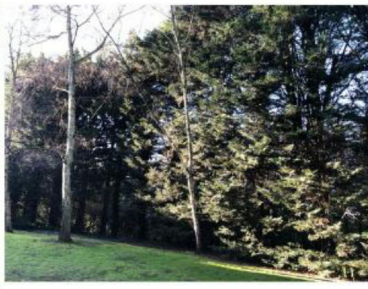
The rear garden of Mourne House contains young birch trees and is bordered by a large cypress hedge c8m from the property.

None of the technical reports take any account of the cypress hedge. Cypress has a high water demand and, considering the size of the hedge, must be extracting large amounts of water from the rear garden of Mourne House and thus contributing to shrinkage of the soil. Indeed, the hedge could account for up to the same amount of water extraction as the oak and the beech.

Massive cypress hedge
and birches
in rear garden of
Mourne House

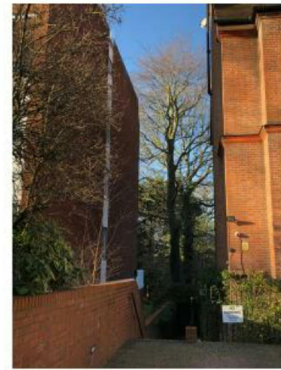
Street view

The site visit confirmed the previous reports that the beech and the oak are mature healthy trees that long predated the construction of Mourne House (1976). In fact the trees almost certainly predate 15 Maresfield Gardens (1883). The oak is probably over 200 years old and the beech, a faster growing tree than oak, at least 150 years old. Both trees were mature and almost certainly had a similar stature when Mourne House was built. Both trees show evidence of pollarding several years ago since when they have produced extensive regrowth. The trees are clearly visible from the street .

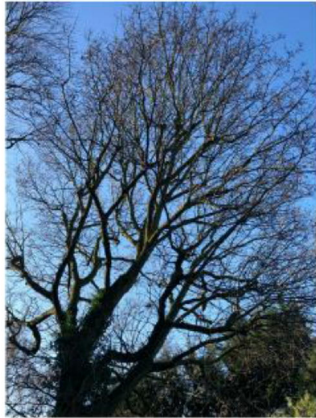
Oak

Evidence of pollarding several years ago

The oak and the beech should be given TPO status.
