75 Lawn Road

Structural Survey

March 2019

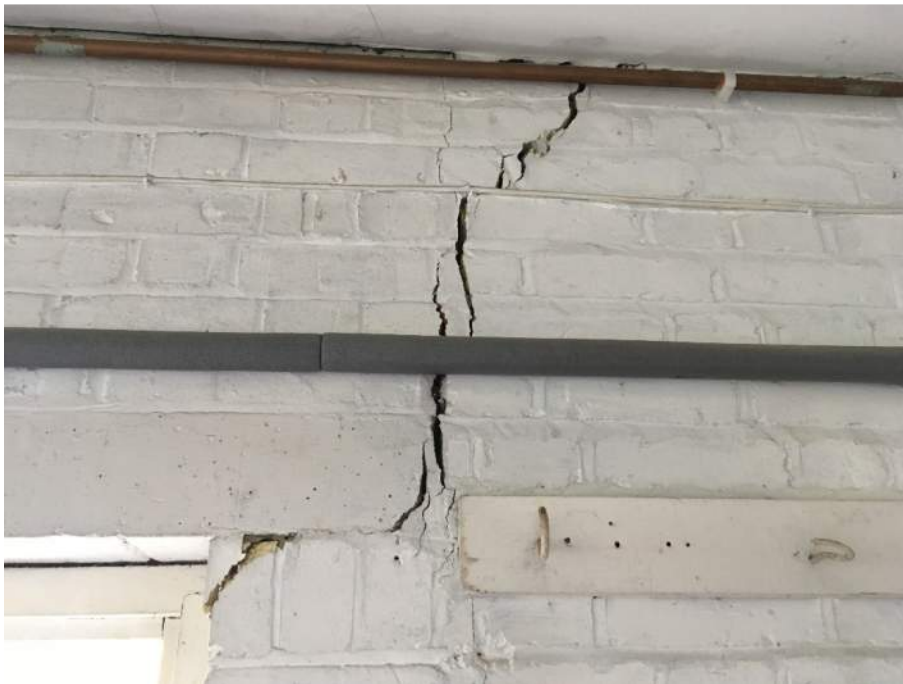
Damage in Garage

The damage suggests the garage section of the building is rotating towards the rear garden. Possible causes could be the large trees in the rear gardens or damaged drainage. The guttering and down pipe in photograph 7 shows signs of overflowing. The garage floor has also dropped away from the manhole in the centre of the garage. There is a possibility the drainage run from the rear garden manhole has failed.

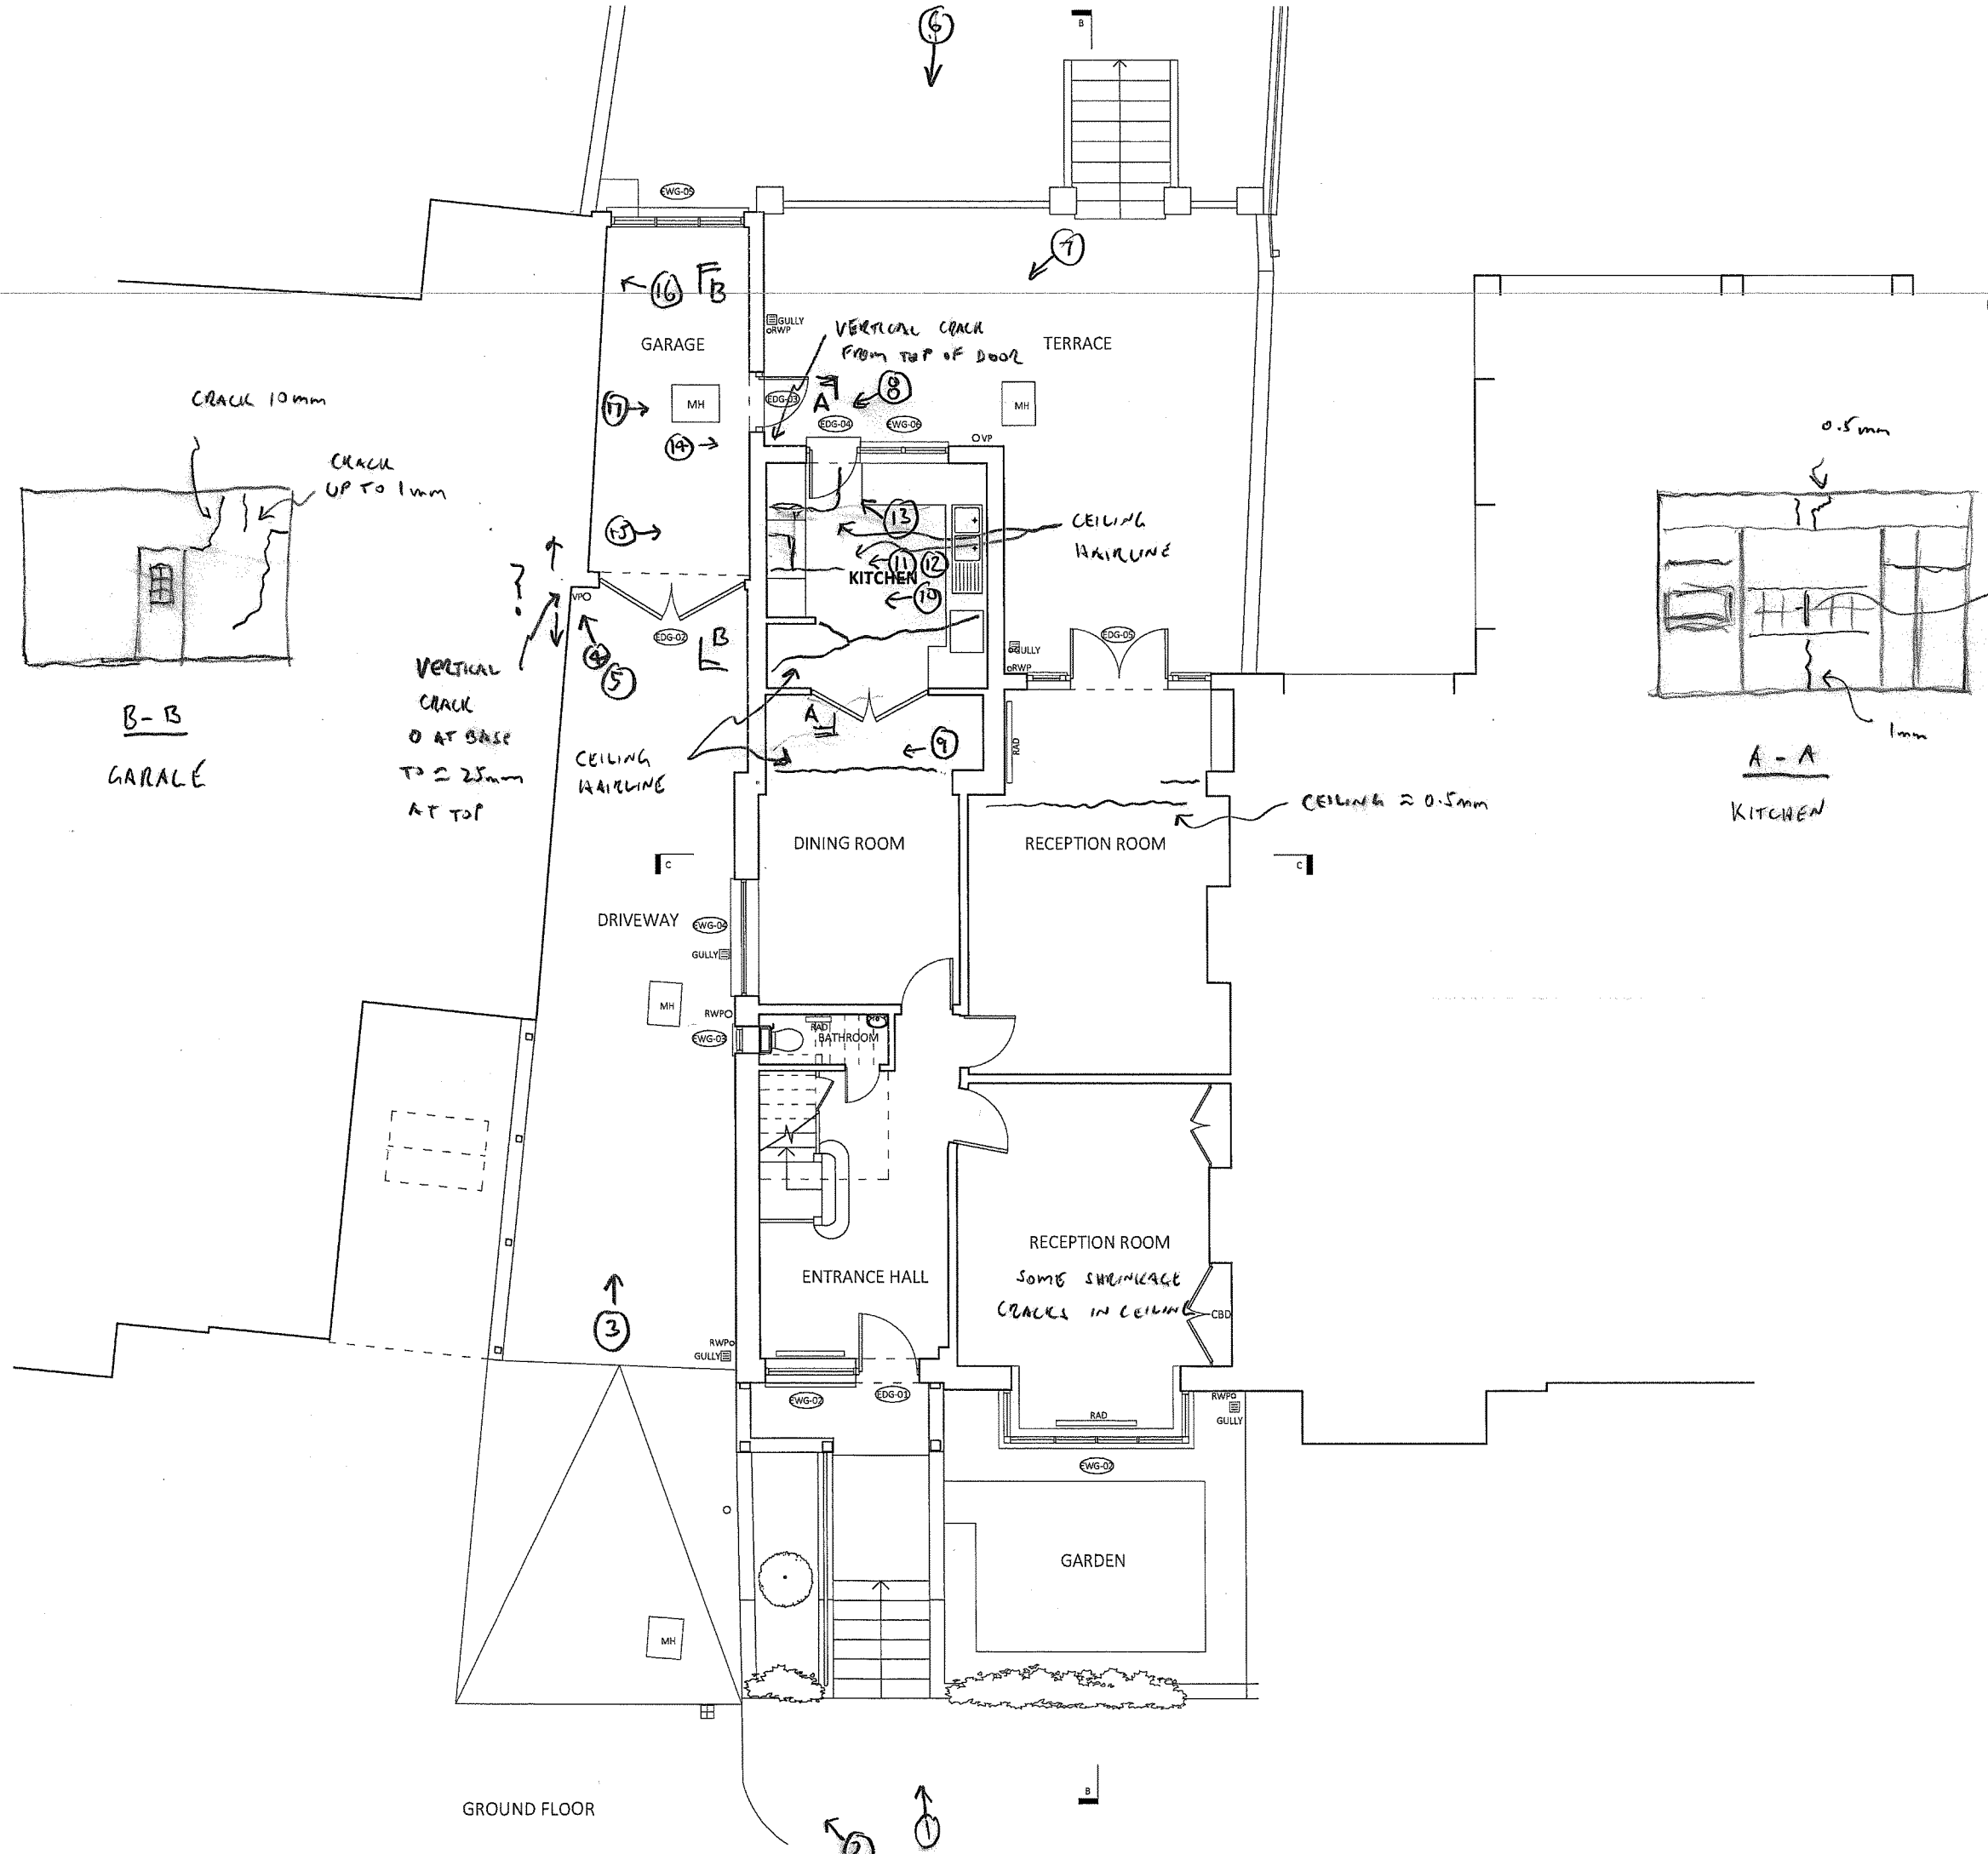
SK/01
 SITE VISIT
 8/3/19

EngineersHRW visited the site on the 8 March to review the condition of the existing building. This was a visual survey and did not include any intrusive works. The notes in Appendix II identify the structurally significant damage to the building and is shown in photographs in Appendix 3. It should be noted that there are minor hairline cracks that are not structurally significant throughout the house. A more extensive photographic record has been made to allow for future reference but is not included in this report.

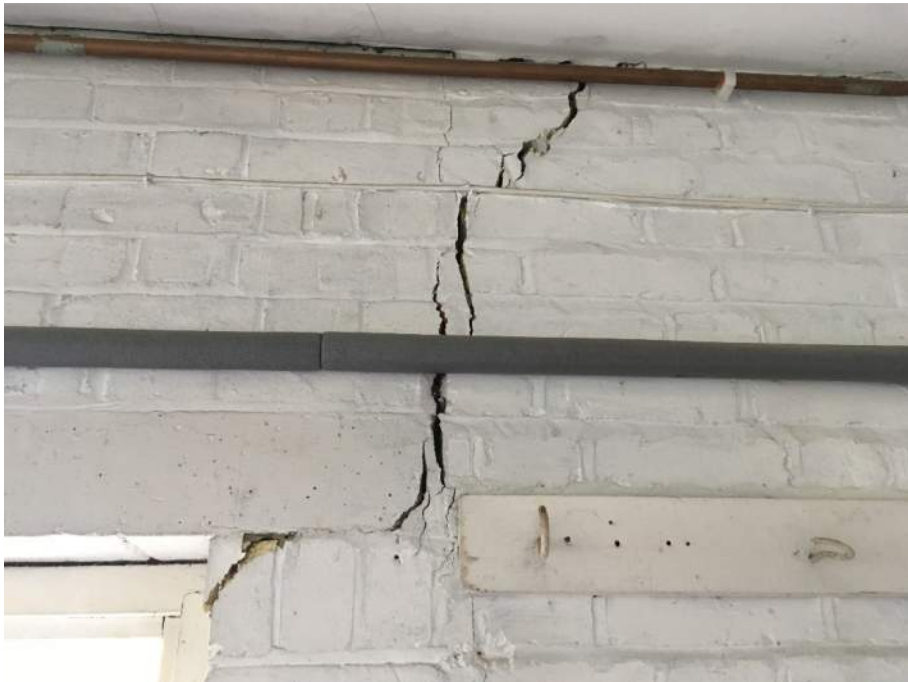
Photograph 14

The most significant damage to the building is at the junction of the rear two storey garage section of the house where it meets the main body of the house. At first floor the cracks in the masonry wall dividing these elements are up to 20mm wide. These can be seen in photographs 14, 19 and 23. Minor cracks extend into the adjacent rooms at ground and first floor. The front wall of the garage shows evidence of movement relative to the adjacent property. The pointing at the junction shows a widening separation with height.

This above ground damage cannot easily be reversed, and it may take a number of years for the underlying clay soils to be fully re-hydrated again. Further monitoring of the cracks could ascertain if the movement is seasonal or progressive, but in any instance the most likely and practical solution is to undertake underpinning. This would secure the property and ensure its long-term protection against any future ground movement. It should be noted that the same effect of shoring the property below ground could be achieved through the installation of a basement

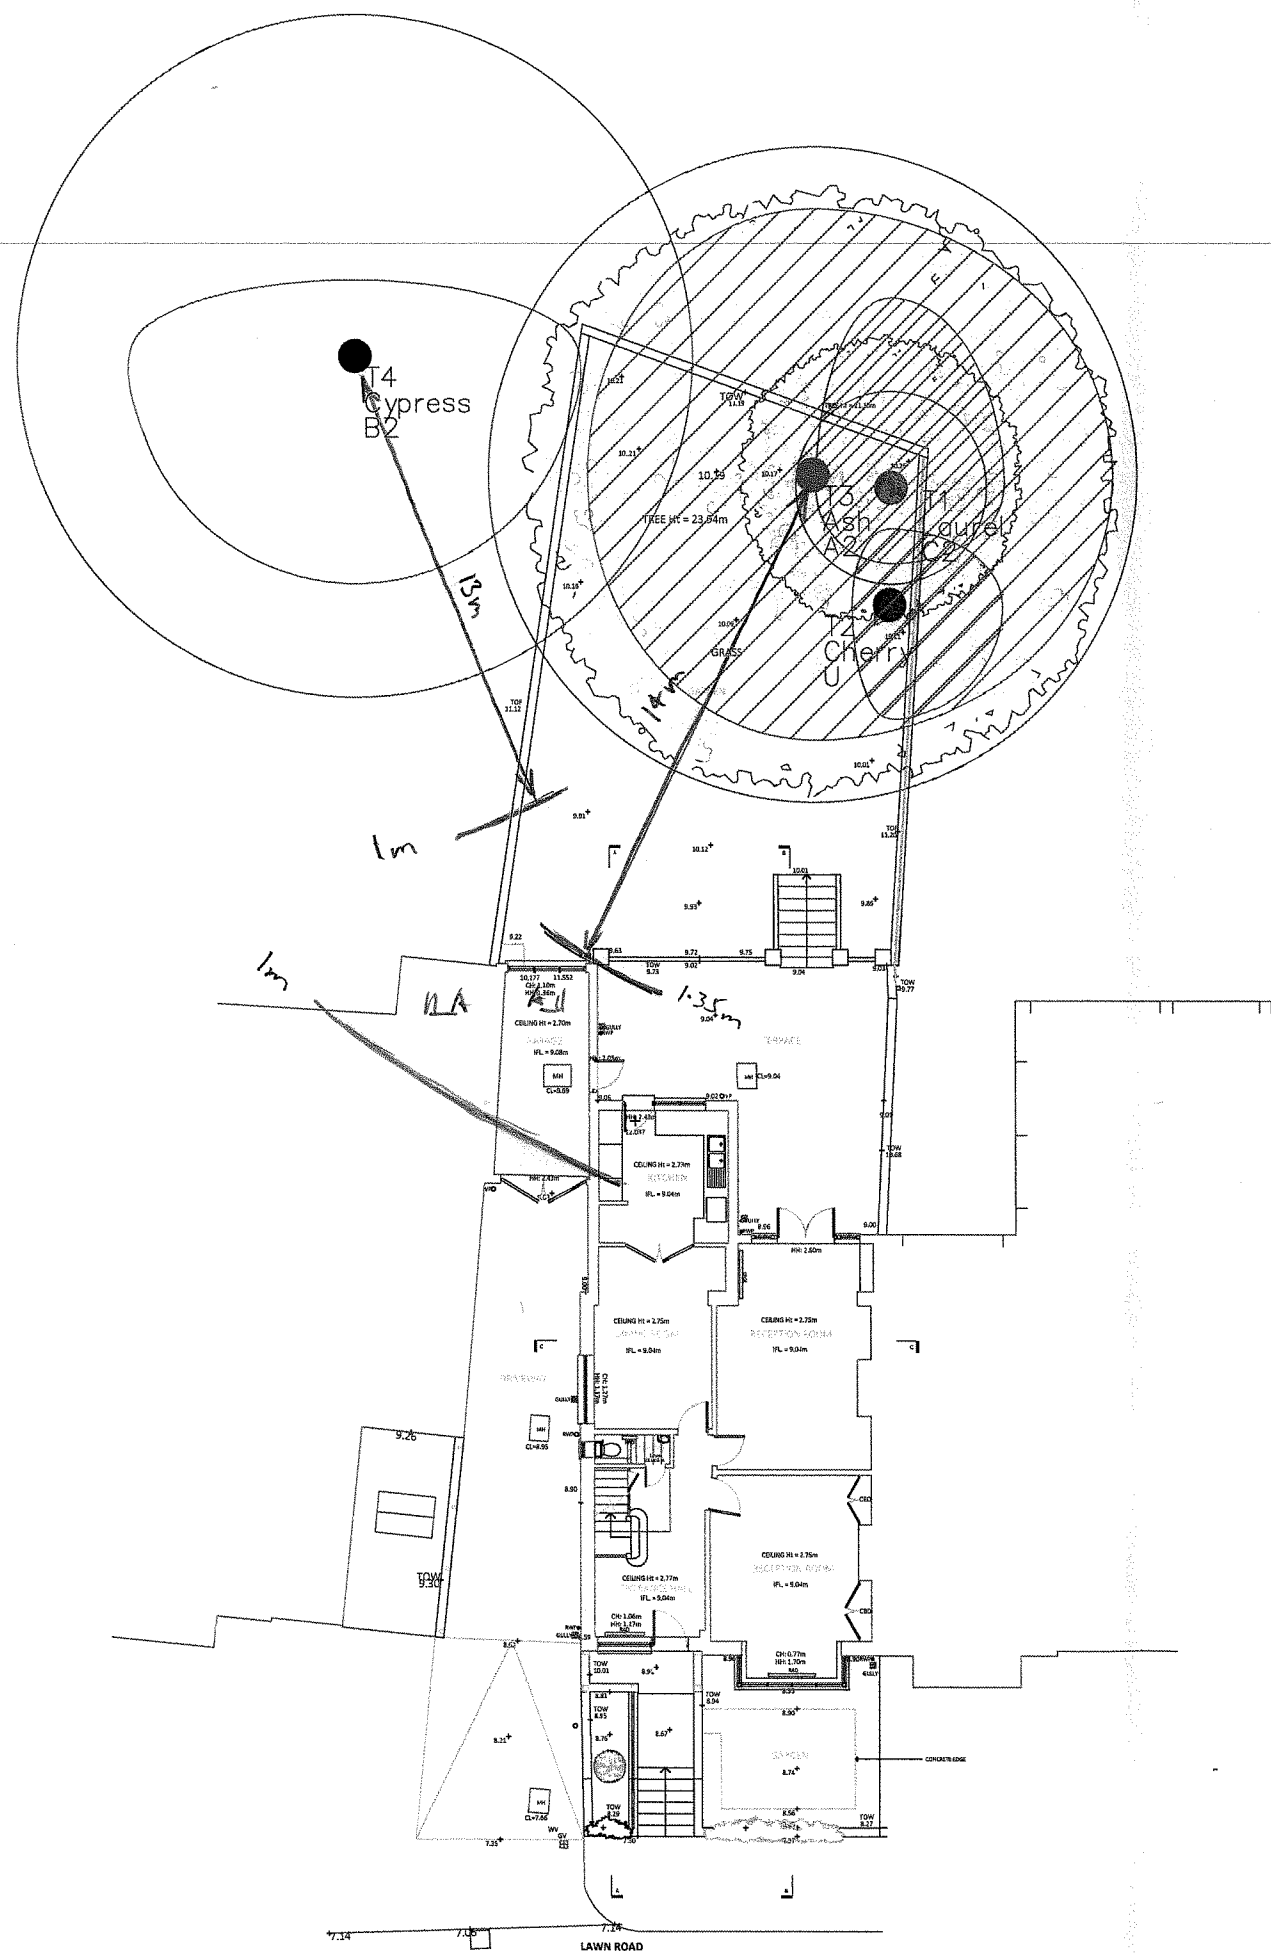
Tree Review Notes

Appendix IV indicates the influence zones of the trees based on the NHBC guidance. This shows that the Ash to the rear of No 75 may have an impact on the existing foundations. It is however not sufficiently definitive to confirm that this is the cause of the subsidence. The NHBC guidance would be for a depth of foundation of 1.35m from ground level, based on the ground level in the upper garden. Note that the existing foundation depth in the terrace area is approximately 0.5m below ground level and 1.1m below garden level. Typically, the foundations, based on the NHBC guidance, would be founded at a depth of 1m minimum below ground level.
