**75 LAWN ROAD, LONDON  
NW3 2XB**

**BASEMENT IMPACT ASSESSMENT ADDENDUM  
MAY 2019**

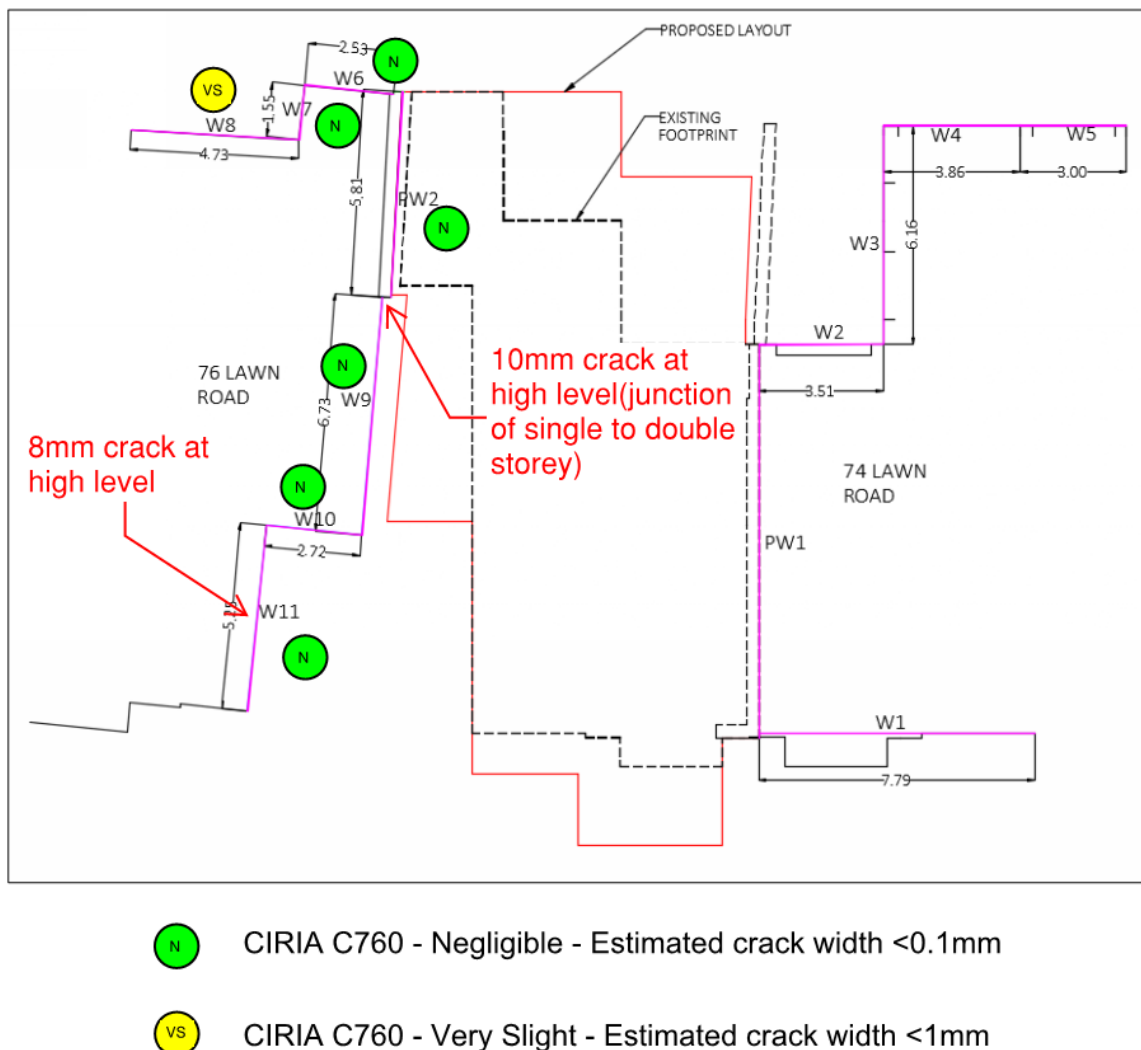
**Figure 1: Ground Movement Assessment Wall Location Plan**  
(with Alan Baxter Report text added in red)

Figure 1 has the cracks within the proximity of the works identified in the Alan Baxter Report added for information. This shows that one wall, W11, now has an existing crack that may be subject to additional movement due to the basement works. The predicted movement is however negligible i.e. less than 0.1mm. The crack at the junction of the two-storey attached section of the buildings is not considered as part of the analysis is as it is at the junction of what appears to be two different walls (W9 and PW2).
