### Level and Crack Monitoring

Our Ref: [REDACTED] Date of Issue: 24/12/2019

| Address: | 63a Belsize Lane |

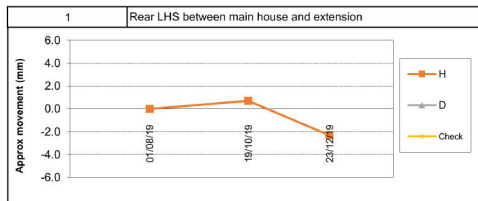
### Crack Monitoring - Movement Against Time

| Studs nos | Align-ment | Visit Date | 01/06/19 | Visit Date | 19/10/19 | Visit Date | 23/12/19 | Visit Date | | Visit Date | | Visit Date | |
|---|---|---|---|---|---|---|---|---|---|---|---|---|---|
| 1 | H | 85.34 | HL | 86.04 | HL | 83.03 | 0.50 | | | | | | |
