19 Woodchurch Road London NW6

SUMMARY REPORT

**For
London Borough of Camden**

Ref: E&M Summary Report **Revision A** 2019-11-19 - 19 Woodchurch Rd

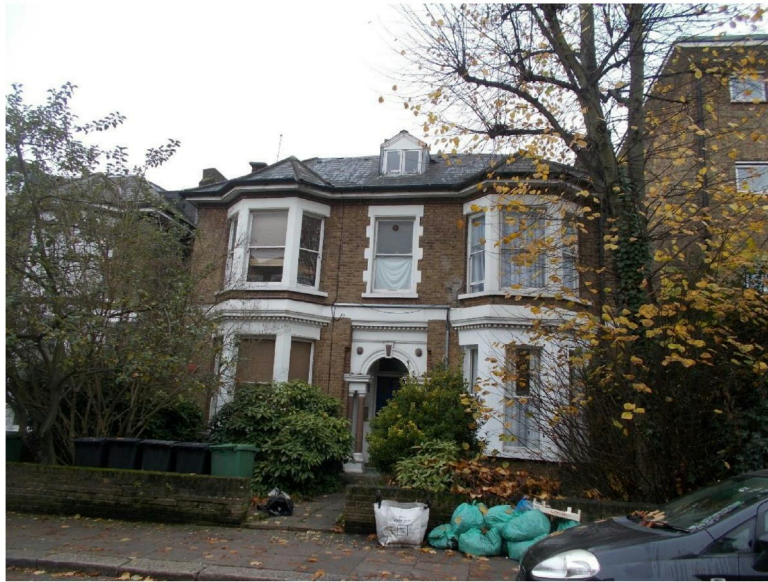
Photograph 01

- b) The building is a three-storey, including Loft Floor, detached house of Victorian architectural features (refer to Photographs 01 to 03 in Appendix B); the building is believed to have been constructed during that era.

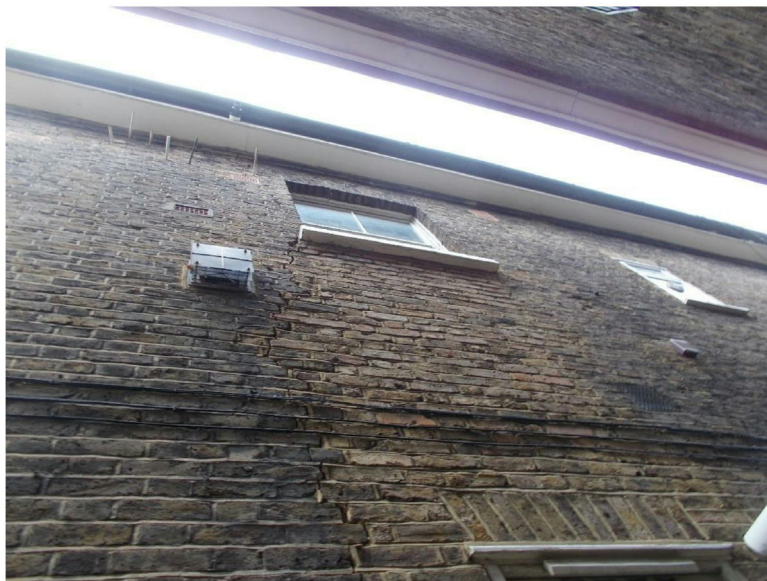
Photograph 04

- e) Externally, cracks of up to approximately 10mm maximum width were evident to the left-hand flank wall (full-height vertical crack) and the middle of the rear façade at 1st Floor level (refer to Photographs 04 to 06).

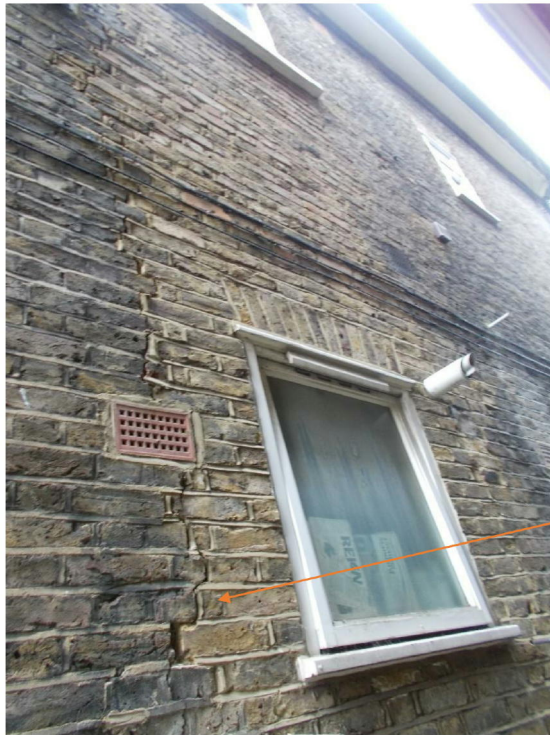
Photograph 05

Possible
location of
crack

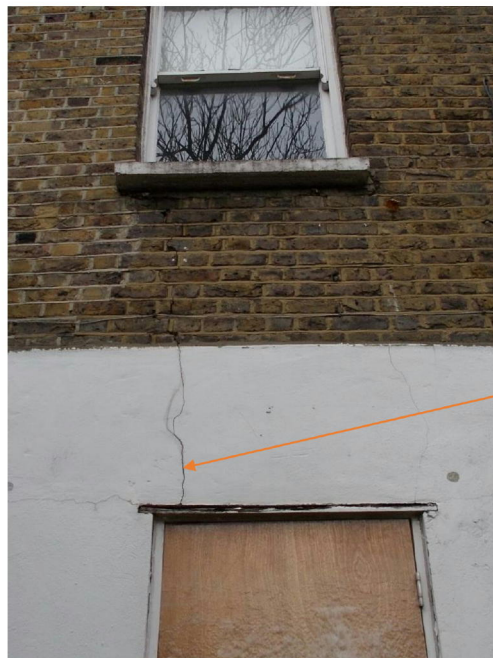
Photograph 07 (Rear Façade)

- f) A selection of some other external cracks is shown in the Photographs 07-08.
- g) Internally the cracks of greatest magnitude were evident within the 1st Floor Flat 4, adjacent to the kitchen window to the flank wall of 10mm maximum width (refer to Photograph 09). Also evident within the 1st Floor common hall, there is a full height vertical crack of approximately 6mm maximum width to the right-hand partition wall and also within the common hall/stairs an approximately 5mm maximum wide crack below the 1st Floor window front bay (refer to Photographs 10 and 11).

Possible
location of
crack

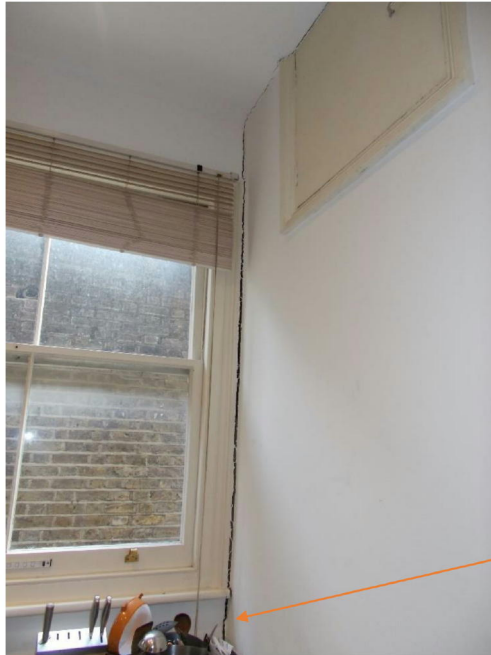
Photograph 09

Possible
location of
crack

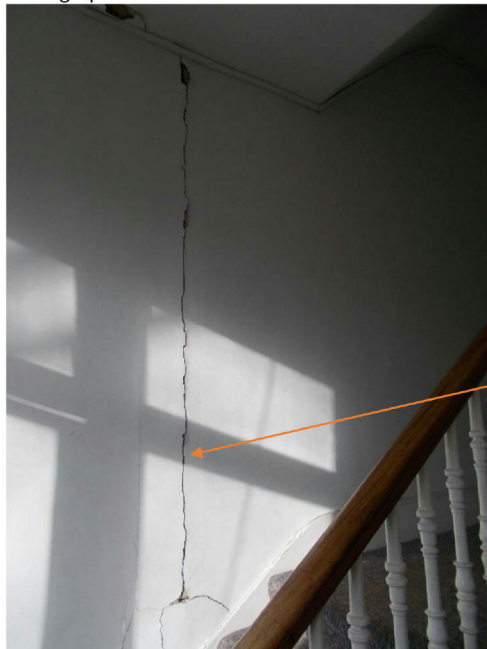
Photograph 10 (Common Hall/Stairs)

Possible
location of
crack

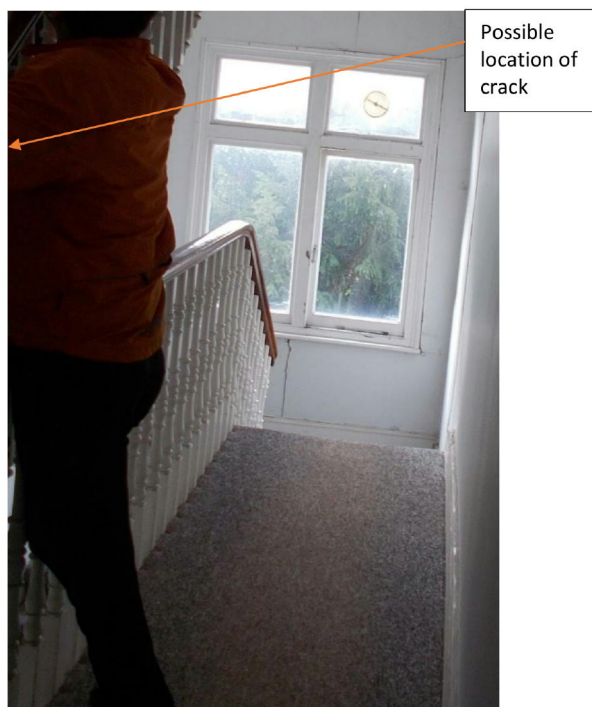
Photograph 11 (Common Hall/Stairs)

Possible
location of
crack

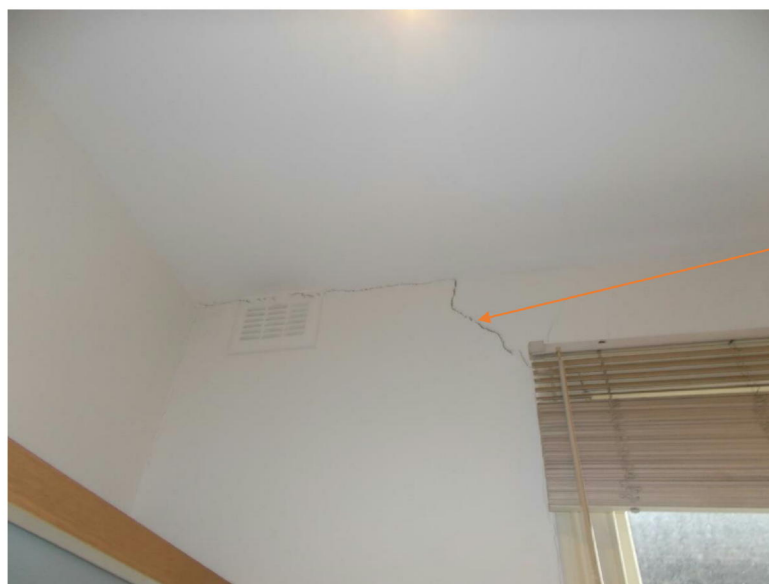
Photograph 12 (Flat 4 Kitchen)

- h) A selection of other internal cracks are shown in the Photographs 12-17.
- i) Please note that both Flats 1 and 5 were recently redecorated and the cracks were filled.

Possible
location of
crack
