Site Details: Vine House, Hampstead Square, London, NW3 1 AB

Prepared for: Mrs. J. Gosman

Title: GOS\_VHHS\_AIA\_001

Published Date: 21<sup>st</sup> June 2019

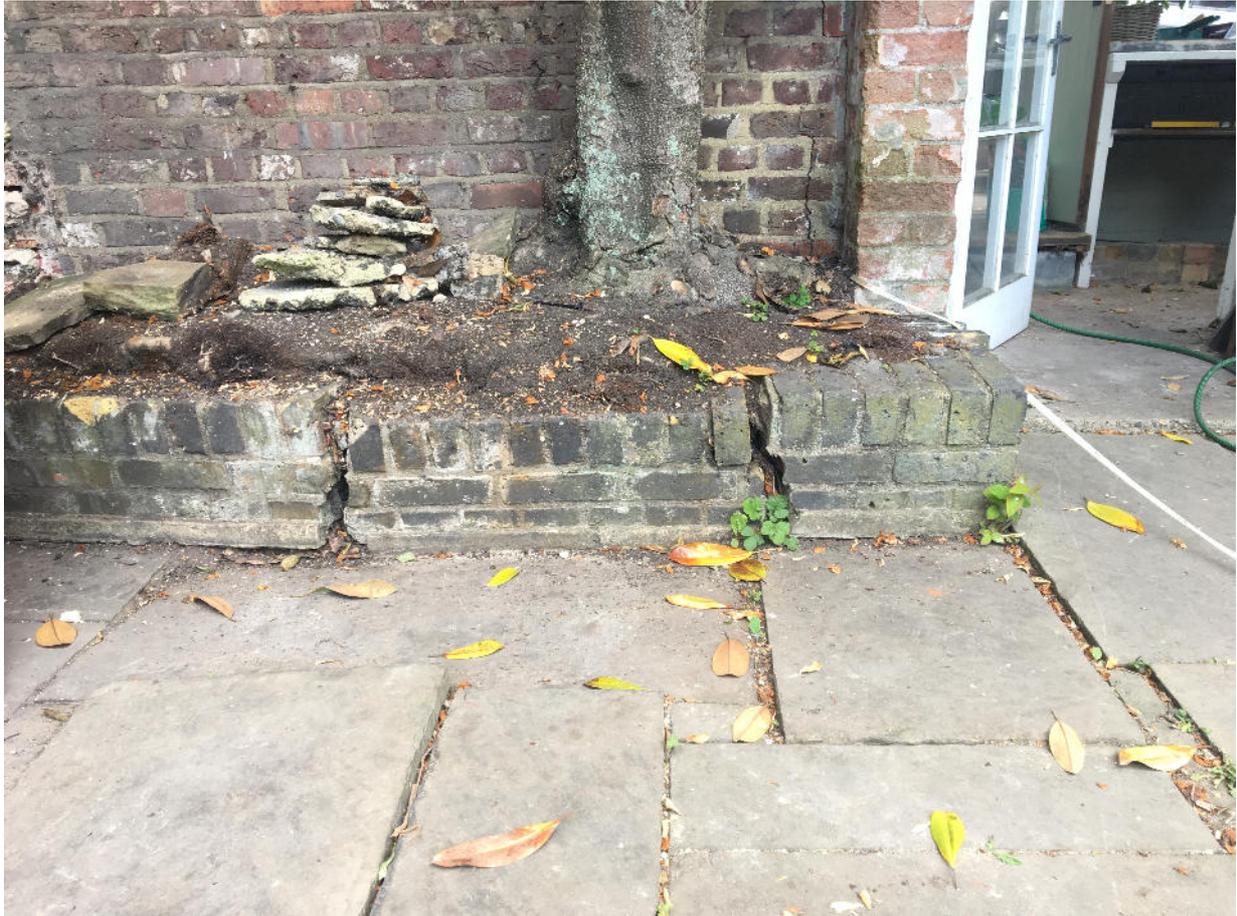
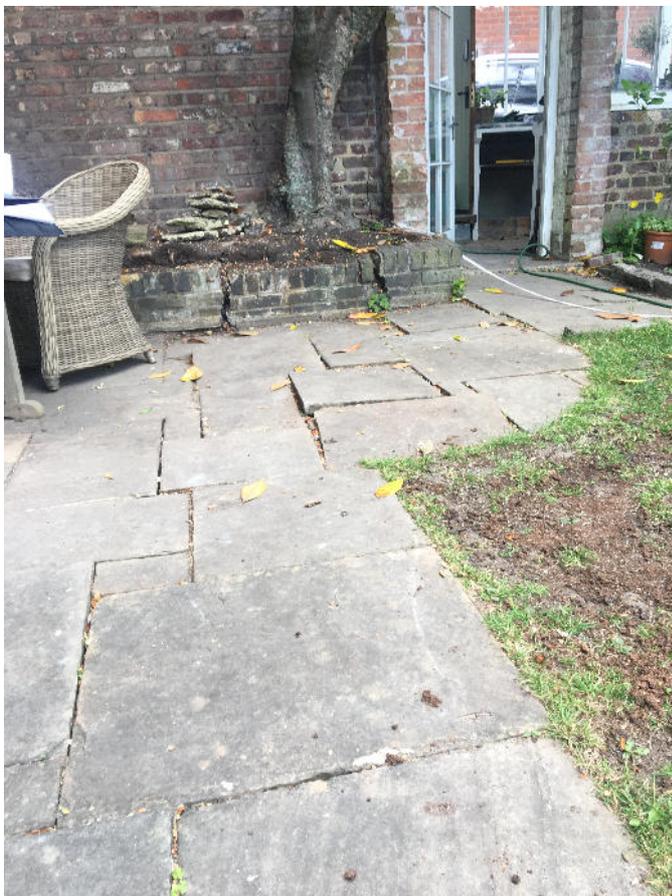
Notably, a mature *Magnolia grandiflora* tree is growing in very close proximity to the area of proposed development (*boiler house/ green house*). The tree appears to have been originally planted within a low raised planting bed of brick construction, which it has long since outgrown. Major roots have caused significant structural damage to the retaining wall, which has cracked and separated in a number of places. Two large fractures are present in the south facing retaining wall, with major roots breaking the surface of the soil within the planting bed. The stem, buttressing and major roots of the tree are also directly impacting on the southern elevation of the boiler house. A large longitudinal crack is visible on the external south elevation of the boiler house wall behind the tree and is mirrored internally also, with further horizontal cracking observed along the brickwork. Additionally, a number of paving slabs which form the nearby patio area have also lifted and distorted in places, which can be attributed to the presence of shallow, major roots belonging to the tree exerting forces against the underside of the paving slabs, as they have extended over time into the preferable soil environment of the soft landscaped garden. (*See Appendix C – Supporting Photographs*).

*The Magnolia T1 is located within a low raised planting bed in close proximity to the southern elevation of the existing boiler house.*

*Major, woody roots have caused direct impact damage to the retaining wall where they have outgrown the containerised nature of the bed through years of incremental growth. The adjacent patio surface is also distorted and lifting up in places where roots beneath the paving are exerting force against the underside of the slabs. Again, through many years of secondary thickening, the roots have increased in diameter and are distorting the surface.*

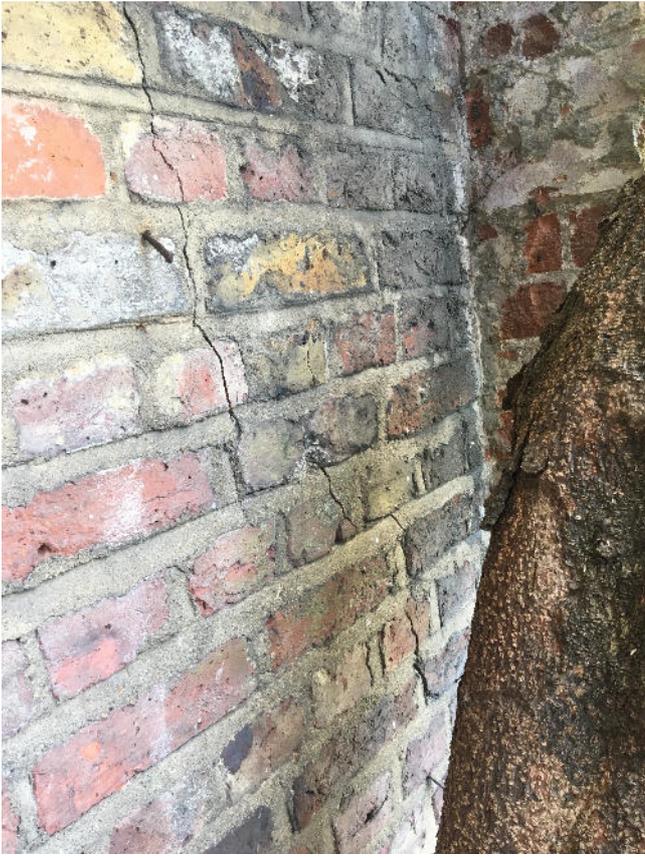
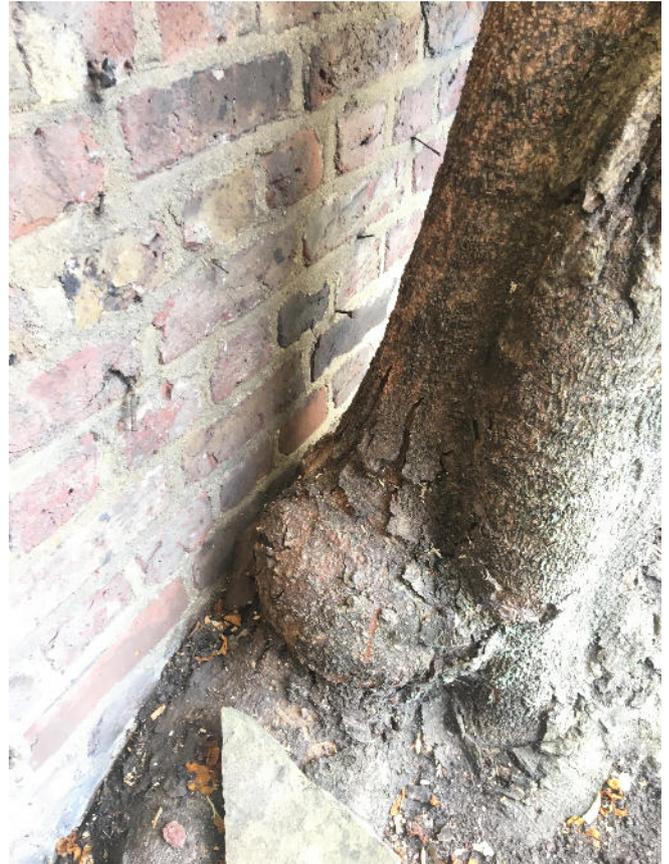
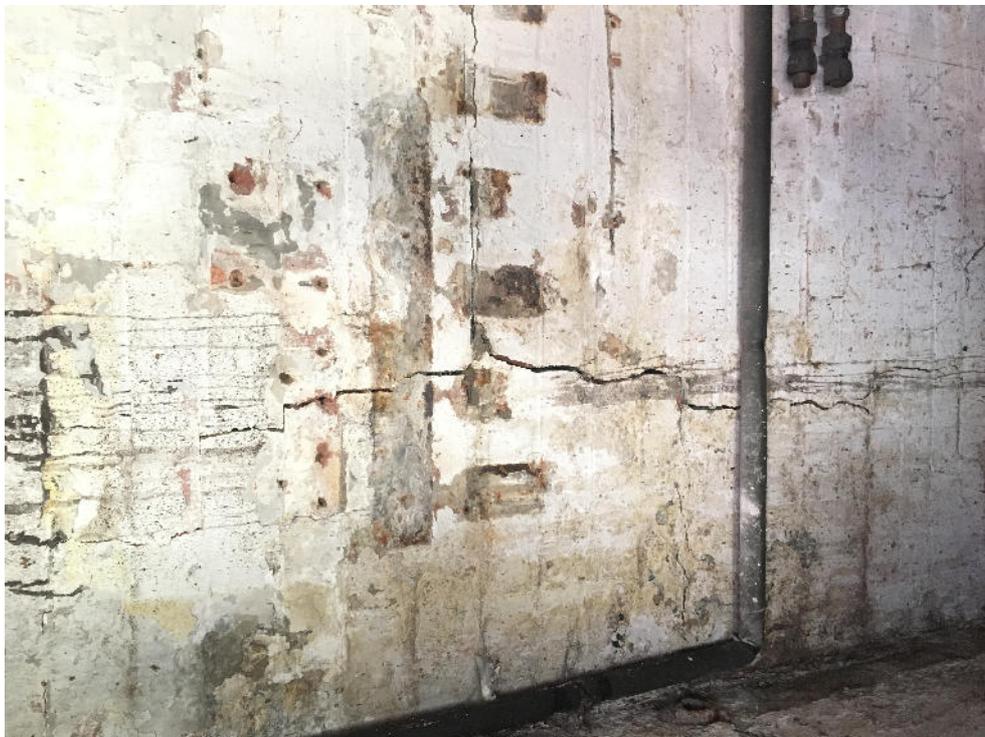
| Tree No. | Species | Height (m) | Stem Diameter (mm) | Branch Spread (m) | First Significant Branch Height and Direction of Growth (m) | Canopy Height (m) | Life Stage | General Comments Inc. Physiological and Structural Condition | Preliminary / General Management Recommendations | Estimated Remaining Contribution (Years) | Category |
|---|--|---|---|---|---|---|---|--|--|--|---|
| 1 | <i>Magnolia</i><br>( <i>Magnolia grandiflora</i> ) | 10 | 1 – 250<br>2 – 150<br><br>SE – 275 | N – 3<br>E - 4<br>S – 3<br>W – 4 | 1 – S | 2 | M | Physiological Condition – Good<br>Structural Condition – Fair<br><br>Originally planted within a low retaining bed of brick construction in close proximity to the south elevation of the boiler house. Direct impact from the stem, buttressing and major roots have caused structural damage to the walls of the retaining bed and the boiler house as the tree has incrementally increased in size over its lifetime. Major roots beneath the nearby paved patio surface have also caused slabs to lift and become distorted.<br><br>(See Appendix C – Supporting Photographs)<br><br>(SEE TREE CONSTRAINTS ASSESSMENT SECTION 8.2) | <b>Remove tree;</b><br><br><b>Remove stump using a stump grinder;</b><br><br><b>Remove and dispose of all arisings accordingly.</b><br><br>(SEE TREE CONSTRAINTS ASSESSMENT SECTION 8.2) | <10 | C 1 |

*The stem base, buttressing and major roots of T1 are directly impacting on the southern elevation of the boiler house.*

*Significant cracks are present in the existing brickwork, visible on the outside behind the tree and in the lower photo taken from inside the boiler house; vertical and horizontal cracks are present which are consistent with the position of T1 on the other side of the wall and at the level of the stem base of T1.*

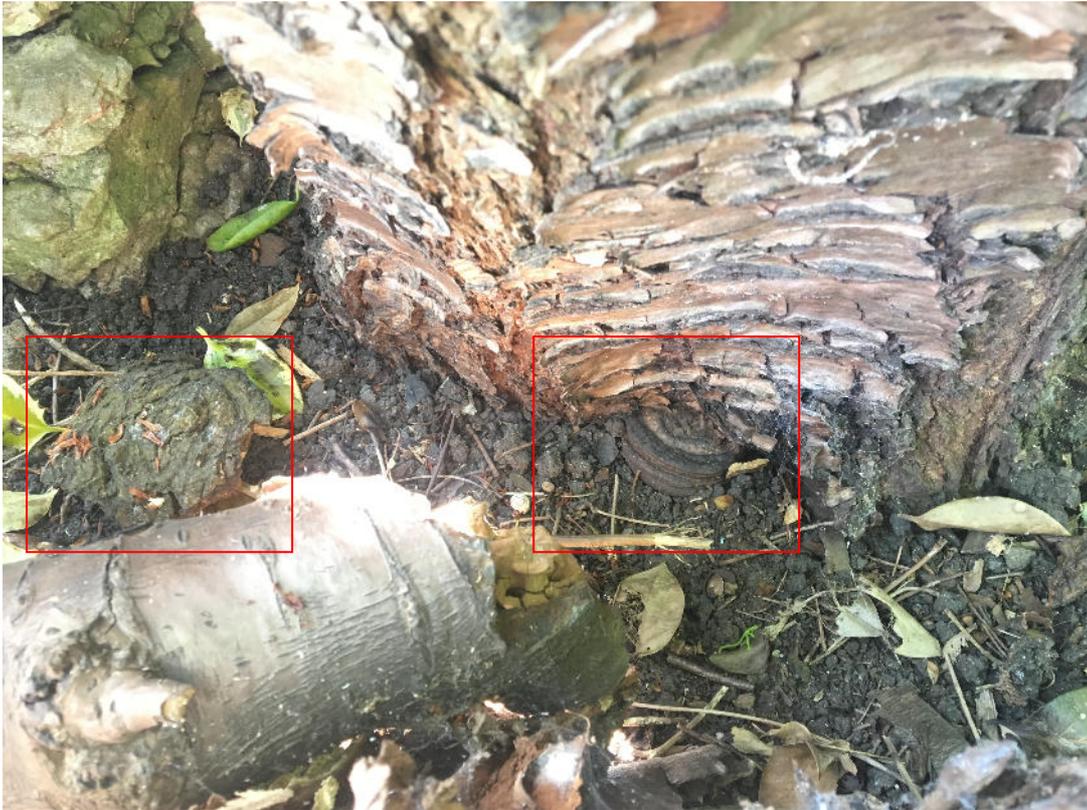
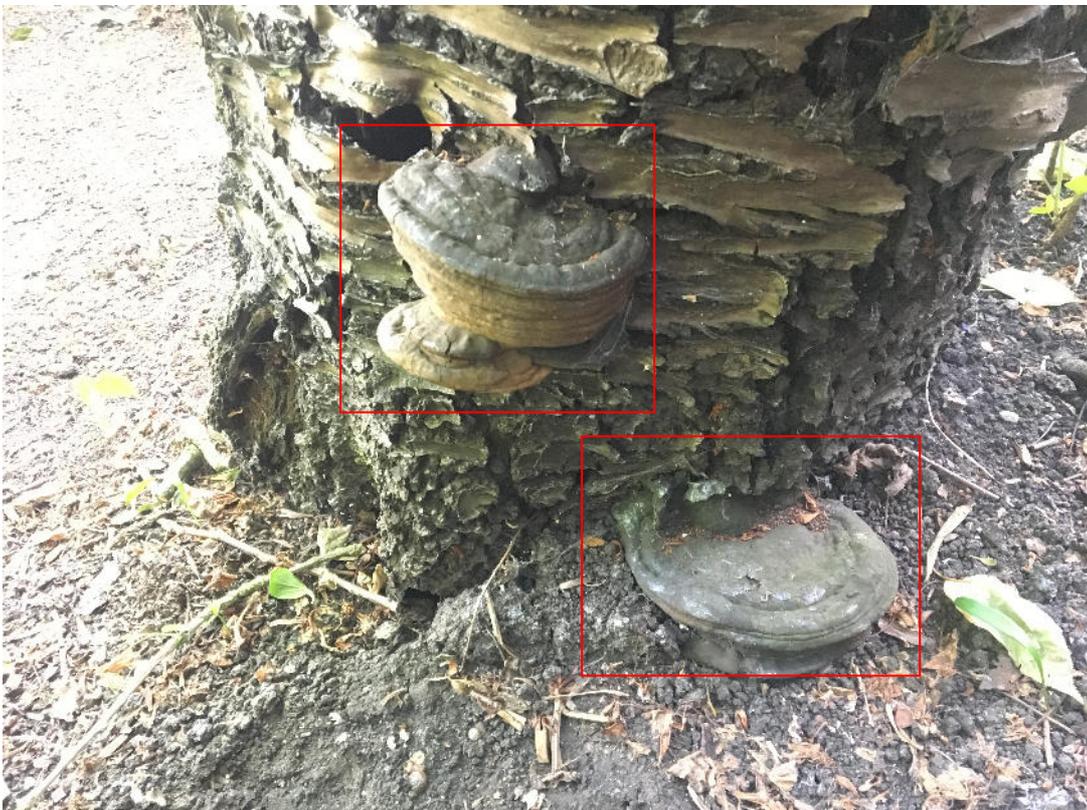
| Tree No. | Species | Height (m) | Stem Diameter (mm) | Branch Spread (m) | First Significant Branch Height and Direction of Growth (m) | Canopy Height (m) | Life Stage | General Comments Inc. Physiological and Structural Condition | Preliminary / General Management Recommendations | Estimated Remaining Contribution (Years) | Category |
|---|---|---|---|---|---|---|---|---|---|--|---|
| 10 | <i>Wild Cherry (Prunus avium)</i> | 9 | 275 | N – 2<br>E - 5<br>S – 4<br>W – 4 | 2 – E | 2 | M | Physiological Condition – Poor<br>Structural Condition – Poor<br><br>Located in a raised bed at the western end of the garden. Significant crown dieback, major and minor sized deadwood in the crown. Fruiting body of <i>Ganoderma.sp</i> fungus on the east side of the stem base. <i>Ganoderma</i> is a parasitic disease which causes white heart rot to the base of the stem and roots of broadleaved trees and invariably leads to stem failure. Considering where T10 is located within the garden, the condition of the tree and presence of <i>Ganoderma</i> fungus, retention of the tree exceeds the risk tolerance level.<br><br>(See Appendix C – Supporting Photographs) | <b>Remove tree;</b><br><br><b>Remove stump using a stump grinder;</b><br><br><b>Remove and dispose of all arisings accordingly.</b> | – | U |

| Tree No. | Species | Height (m) | Stem Diameter (mm) | Branch Spread (m) | First Significant Branch Height and Direction of Growth (m) | Canopy Height (m) | Life Stage | General Comments Inc. Physiological and Structural Condition | Preliminary / General Management Recommendations | Estimated Remaining Contribution (Years) | Category |
|---|---|---|---|---|---|---|---|--|--|--|---|
| 11 | <i>Wild Cherry</i><br>( <i>Prunus avium</i> ) | 9 | 275 | N - 3<br>E - 4<br>S - 4<br>W - 3 | 3 - NE | 3 | M | <p>Physiological Condition – Poor<br/>Structural Condition – Poor</p> <p>Located in a raised bed at the western end of the garden. Significant crown dieback, major and minor sized deadwood in the crown.</p> <p>Numerous fruiting bodies of <i>Ganoderma.sp</i> fungus on the northwest side of the stem base. <i>Ganoderma</i> is a parasitic disease which causes white heart rot to the base of the stem and roots of broadleaved trees and invariably leads to stem failure. Bark delamination and probe testing the area suggests heartwood decay is onset. Considering where T11 is located within the garden, the condition of the tree and presence of <i>Ganoderma</i> fungus, retention of the tree exceeds the risk tolerance level.</p> <p>(See Appendix C – Supporting Photographs)</p> | <p><b>Remove tree;</b></p> <p><b>Remove stump using a stump grinder;</b></p> <p><b>Remove and dispose of all arisings accordingly.</b></p> | - | U |

*T10 and T11 are both host to Ganoderma.sp fungus. Fruiting bodies are present at the stem bases of both trees, which also exhibit poor physiological health, with significant crown dieback evident. T11 is also shedding bark from the stem and probe testing an area of bark delamination on the lower stem signified onset heartwood decay in an advanced stage.*

*Both trees are located in the west side garden and considered to be in a high target area. The poor physiological health and structural condition of the trees exceed the risk tolerance level for their safe retention and are to be removed.*
