## Drainage Investigation Report

### For Subsidence Management Services

**Risk Address:** 2 Honeybourne Road, London, NW6 1JJ

**Visit Date:** 25th January 2019

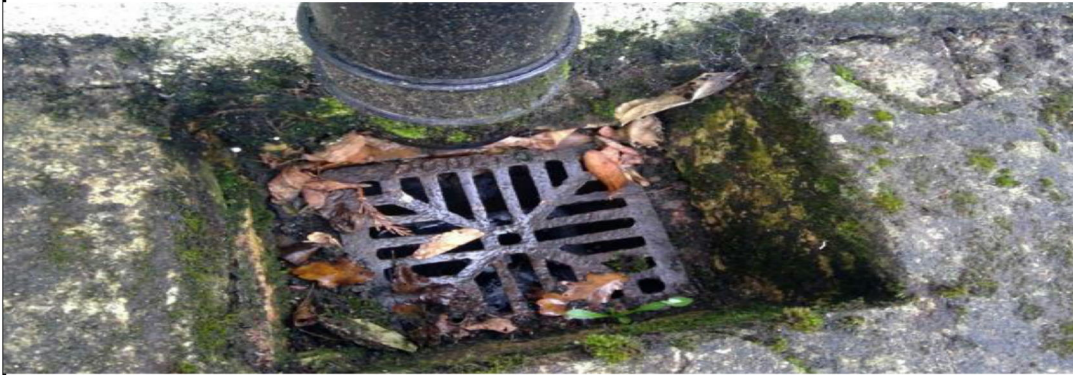
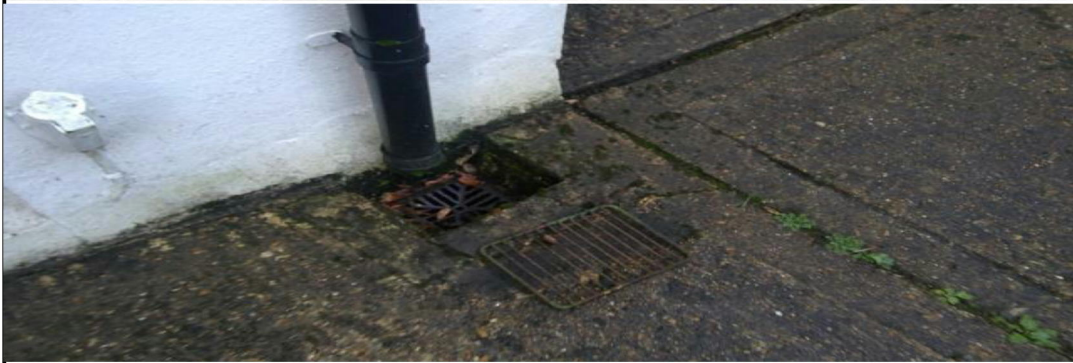
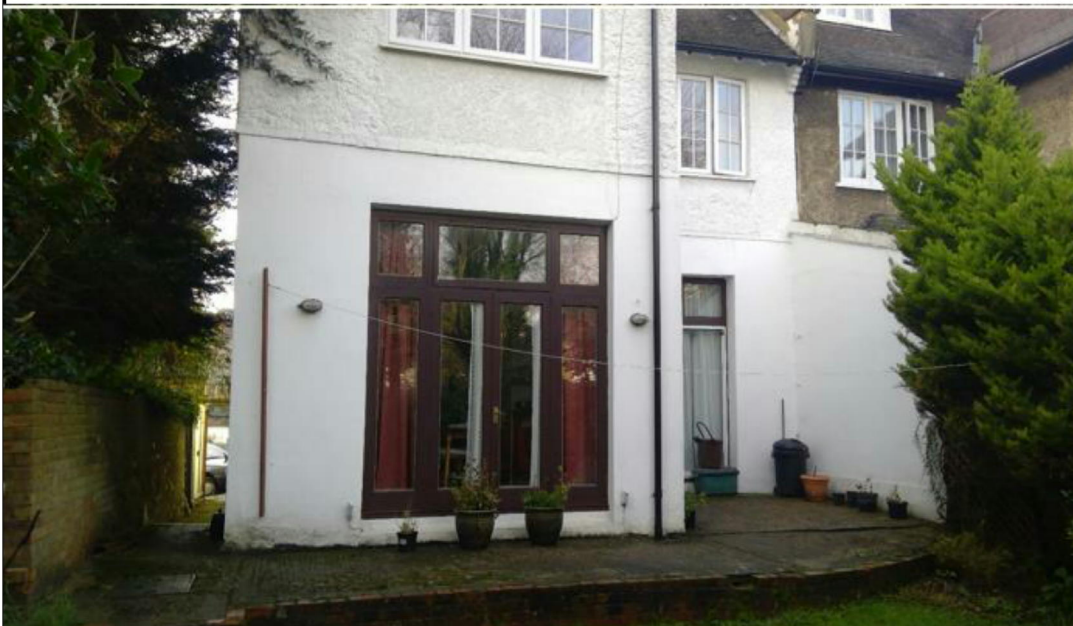
RWG1

There was no connection into MH1 from RWG1. The gully is recessed down into the raised concrete at the rear of the property and could not be accessed.

Excavate and replace the gully together with a section of pipework

Survey from excavation and report on findings
