Arboricultural Consultancy for Lloyds Bank

Insured	Mrs Maria Templeton	Address	2 Honeybourne Road, London, NW6 1JJ		
Client	Subsidence Management Services	Contact	Michael Hicks	Claim No.	
ES Ref		Consultant	Lewis Fraser	Contact No.	
Report Date	12/03/2019

5. Technical Synopsis

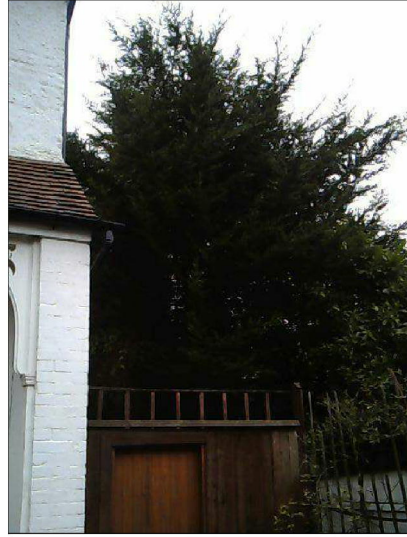
T7 - Cypress

In assessing the extent of damage, the potential drying influence of the vegetation on site and based on our site investigations, taking account of vegetation location, relative to the focal area of movement/ damage, it is our opinion that, T6 and T7 (Cypress) are considered the dominant features and accordingly we have identified them as the principal cause of the subsidence damage.

Removal of T5, T6 and T7 (Cypress) will offer the most certain and reliable arboricultural solution likely to restore long-term stability.

Tree No.	Species	Age Cat	Approx. Height (m)	Distance to Building (m) *	Ownership	Action	Requirement
T5	Cypress	1	11	5	A - Third Party	Remove	Remove close to ground level.
T6	Cypress	1	11.5	1.9	A - Third Party	Remove	Remove close to ground level.
T7	Cypress	1	10	1.7	A - Third Party	Remove	Remove close to ground level.

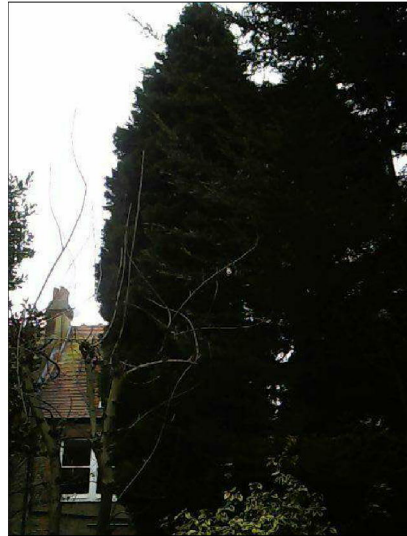
T5 - Cypress

T5 (Cypress) cannot be discounted as contributing to the overall level of soil drying proximate to the area of damage and is therefore also considered to retain a contributory influence, albeit in a limited / secondary capacity when compared to T6 and T7.
