London School of Hygiene & Tropical Medicine

Structural survey report - Phase 2b

Project number: 60562862

13 September 2019

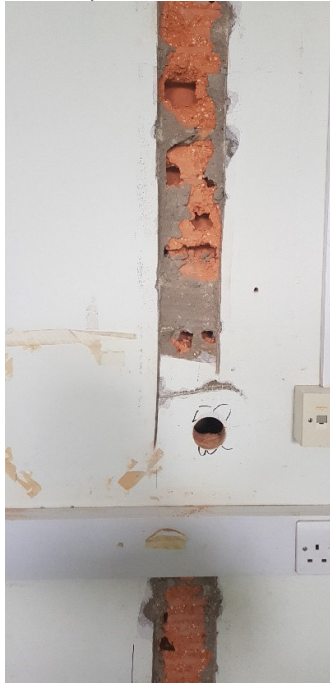
Photograph 1 – Wall 1 two leaf terracotta hollow pot with void between

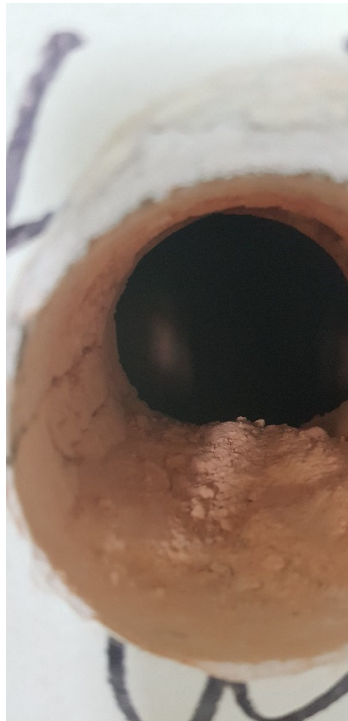
Photograph 2 – Wall 1 two leaf terracotta hollow pot with void between

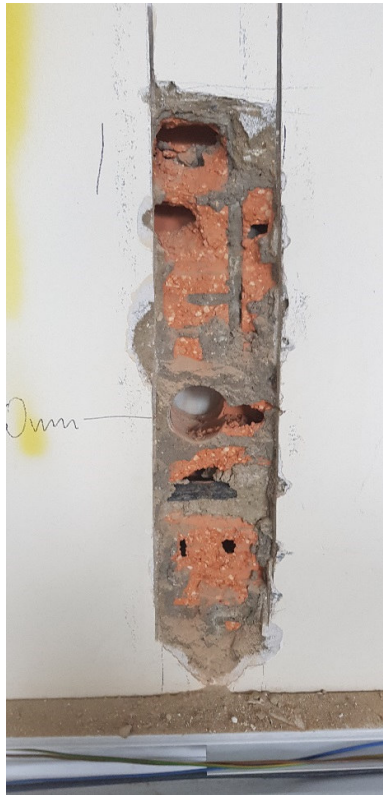
Photograph 3 – Wall 2 terracotta hollow pot

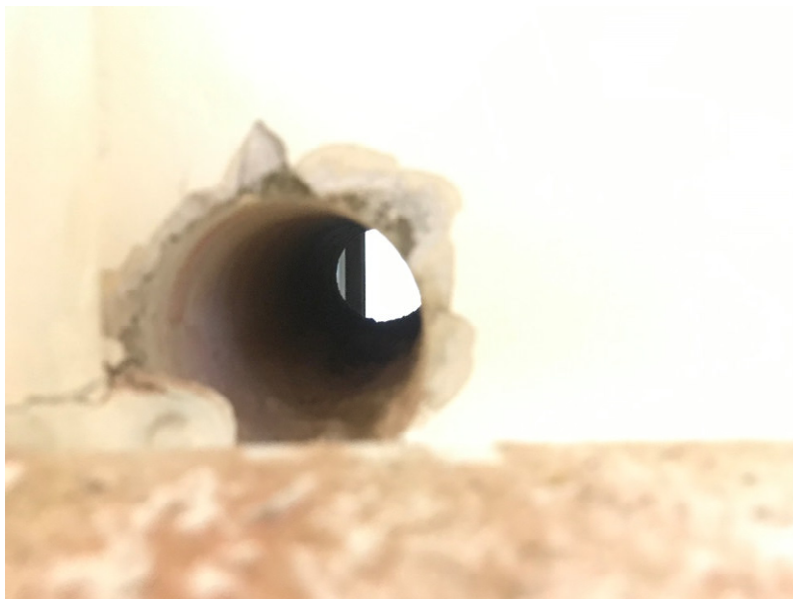
Photograph 4 – Wall 3 250mm masonry wall (Taken inside room 221)

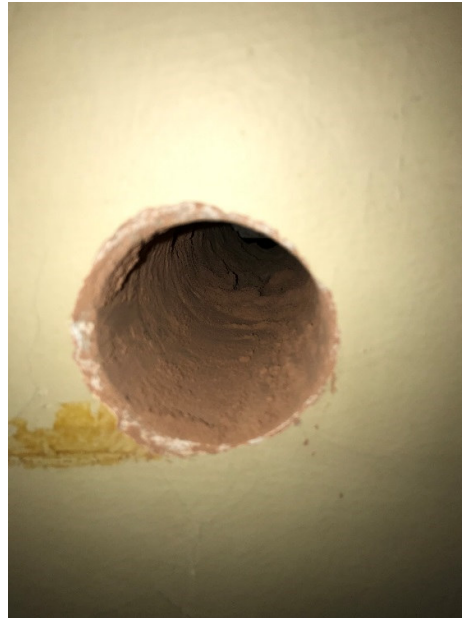
Photograph 5 – Wall 3 250mm masonry wall (Taken inside cold room 214). Refer to photographs 36-38 for more details

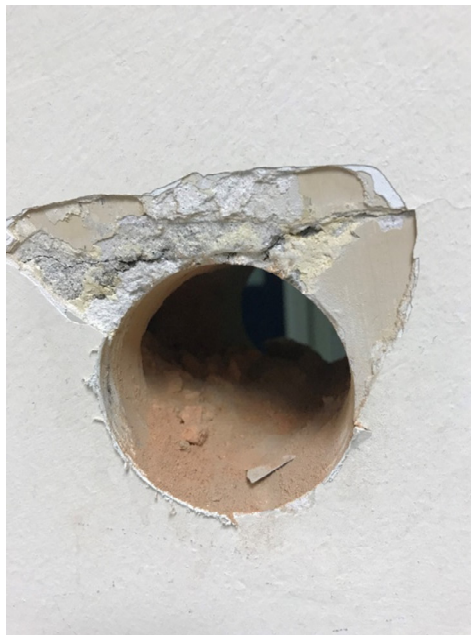
Photograph 6 – Wall 4 terracotta hollow pot

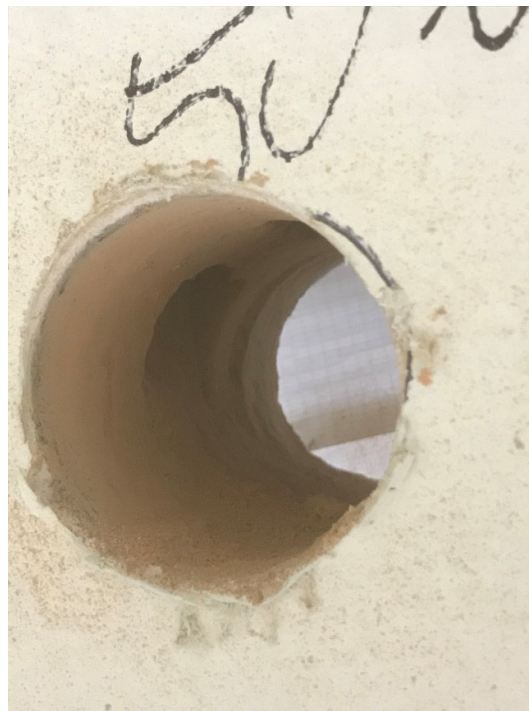
Photograph 7 – Wall 5 terracotta hollow pot

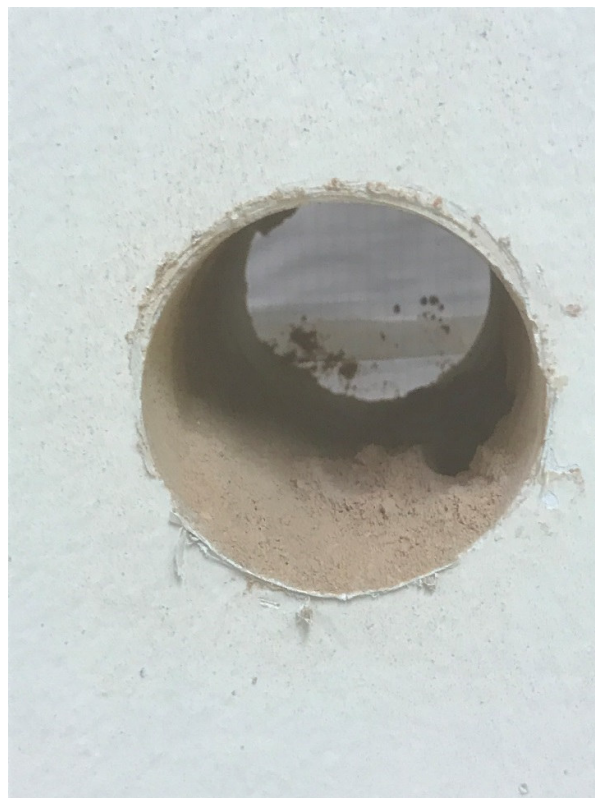
Photograph 8 – Wall 6 terracotta hollow pot

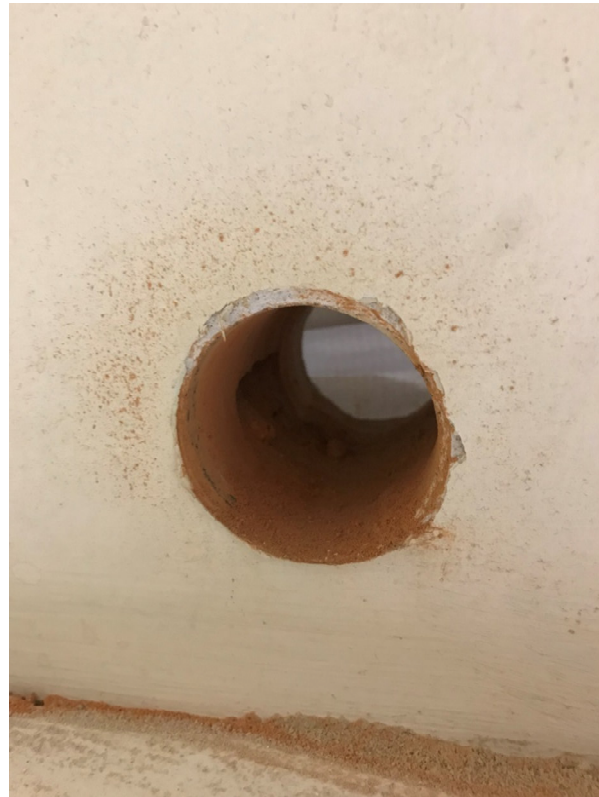
Photograph 9 – Wall 7 terracotta hollow pot

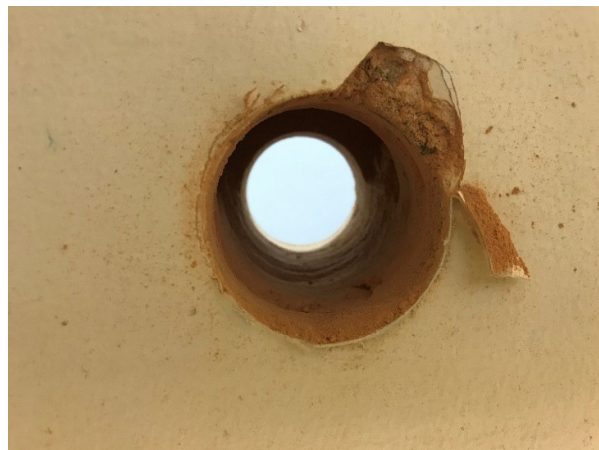
Photograph 10 – Wall 8 terracotta hollow pot

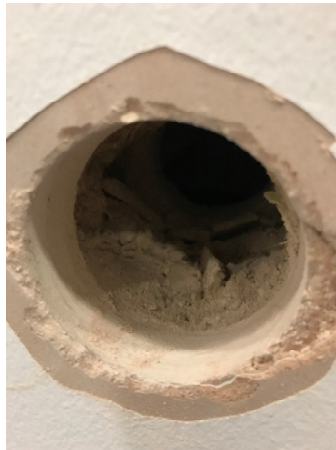
Photograph 11 – Wall 9 plasterboard partition

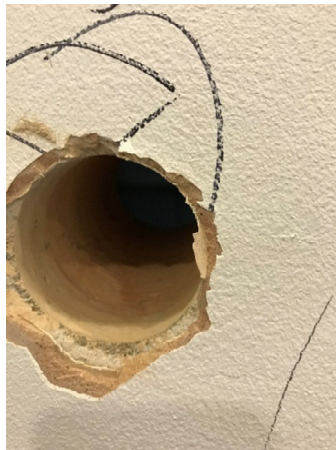
Photograph 12 – Wall 10 terracotta hollow pot

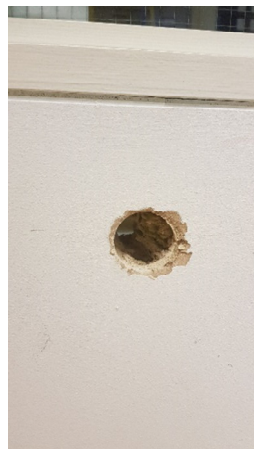
Photograph 13 – Wall 11 glazed and plasterboard partition

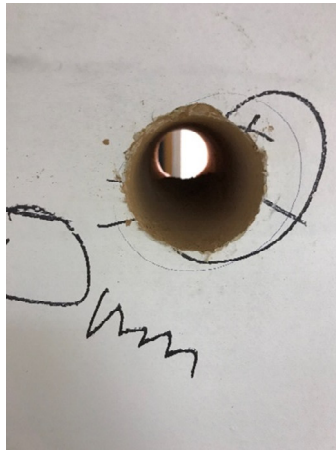
Photograph 14 – Wall 12 250mm thick terracotta hollow pot

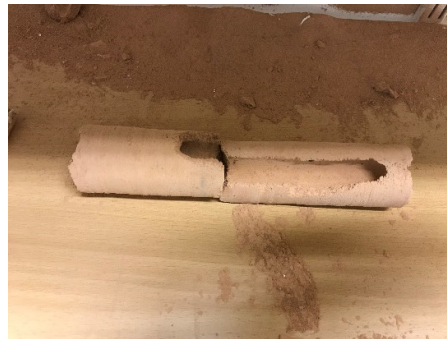
Photograph 15 – Wall 12 250mm thick terracotta hollow pot core sample

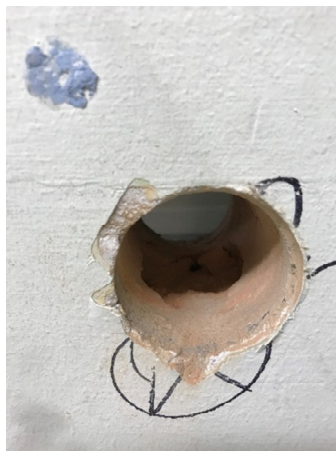
Photograph 16 – Wall 13 terracotta hollow pot

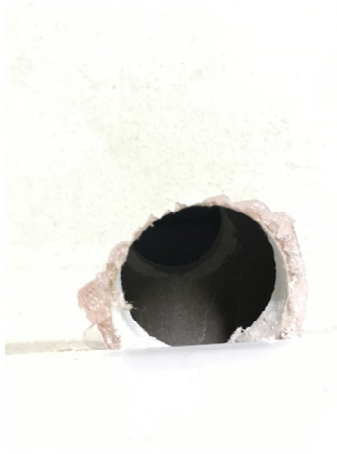
Photograph 17 – Wall 14 plasterboard partition

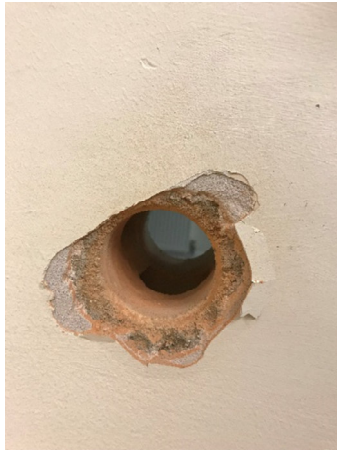
Photograph 18 – Wall 15 terracotta hollow pot

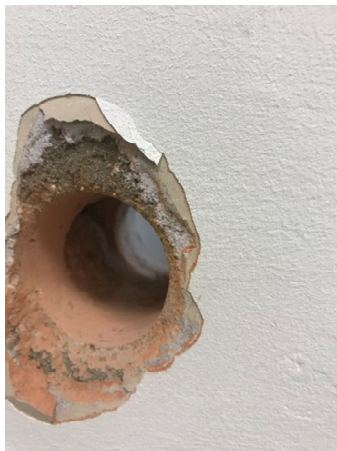
Photograph 19 – Wall 16 terracotta hollow pot

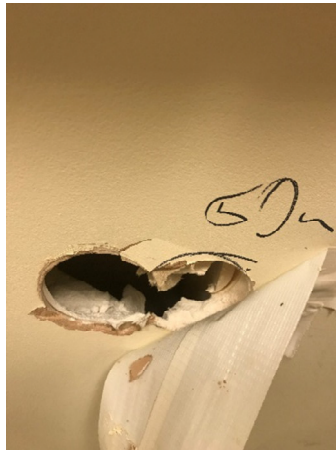
Photograph 20 – Wall 17 glazed and plasterboard partition

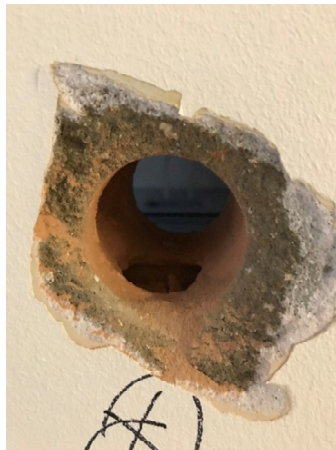
Photograph 21 – Wall 18 terracotta hollow pot

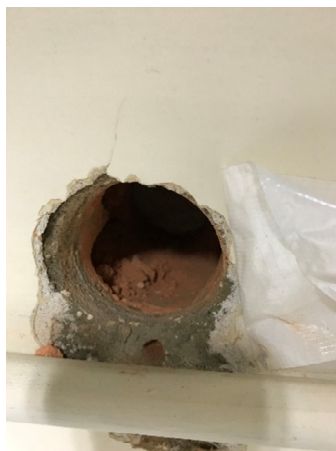
Photograph 22 – Wall 19 terracotta hollow pot

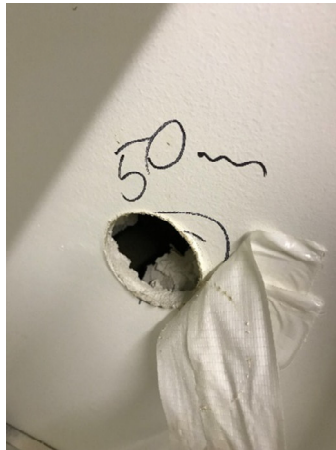
Photograph 23 – Wall 20 plasterboard partition

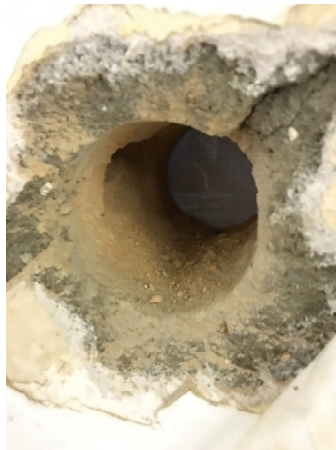
Photograph 24 – Wall 21 terracotta hollow pot

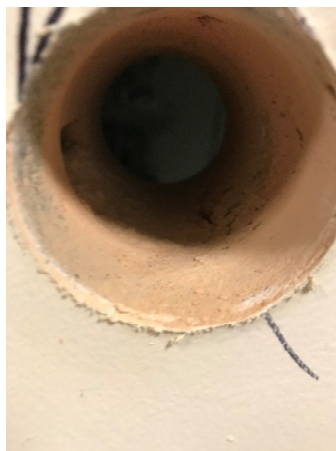
Photograph 25 – Wall 22 terracotta hollow pot

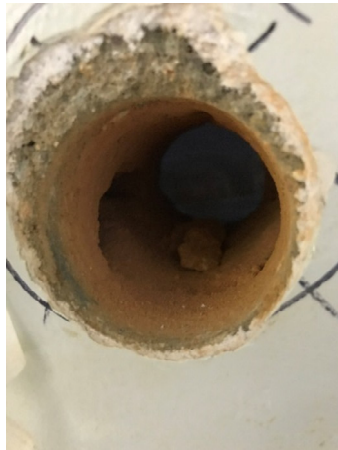
Photograph 26 – Wall 23 terracotta hollow pot

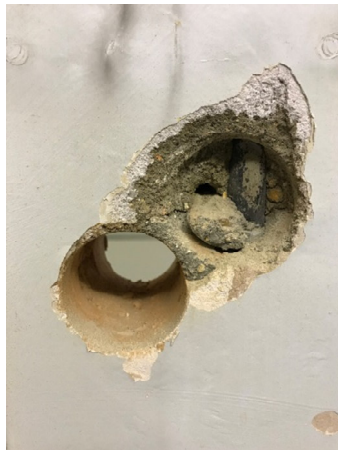
Photograph 27 – Wall 24 terracotta hollow pot

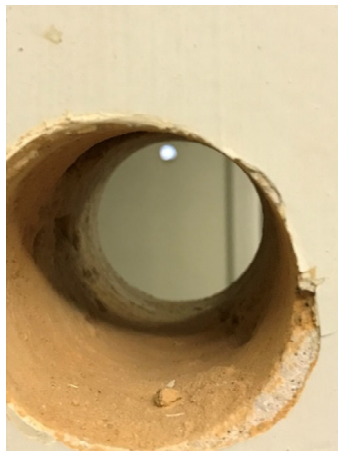
Photograph 28 – Wall 25 terracotta hollow pot

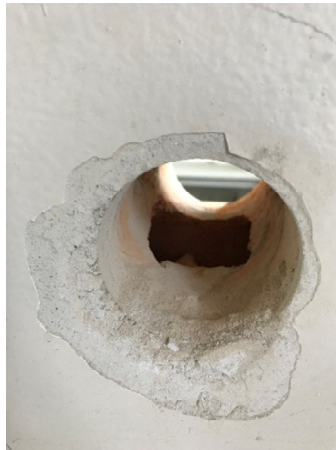
Photograph 29 – Wall 26 terracotta hollow pot

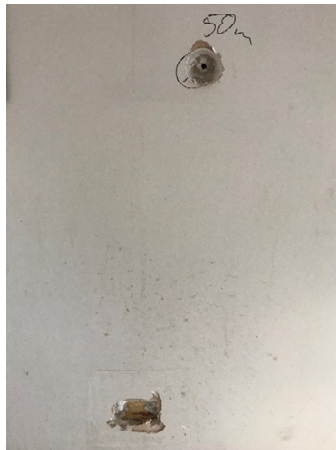
Photograph 30 – Wall 27 plasterboard partition

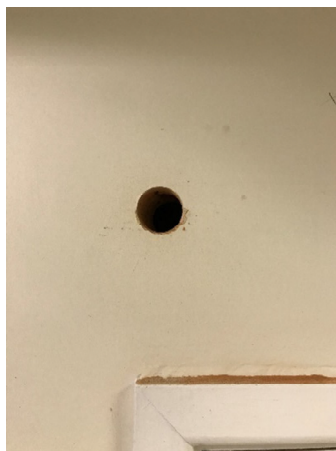
Photograph 31 – Wall 28 terracotta hollow pot

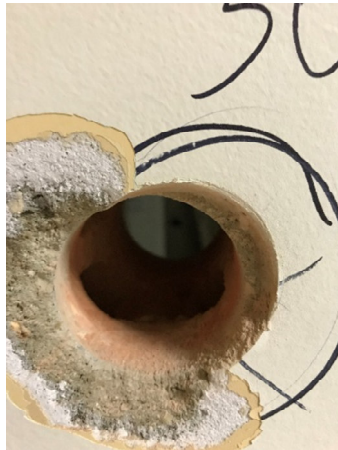
Photograph 32 – Wall 29 terracotta hollow pot

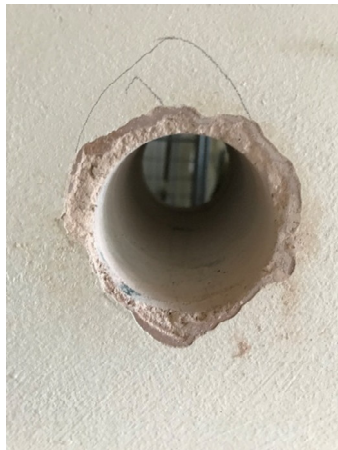
Photograph 33 – Wall 30 blockwork (filled in door)

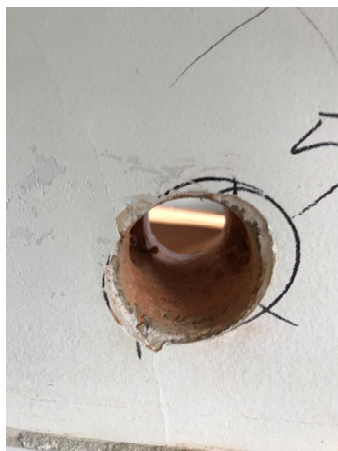
Photograph 34 – Wall 31 terracotta hollow pot

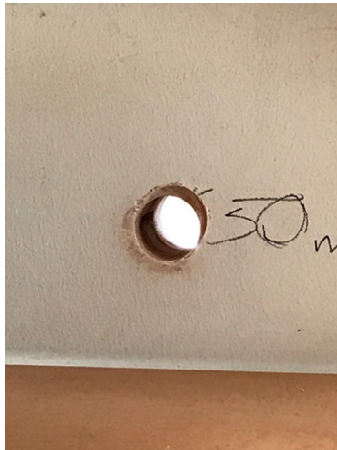
Photograph 35 – Wall 32 terracotta hollow pot

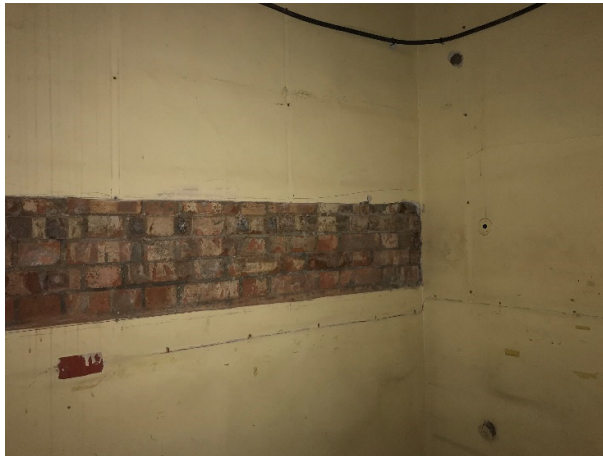
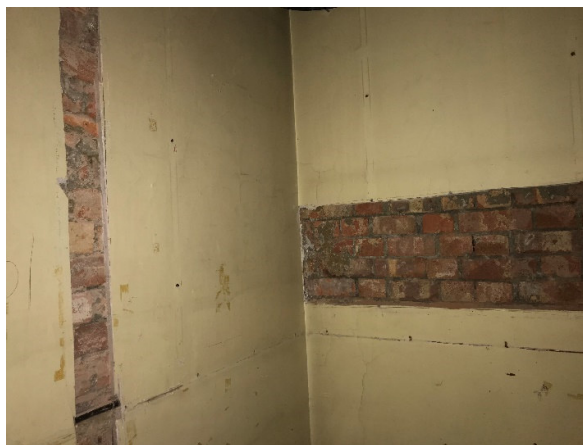
Photograph 36 & 37 – Masonry Wall back of lift 3

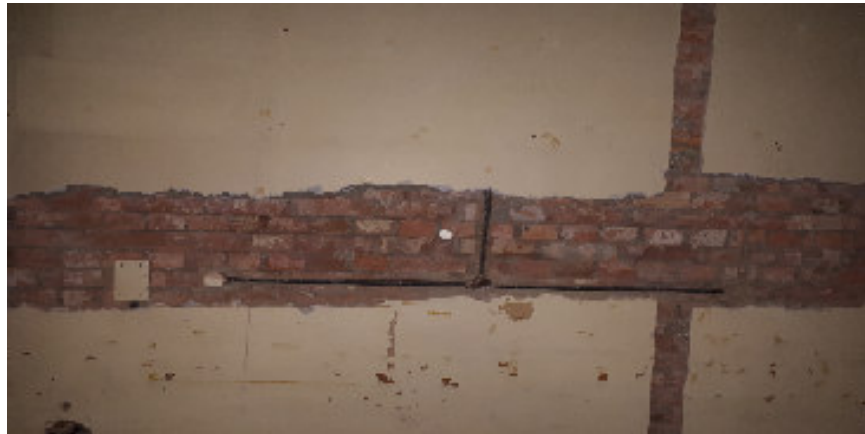
Photograph 38 – Masonry Wall spanning from external wall to Lift 3
