Arboricultural Appraisal Report

Subsidence Damage Investigation at:

114 Highgate Road
London
NW5 1PB

CLIENT:	Crawford & Company
CLIENT REF:	[REDACTED]
MWA REF:	[REDACTED]
MWA CONSULTANT:	Andy Clark
REPORT DATE:	23/01/2020

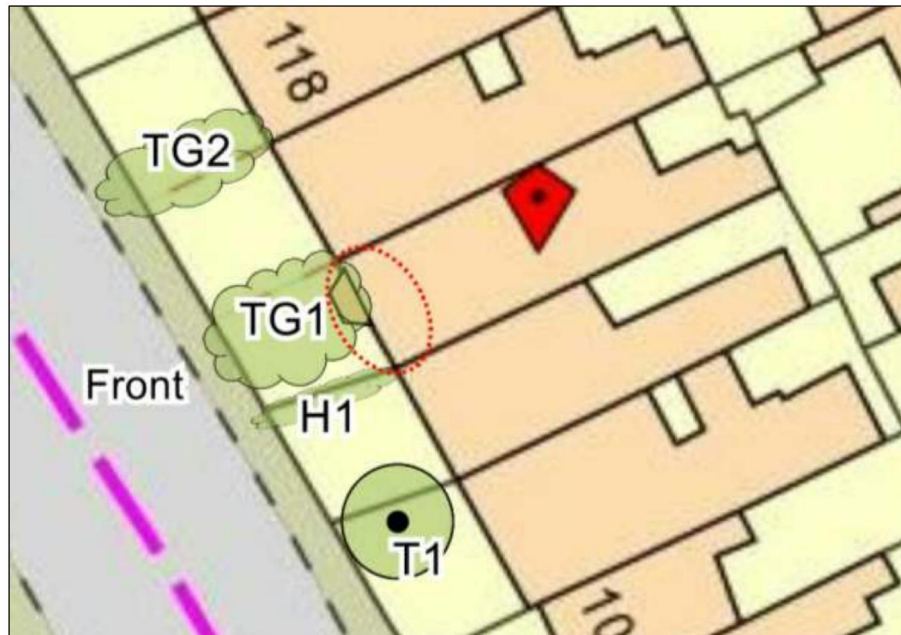
Site Plan

Approximate areas of damage

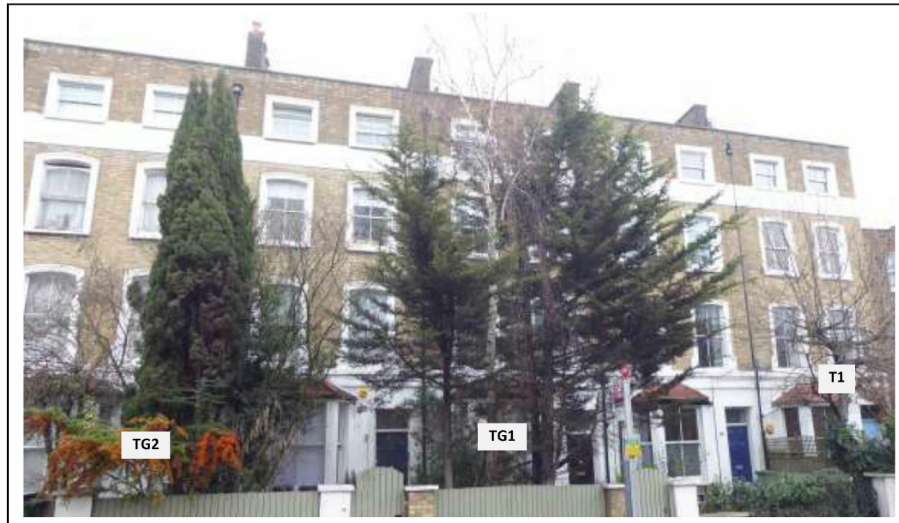
Overview of TG1 group, TG2 group and T1 Cherry

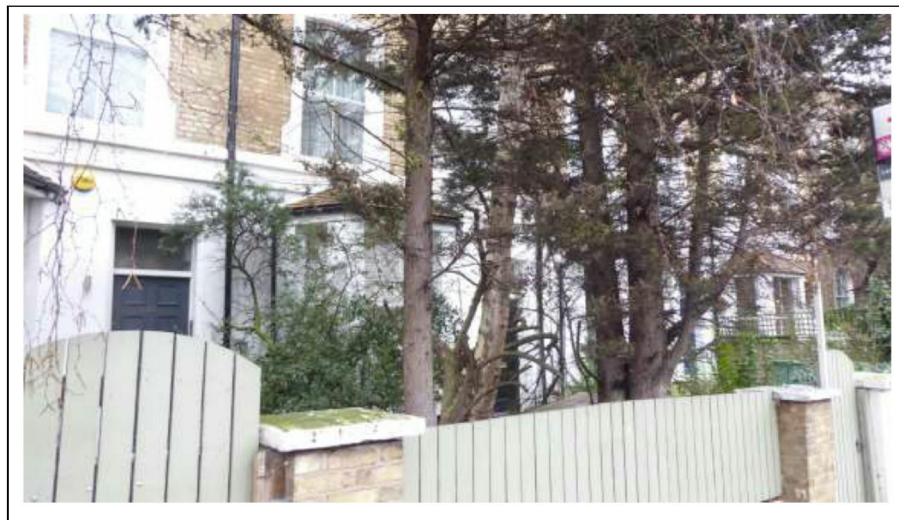
Our survey has identified vegetation within influencing distance of the building with a current potential to influence soil volumes below foundation level; the most significant of which in relation to the current damage is the TG1 group of Cypress, Birch and Ceanothus.

Based on the information currently available, engineering opinion and our own site assessment we conclude the damage appears consistent with shrinkage of the clay fraction due to the soil drying effects of vegetation.

View of TG1 group

If an arboricultural solution is to be implemented to mitigate the influence of the trees/shrubs considered to be responsible for the damage we recommend that TG1 group is removed. Other vegetation recorded presents a potential future risk to building stability and management is therefore recommended.

Tree No.	Species	Ht (m)	Dia (mm)	Crown Spread (m)	Dist. to building (m)	Age Classification	Ownership
TG1	Mixed spp. group of Cypress, Birch and Ceanothus	10.5	400 Ms *	7.5	1.5	Younger than Property	Policy Holder
Management history		No past management noted.					
Recommendation		Remove (fell) to all near ground level and treat stumps to inhibit regrowth.

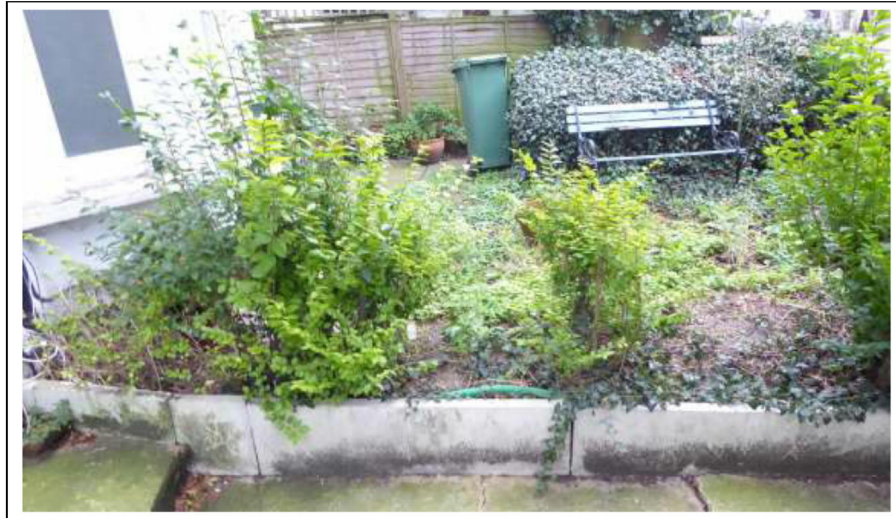
View of H1 Privet hedge

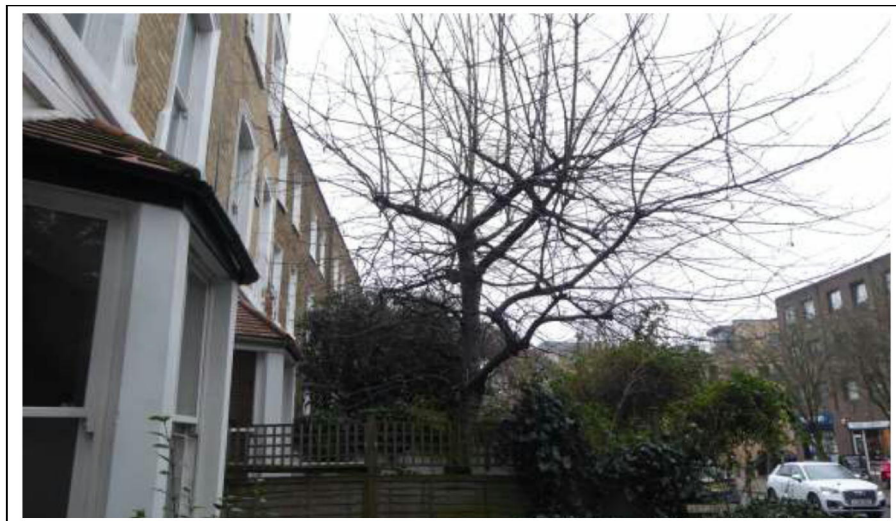
View of T1 Cherry

Tree No.	Species	Ht (m)	Dia (mm)	Crown Spread (m)	Dist. to building (m)	Age Classification	Ownership
T1	Cherry	8.5	300 *	7.0	6.1	Younger than Property	Third Party: 110 Highgate Road, NW5 1PB
Management history		Subject to past management/pruning - previously crown reduced.					
Recommendation		Prune back to previous pruning points and repeat on a biennial cycle.					
TG2	Mixed spp. group of Juniper, Laburnum, Pyracantha and Viburnum	8.0 *	180 Ms *	5.5	4.2 *	Younger than Property	Third Party: 118 Highgate Road, NW5 1PB
Management history		No past management noted.					
Recommendation		Remove (fell) Viburnum to near ground level and treat stump to inhibit regrowth. Maintain remainder at broadly no more than current dimensions by periodic pruning.					
H1	Privet hedge	1.0	50 Ms *	1.0	0.4	Younger than Property	Third Party: 112 Highgate Road, NW5 1PB
Management history		Recently reduced to current height.
