TECHNICAL REPORT ON A SUBSIDENCE CLAIM

[REDACTED]
114 Highgate Road Management Limited
114 Highgate Road
London
NW5 1PB

SUBSIDENCE CLAIM

16th December 2019

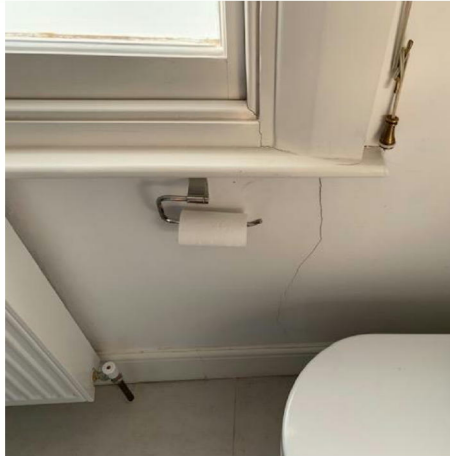
Cracking in en-suite to Flat C

Flat 2 – Cracking in living room adjacent to front elevation and the top floor bathroom and study. Cracks to the front wall and the party walls. Maximum crack width 2-3mm.

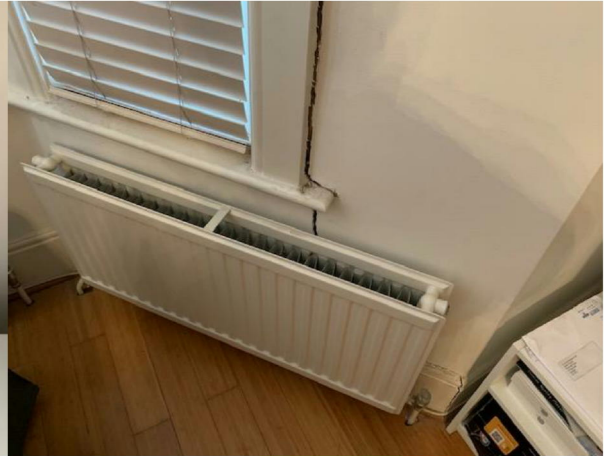
Cracking to front bay in Flat A

Flat A – Cracking in front lounge and the abutment of the bay window and the main house. Maximum crack width of 6-7mm.

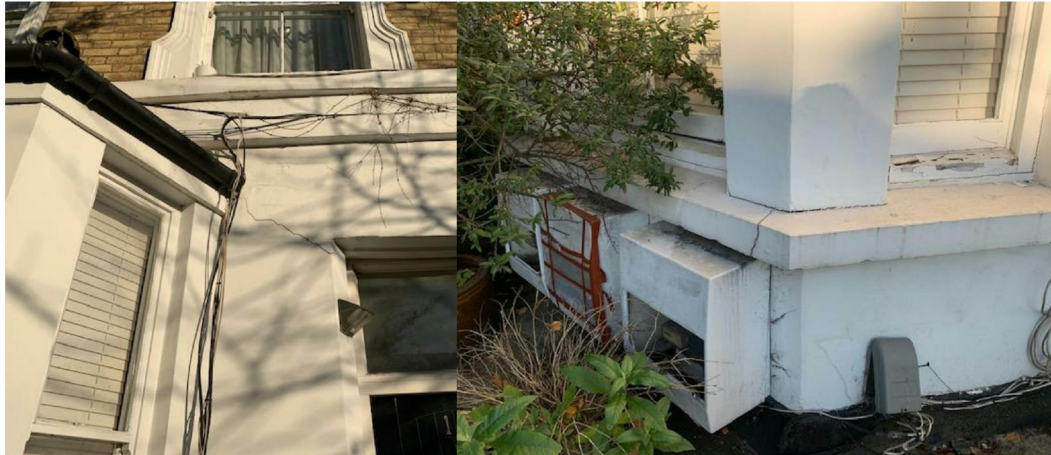
Cracking around front bay window

Cracking on front bay sill

There is cracking at the abutment of the front bay window and the main house as well as the front elevation at the junction of the party wall.

In structural terms the damage falls into Category 3 of Table 1, Building Research Establishment⁵ Digest 251, which describes it as "moderate".

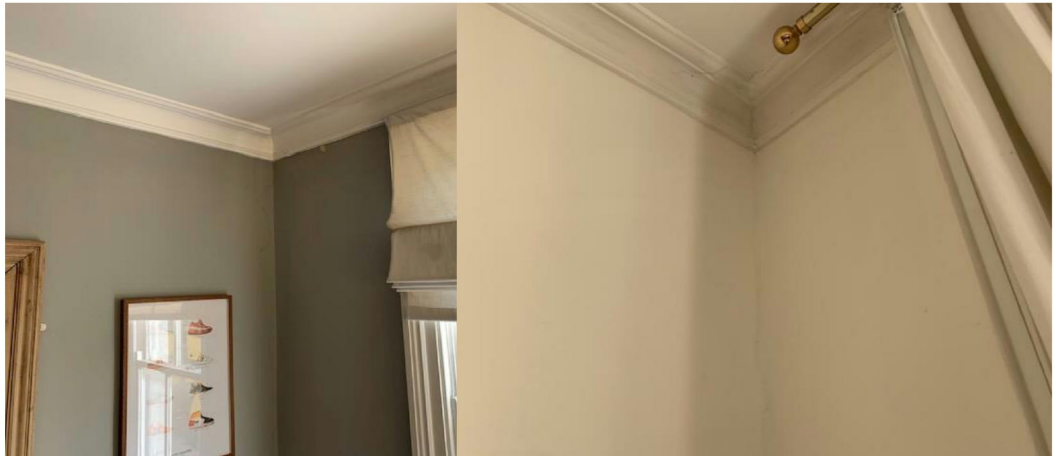
Flat B – Cracking in living room to front elevation. Cracks to the front wall and the party walls. Maximum crack width 2-3mm.

Front Wall cracking in Flat B

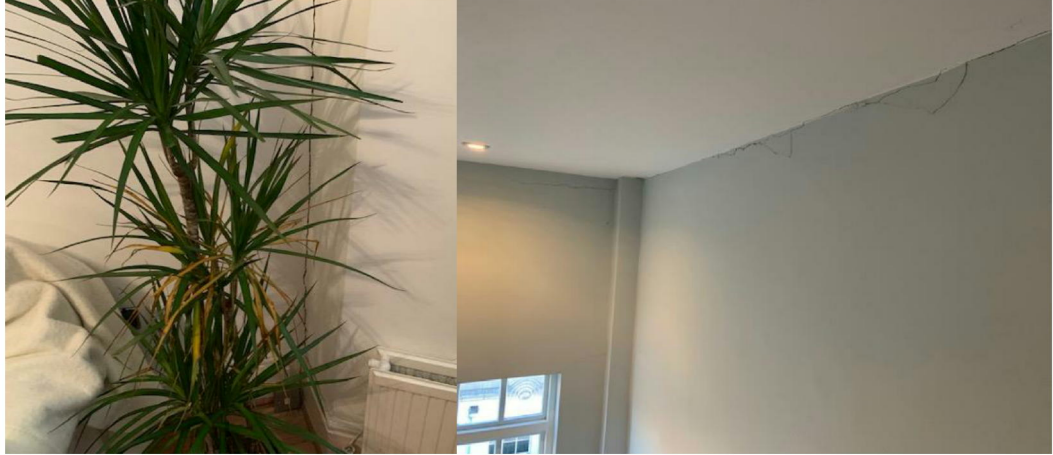
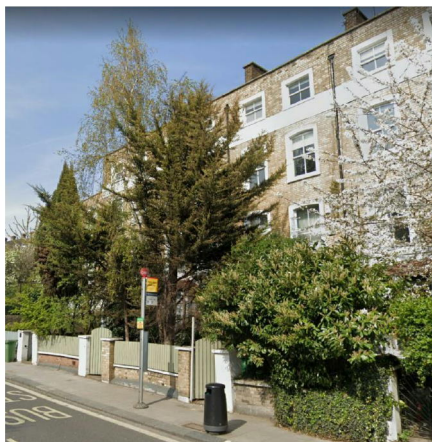
The timing of the event, the presence of shrinkable clay beneath the foundations and the proximity of vegetation where there is damage indicates the shrinkage to be root induced. This is a commonly encountered problem and probably accounts for around 70% of subsidence claims notified to insurers.

Vegetation in the Insureds and neighbours front gardens

The cause of the movement needs to be dealt with first. We have completed a Soil Risk Analysis (VISCAT Assessment) and we are satisfied that your trees can be removed.

We will obtain an Arborists report and quotation for the recommended tree works and undertake statutory checks for Preservation Orders or whether the tree(s) are in a Conservation Area.
