Arboricultural Appraisal Report

Subsidence Damage Investigation at:

19 Lawford Road
Kentish Town
London
NW5 2LH

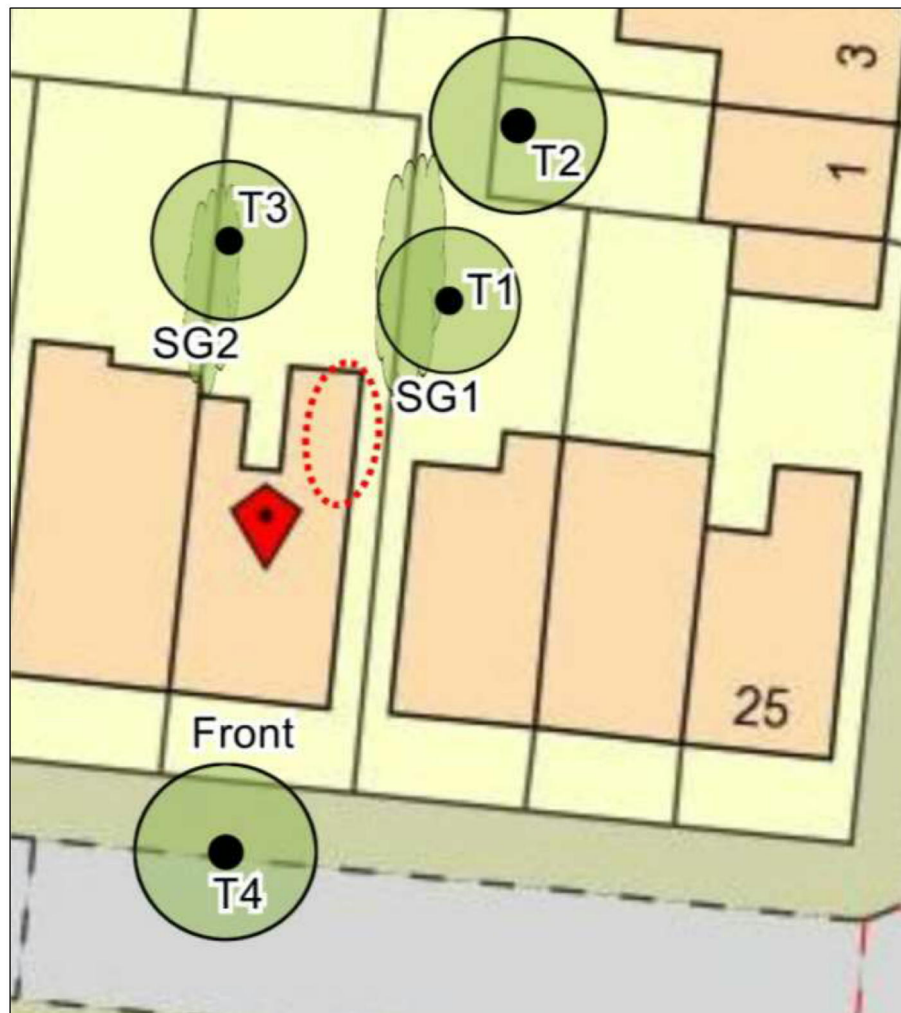
Site Plan

Approximate areas of damage

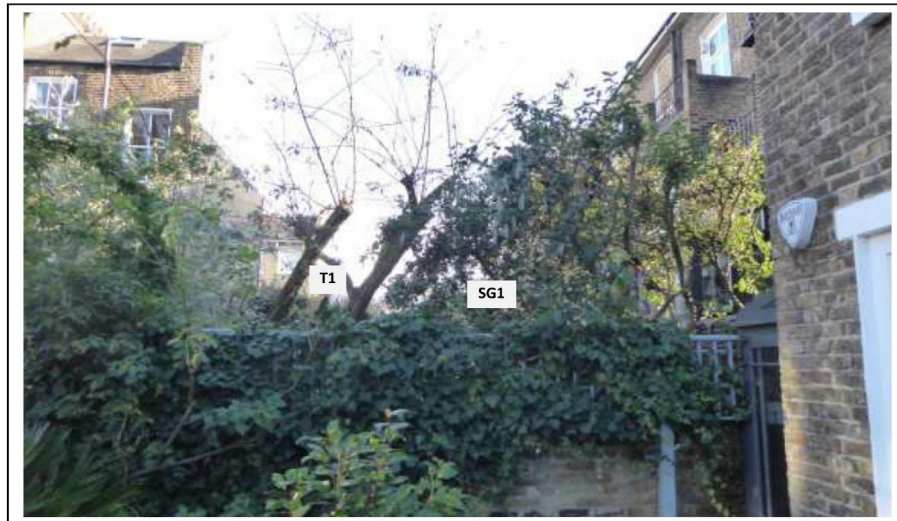
Our survey has identified vegetation within influencing distance of the building with a current potential to influence soil volumes below foundation level, the most significant of which in relation to the current damage are T1 False acacia and T2 Sycamore. There is also a potential for localised contribution from nearby elements of SG1 group.

View of SG1 shrub group and T1 False Acacia

If an arboricultural solution is to be implemented to mitigate the influence of the trees/shrubs considered to be responsible for the damage we recommend that T1 False Acacia, T2 Sycamore and nearby elements of SG1 group are removed. Other vegetation recorded presents a potential future risk to building stability and management is therefore recommended.

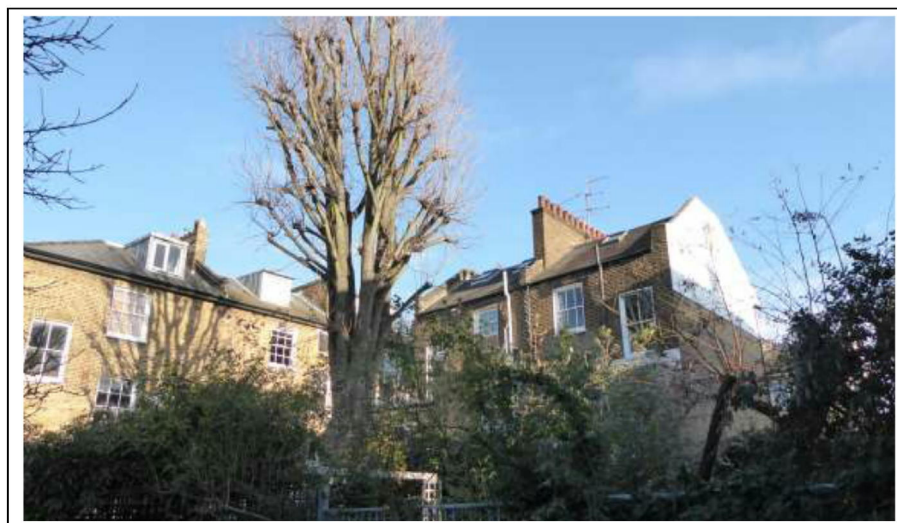
View of T2 Sycamore

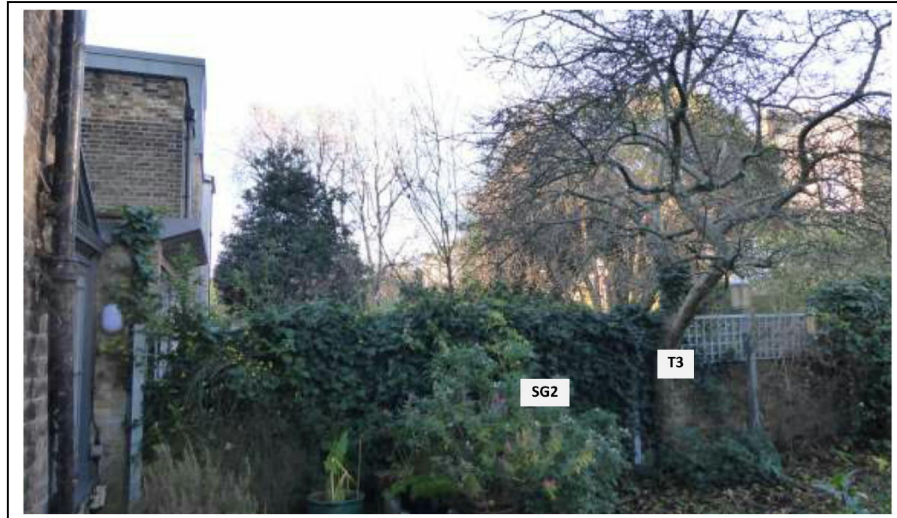
View of T3 Apple and SG2 shrub group

Tree No.	Species	Ht (m)	Dia (mm)	Crown Spread (m)	Dist. to building (m)	Age Classification	Ownership
T3	Apple	6.5	250	7.0	6.1	Younger than Property	Policy Holder
Management history		No past management noted.					
Recommendation		Maintain broadly at no more than current dimensions by periodic pruning.					
T4	Maple	8.5	370	3.0	5.3	Younger than Property	Local Authority
Management history		Subject to past management/pruning - previously pollarded.					
Recommendation		None at present.					
SG2	Mixed spp. shrub group of mostly Ivy, Jasmine, Privet, Amelanchier and Choisya	4.0	30 Ms *	2.0	1.0	Younger than Property	Policy Holder
Management history		Subject to past management/pruning - appears regularly pruned.					
Recommendation		Maintain broadly at no more than current dimensions by periodic pruning.

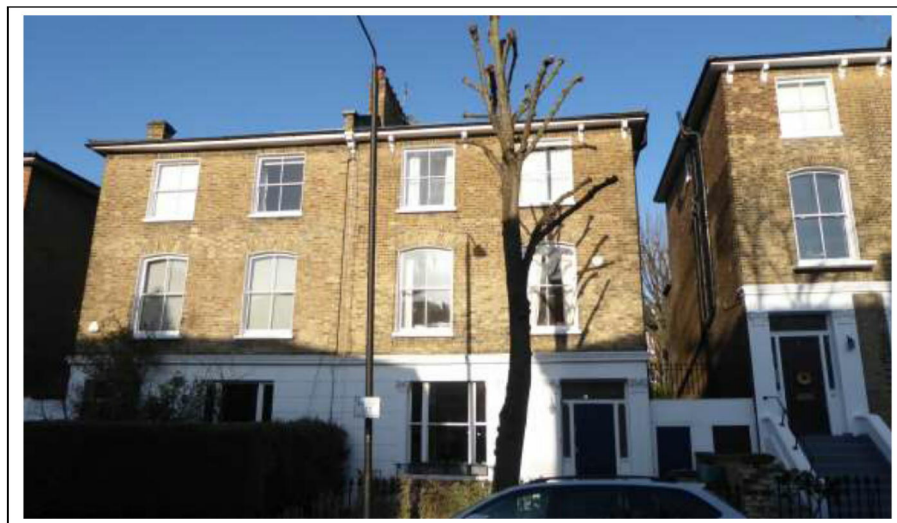
View of T4 Maple
