## TECHNICAL REPORT ON A SUBSIDENCE CLAIM

19 Lawford Road, Kentish Town  
London, NW5 2LH

30 September 2019

TECHNICAL REPORT

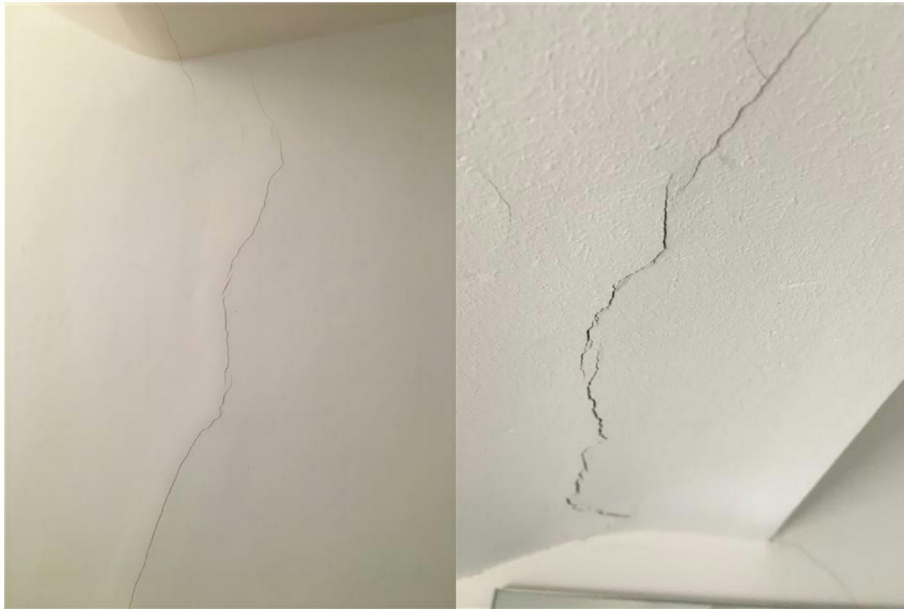
Fracturing at junction between main body and rear outrigger

Damage to ceiling in rear bathroom

On the right-hand wall there is separation between the wall and ceiling. There is also a fracture which is up to 2mm in width within the ceiling.

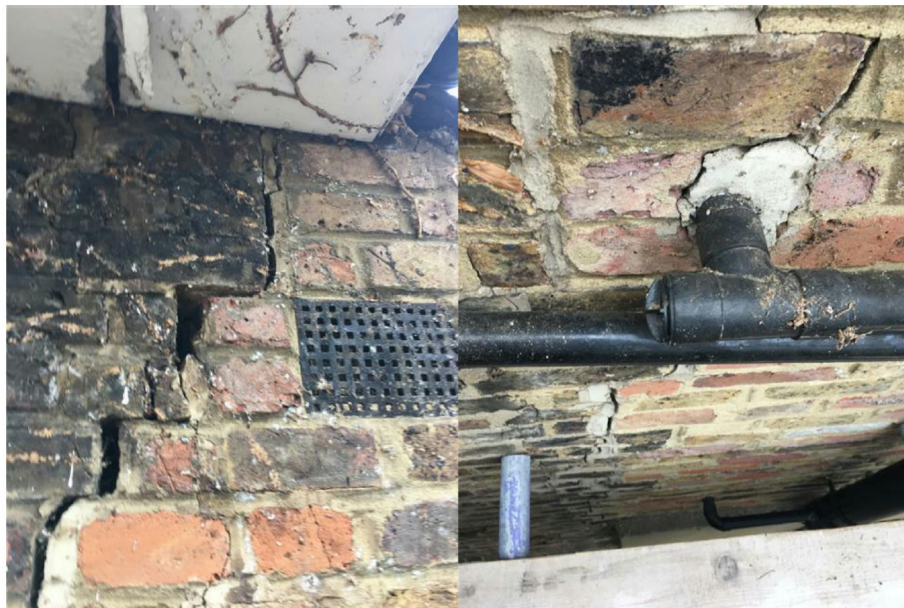
Separation between main building and outrigger

Cracking extends for full height of wall

At the junction between the main body and rear outrigger there is a tapered vertical fracture. The cracking is up to 14 mm wide at high-level. We can be satisfied that much of this movement and cracking occurred sometime ago and has been hidden by the now removed Ivy. This conclusion being drawn on the basis that the internal damage is much less pronounced than that noted externally.

The cracking reduces in width as it migrates down the building towards ground level.

In structural terms the damage falls into Category 3 of Table 1, Building Research Establishment<sup>8</sup> Digest 251, which describes it as "moderate".

The pattern and nature of the cracks is indicative of an episode of subsidence. The cause of movement appears to be clay shrinkage.

The timing of the event, the presence of shrinkable clay beneath the foundations and the proximity of vegetation where there is damage indicates the shrinkage to be root induced. This is a commonly encountered problem and probably accounts for around 70% of subsidence claims notified to insurers.

Although the cause of the movement needs to be dealt with, Current legislation requires certain investigations to be carried out to support an application for the tree works.

Typically, these investigations would involve trial pit(s) to determine the depth and type of footings, boreholes to determine the nature of the subsoil/influence of any roots and monitoring to establish the rate and pattern of movement. The monitoring data provided must be sufficient to show a pattern of movement consistent with the influence of the vegetation and therefore it may be necessary to carry out the monitoring for up to a 12 month period.

It will also be necessary to obtain a specialist Arboricultural Report.

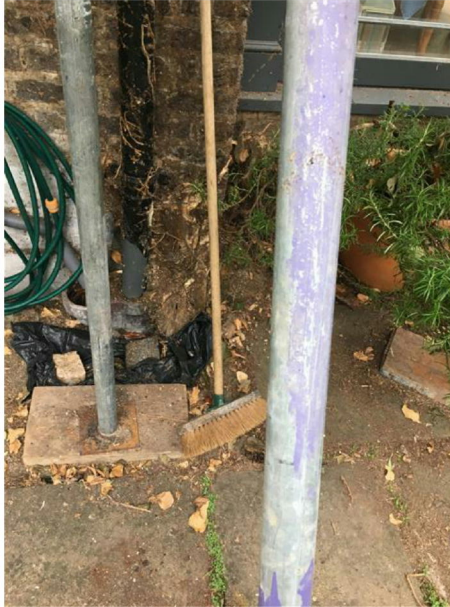
Removed ivy

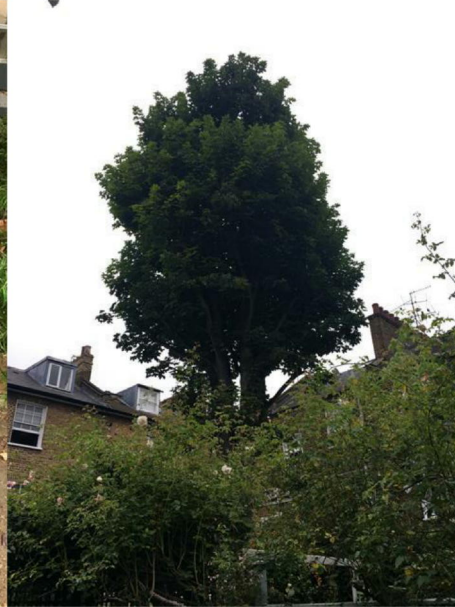
Sycamore to rear

Prior to proceeding in line with the above we will check the status of the Sycamore.

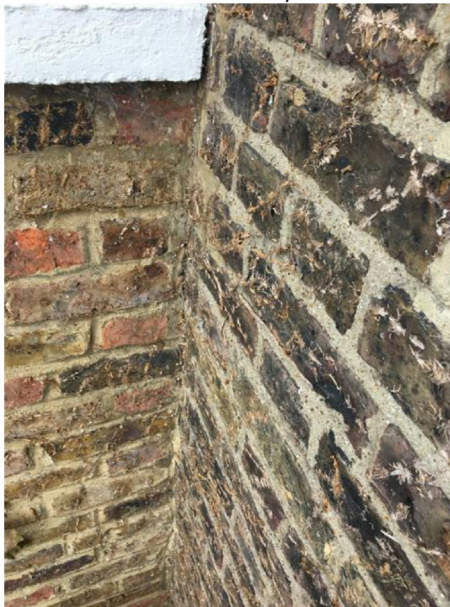
On the left-hand side there was no notable obvious displacement between the main dwelling and rear outrigger.

No evidence of damage to left hand side
