## Arboricultural Appraisal Report

### Subsidence Damage Investigation at:

19 Lawford Road  
Kentish Town  
London  
NW5 2LH

| REPORT DATE: | 06/01/2020 |

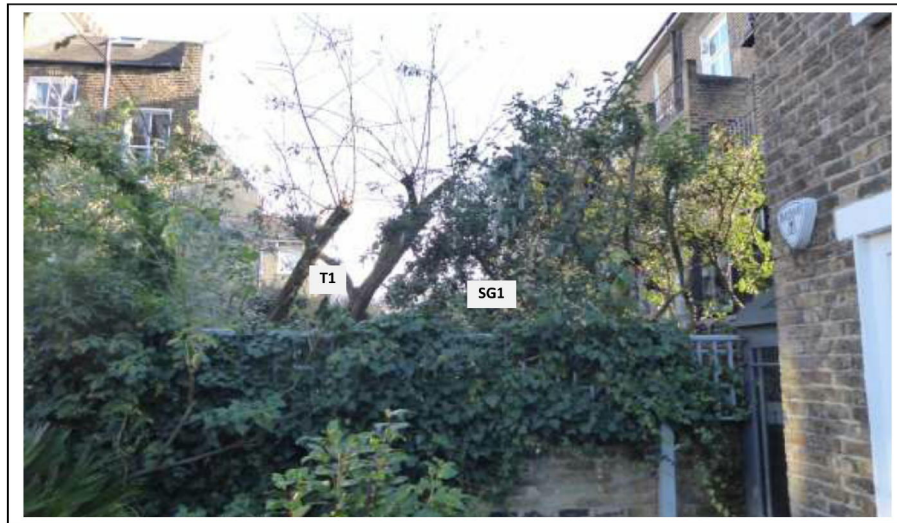
Our survey has identified vegetation within influencing distance of the building with a current potential to influence soil volumes below foundation level, the most significant of which in relation to the current damage are T1 False acacia and T2 Sycamore. There is also a potential for localised contribution from nearby elements of SG1 group.

| Tree No. | Species | Ht (m) | Dia (mm) | Crown Spread (m) | Dist. to building (m) | Age Classification | Ownership |
|---|---|---|---|---|---|---|---|
| SG1 | Mixed spp. shrub group of mostly Ivy and Pittosporum | 4.5 | 120 Ms * | 5.0 * | 1.4 | Younger than Property | Third Party:<br>21 Lawford Road,<br>NW5 2LH |
| Management history | | Subject to past management/pruning - previously crown reduced. | | | | | |

View of SG1 shrub group and T1 False Acacia

If an arboricultural solution is to be implemented to mitigate the influence of the trees/shrubs considered to be responsible for the damage we recommend that T1 False Acacia, T2 Sycamore and nearby elements of SG1 group are removed. Other vegetation recorded presents a potential future risk to building stability and management is therefore recommended.

| Tree No. | Species | Ht (m) | Dia (mm) | Crown Spread (m) | Dist. to building (m) | Age Classification | Ownership |
|---|---|---|---|---|---|---|---|
| Recommendation | | Remove (fell) to near ground level and treat stump to inhibit regrowth. | | | | | |
| Recommendation | | Remove (fell) all within 4.0m to near ground level and treat stumps to inhibit regrowth. | | | | | |

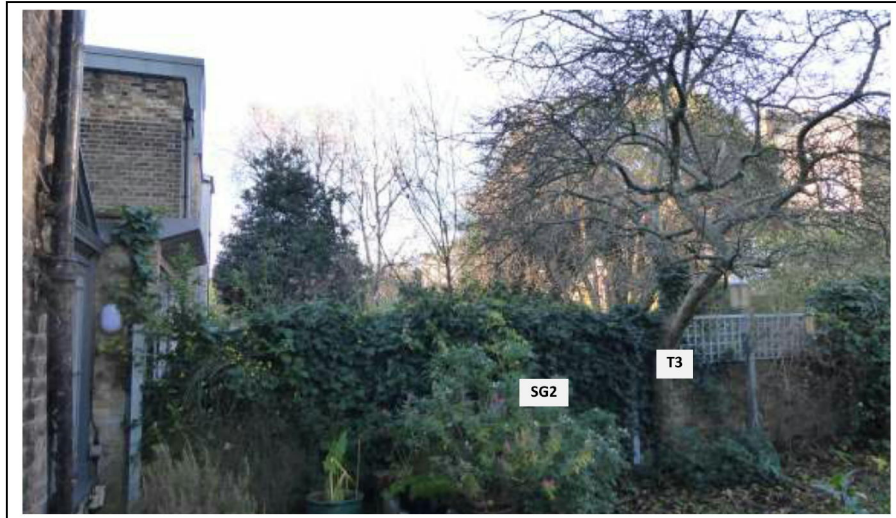
| Tree No. | Species | Ht (m) | Dia (mm) | Crown Spread (m) | Dist. to building (m) | Age Classification | Ownership |
|---|---|---|---|---|---|---|---|
| T3 | Apple | 6.5 | 250 | 7.0 | 6.1 | Younger than Property | Policy Holder |
| SG2 | Mixed spp. shrub group of mostly Ivy, Jasmine, Privet, Amelanchier and Choisya | 4.0 | 30 Ms * | 2.0 | 1.0 | Younger than Property | Policy Holder |

View of T3 Apple and SG2 shrub group

| Tree No. | Species | Ht (m) | Dia (mm) | Crown Spread (m) | Dist. to building (m) | Age Classification | Ownership |
|---|---|---|---|---|---|---|---|
| Recommendation | | Maintain broadly at no more than current dimensions by periodic pruning. | | | | | |

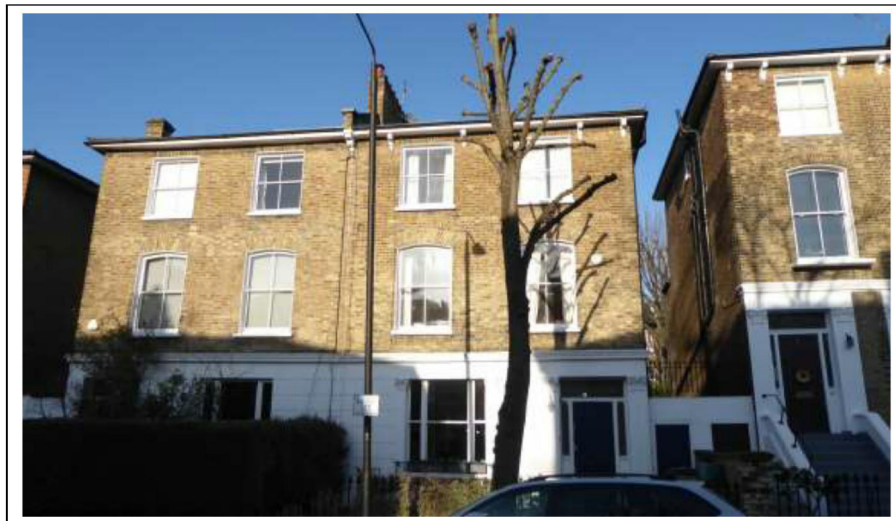
| Tree No. | Species | Ht (m) | Dia (mm) | Crown Spread (m) | Dist. to building (m) | Age Classification | Ownership |
|---|---|---|---|---|---|---|---|
| T4 | Maple | 8.5 | 370 | 3.0 | 5.3 | Younger than Property | Local Authority |
| Management history | | Subject to past management/pruning - previously pollarded. | | | | | |

View of T4 Maple

| Tree No. | Species | Ht (m) | Dia (mm) | Crown Spread (m) | Dist. to building (m) | Age Classification | Ownership |
|---|---|---|---|---|---|---|---|
| Recommendation | | None at present. | | | | | |
