Arboricultural Appraisal Report

Subsidence Damage Investigation at:

11 Shirlock Road
London
NW3 2HR

CLIENT:	Crawford & Company
CLIENT REF:	[REDACTED]
MWA REF:	[REDACTED]
MWA CONSULTANT:	Andy Clark
REPORT DATE:	08/08/2018

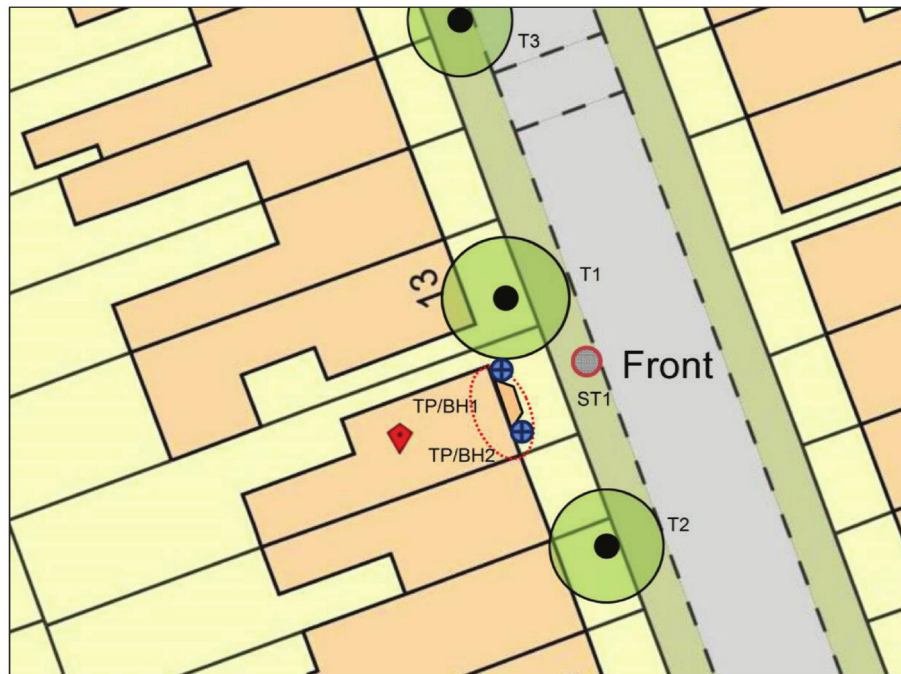
SITE PLAN

Approximate areas of damage

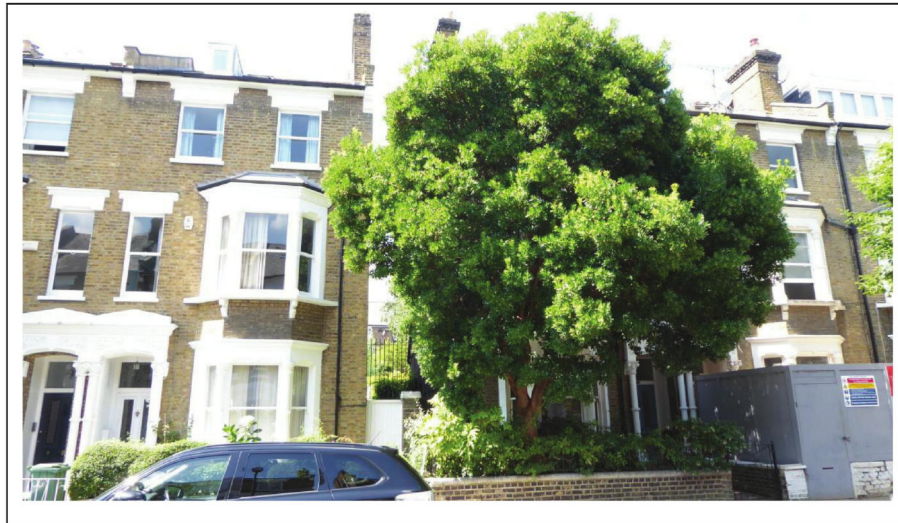
Given the size and relative proximity to the property of T1 Strawberry Tree, the roots of this tree will also be present below the property foundations and influencing soil moisture content.

Based on the technical reports currently available, engineering opinion and our own site assessment we conclude the damage is consistent with shrinkage of the clay subsoil related to moisture abstraction by vegetation. Having considered the available information, it is our opinion that the Local Authority Whitebeam, formerly at ST1, was a contributory cause of the current subsidence damage prior to its recent removal, with T1 Strawberry Tree also being significant.

View of T1 Strawberry Tree

If an arboricultural solution is to be implemented to mitigate the current damage and allow the soils beneath the property to recover to a position such that an effective repair solution can be put in place, we recommend that T1 Strawberry tree is removed. No further action is required in respect of ST1

Consideration has been given to pruning alone as a means of mitigating the vegetative influence, however in this case, this is not considered to offer a viable long term solution due to the proximity of the responsible vegetation.

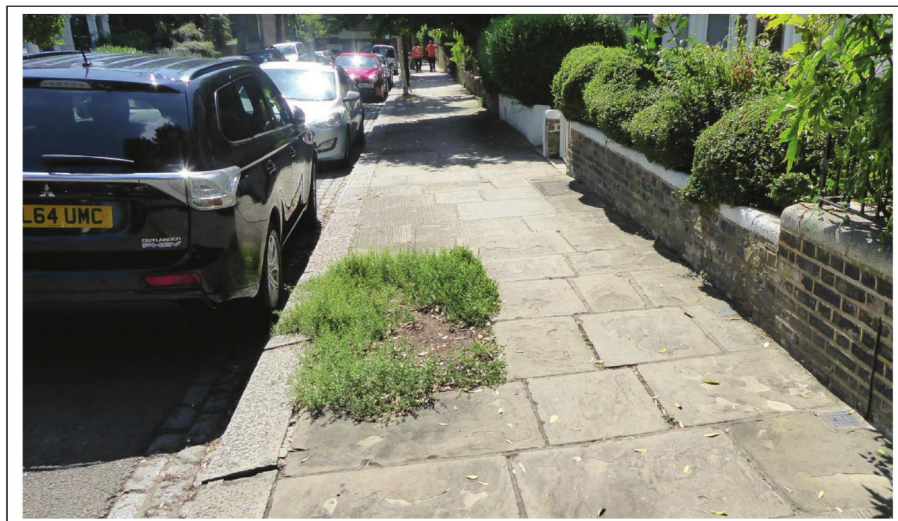
Roots were observed to a depth of 1.5m bgl in TP/BH1 and in TP/BH2, and recovered live samples [positive starch test] have been positively identified (using anatomical analysis) as *Pomoideae* gp.; the origin of which will be the Local Authority Whitebeam tree, formerly located at ST1 on our site plan, confirming the influence of this tree on the soils below the foundations prior to its recent removal.

View of ST1 Vacant street tree pit – former location of LA Whitebeam

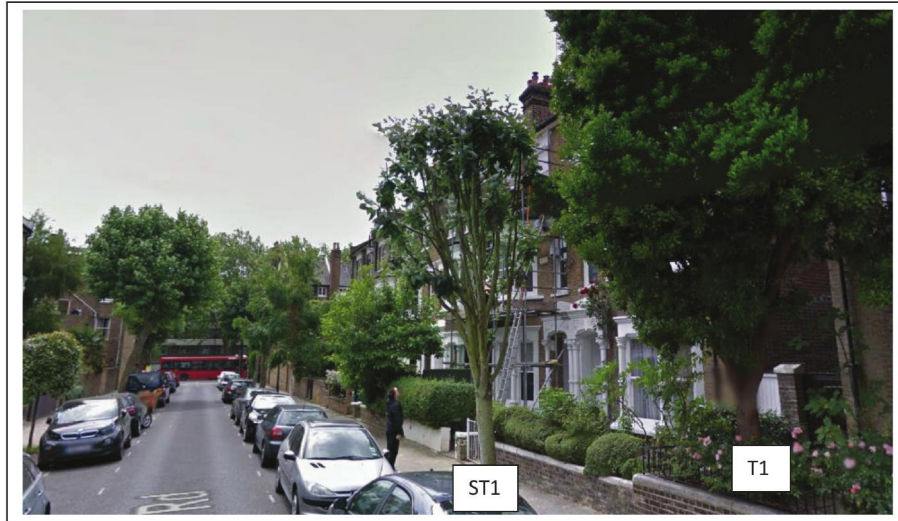
View of ST1 Local Authority Whitebeam prior to removal
[Google Streetview image date June 2015 - showing recent crown reduction]

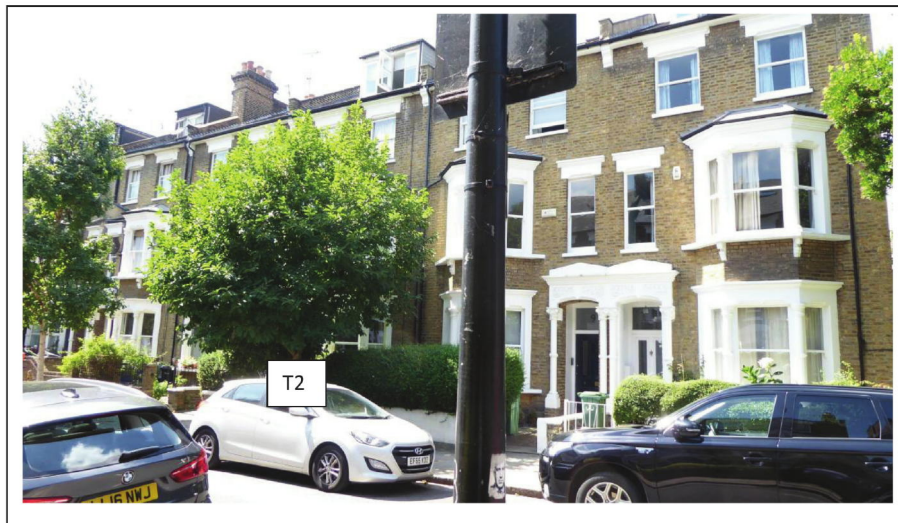
Tree No.	Species	Ht (m)	Dia (mm)	Crown Spread (m)	Dist. to building (m)	Age Classification	Ownership
T2	Magnolia	8.5	300	7.0	7.0	Younger than Property	Third Party: 7 Shirlock Road, NW3
Management history		Subject to past management – previously pollarded at approx. 5.0m. Regrowth appears <10yrs.					
Recommendation		Do not allow to exceed current dimensions					
T3	Maple	9.5	290	6.5	15.9	Younger than Property	Local Authority
Management history		Previously heavily reduced – regrowth appears <5yrs					
Recommendation		Do not allow to exceed current dimensions

View of T2 Magnolia
