REPORT
Refurbishment/Pre-Demolition
Asbestos Survey
carried out at
Fortress Grove

Issue N°:	1
Survey N°:	2596
Survey Author	Stuart Makemson
Issuing Office	Braintree
Date Issued	20 January 2020

Located at: Fortress Grove Kentish Town London NW5

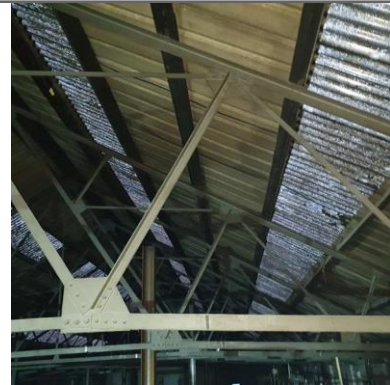
Sample No	Location & Description	Priority Rating	Recommended Action	Comments
DSM/SCO/2596/B01/ROO/01/S	Cement profiled sheeting forming roof.	C	Manage in situ.	In the event of removal the material must be removed by a competent contractor and the waste disposed of to a licensed tip under consignment.

Sample Details					
Sample No: DSM/SCO/2596/B01/ROO/01/S		Visual Sample No:		Similar To:	
Element: forming roof.			Quantity: 1,100 M ²		
Location			Priority Rating C	When Action Required Ongoing Management	
Room Ref No:	Area	Floor			
R:01	Roof 1	Roof			
Priority Rating Details					
Material	Location	Condition	Exposed Population	Accessibility	Assessment Method
Cement products.	External	Poor - localised damage	Workshop / Factory	Difficult concealed / >5m high	Sampled
Asbestos Type		Encapsulation / Sealant			
Chrysotile (Serpentine) - Minor		Sealed / reinforced			
Recommended Action	Manage in situ.				
Inspection Schedule	Annually or directly after works that may disturb the material.				
Comments					
Asbestos was detected in the sample collected from the cement profiled sheeting.					
Drawing Name			Building 1 - Roof.bmp

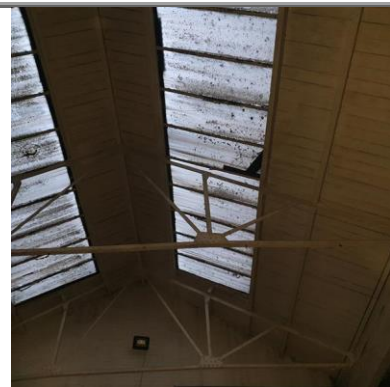
Sample No	Location & Description	Priority Rating	Recommended Action	Comments
DSM/SCO/2596/B01/ROO/02/V	Cement profiled sheeting forming outer skin to roof.	C	Manage in situ.	In the event of removal the material must be removed by a competent contractor and the waste disposed of to a licensed tip under consignment.
DSM/SCO/2596/B01/ROO/03/V	woven gaskets to glass skylights.	C	Manage in situ.	In the event of removal the material must be removed by a competent contractor and the waste disposed of to a licensed tip under consignment.

Sample Details					
Sample No:		Visual Sample No:		Similar To:	
		DSM/SCO/2596/B01/ROO/02/V			
Element: forming outer skin to roof.			Quantity: 160 M ²		
Location			Priority Rating C	When Action Required Ongoing Management	
Room Ref No:	Area	Floor			
R:02	Roof 2	Roof			
Priority Rating Details					
Material	Location	Condition	Exposed Population	Accessibility	Assessment Method
Cement products.	External	Poor - localised damage	Workshop / Factory	Difficult concealed / >5m high	Visual
Asbestos Type		Encapsulation / Sealant			
Chrysotile (Serpentine) - Minor		Sealed / reinforced			
Recommended Action	Manage in situ.				
Inspection Schedule	Annually or directly after works that may disturb the material.				
Comments					
Asbestos was detected in a similar sample collected from the cement profiled sheeting.					
Drawing Name			Building 1 - Roof.bmp

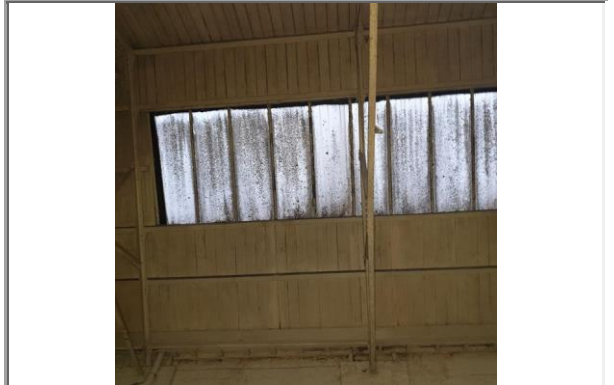
Sample N°	Visual Sample No:	SimilarTo:	Room No:
	DSM/SCO/2596/B01/ROO/03/V		R:02
Sample Origin:			
Building:	Floor:	Area:	Sample Taken From:
Building 1	Roof	Roof 2	woven gaskets
Sample Details:			
Materials: Woven product.	Element: to glass skylights.	Condition: Fair - scratched marked surface	
Location: External	Exposed Population: Workshop / Factory		
Accessibility: Difficult concealed / >5m high	Encapsulation/Sealant: Raw unsealed		
Sample Comments: No sample could be collected due to no physical access to the roof however it is presumed that woven gaskets to the panes of glass are present unless there is strong evidence to the contrary.			
Sample Findings:	Asbestos Type/s Found:	Assessment Method:	Priority Rating:
	Chrysotile (Serpentine) - Major	Presumed	C

Sample Details					
Sample No:		Visual Sample No:		Similar To:	
		DSM/SCO/2596/B01/ROO/03/V			
Element: to glass skylights.			Quantity: 32 pains of glass with gaskets.		
Location			Priority Rating	When Action Required	
Room Ref No:	Area	Floor	C	Ongoing Management	
R:02	Roof 2	Roof			
Priority Rating Details					
Material	Location	Condition	Exposed Population	Accessibility	Assessment Method
Woven product.	External	Fair - scratched marked surface	Workshop / Factory	Difficult concealed / >5m high	Presumed
Asbestos Type		Encapsulation / Sealant			
Chrysotile (Serpentine) - Major		Raw unsealed			
Recommended Action	Manage in situ.				
Inspection Schedule	Annually or directly after works that may disturb the material.				
Comments					
No sample could be collected due to no physical access to the roof however it is presumed that woven gaskets to the panes of glass are present unless there is strong evidence to the contrary.

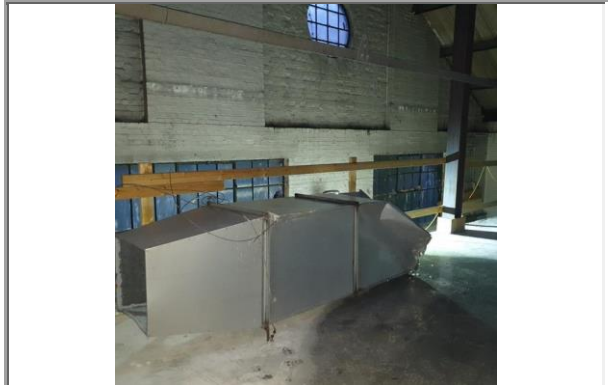
Sample Details					
Sample No:		Visual Sample No:		Similar To:	
DSM/SCO/2596/B01/MEZ/04/S					
Element: to metal trunking joints.			Quantity: 4 X gaskets.		
Location			Priority Rating	When Action Required	
Room Ref No:	Area	Floor	□		
M:01	Mezzanine 1	Mezzanine			
Priority Rating Details					
Material	Location	Condition	Exposed Population	Accessibility	Assessment Method
Mastic	Internal	Poor - localised damage	Workshop / Factory	Easily	Sampled
Asbestos Type		Encapsulation / Sealant			
N.A.D.I.S. -		Sealed / reinforced			
Recommended Action	No further action required.				
Inspection Schedule	No inspection required.				
Comments					
No asbestos was detected in the sample collected from the mastic gaskets to the redundant ductwork.

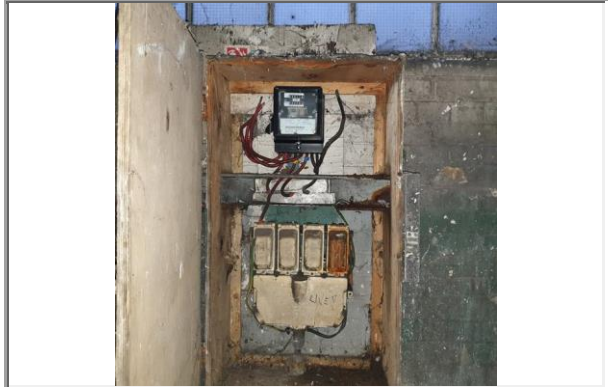
Sample No	Location & Description	Priority Rating	Recommended Action	Comments
DSM/SCO/2596/B01/GRD/05/V	Flash guards / gaskets to electrical boxes.	B	Remove due to proposed demolition / refurbishment	In the event of removal the material must be removed by a competent contractor and disposed of to a licensed tip / transfer station under consignment.

Sample Details					
Sample No:		Visual Sample No: DSM/SCO/2596/B01/GRD/05/V		Similar To:	
Element: to electrical boxes.				Quantity: 1 box	
Location			Priority Rating	When Action Required	
Room Ref No:	Area	Floor			
G:01	Open area 1	Ground Floor			
			B	As soon as Practicable	
Priority Rating Details					
Material	Location	Condition	Exposed Population	Accessibility	Assessment Method
Woven product.	Internal	Fair - scratched marked surface	Workshop / Factory	Easily	Presumed
Asbestos Type		Encapsulation / Sealant			
Chrysotile (Serpentine) -		Sealed / reinforced			
Recommended Action	Remove due to proposed demolition / refurbish				
Inspection Schedule	Annually or directly after works that may disturb the material.				
Comments					
No sample was taken from the electrical box as it was presumed to be live at the time of the survey. It is assumed that the box contains asbestos unless there is strong evidence to the contrary.

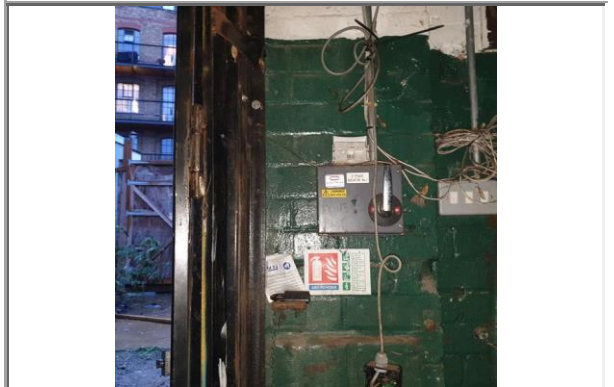
Sample No	Location & Description	Priority Rating	Recommended Action	Comments
DSM/SCO/2596/B01/GRD/06/V	Flash guards / gaskets to electrical boxes.	B	Remove due to proposed demolition / refurbishment	In the event of removal the material must be removed by a competent contractor and disposed of to a licensed tip / transfer station under consignment.

Sample Details					
Sample No:		Visual Sample No: DSM/SCO/2596/B01/GRD/06/V		Similar To:	
Element: to electrical boxes.				Quantity: 1 box	
Location			Priority Rating	When Action Required	
Room Ref No:	Area	Floor			
G:02	Open area 2	Ground Floor			
			B	As soon as Practicable	
Priority Rating Details					
Material	Location	Condition	Exposed Population	Accessibility	Assessment Method
Woven product.	Internal	Fair - scratched marked surface	Workshop / Factory	Easily	Presumed
Asbestos Type		Encapsulation / Sealant			
Chrysotile (Serpentine) -		Sealed / reinforced			
Recommended Action	Remove due to proposed demolition / refurbish				
Inspection Schedule	Annually or directly after works that may disturb the material.				
Comments					
No sample was taken from the electrical box as it was presumed to be live at the time of the survey. It is assumed that the box contains asbestos unless there is strong evidence to the contrary.
