Health and Safety Tree Schedule & Works

Bedford Square (No. of Trees: 79)

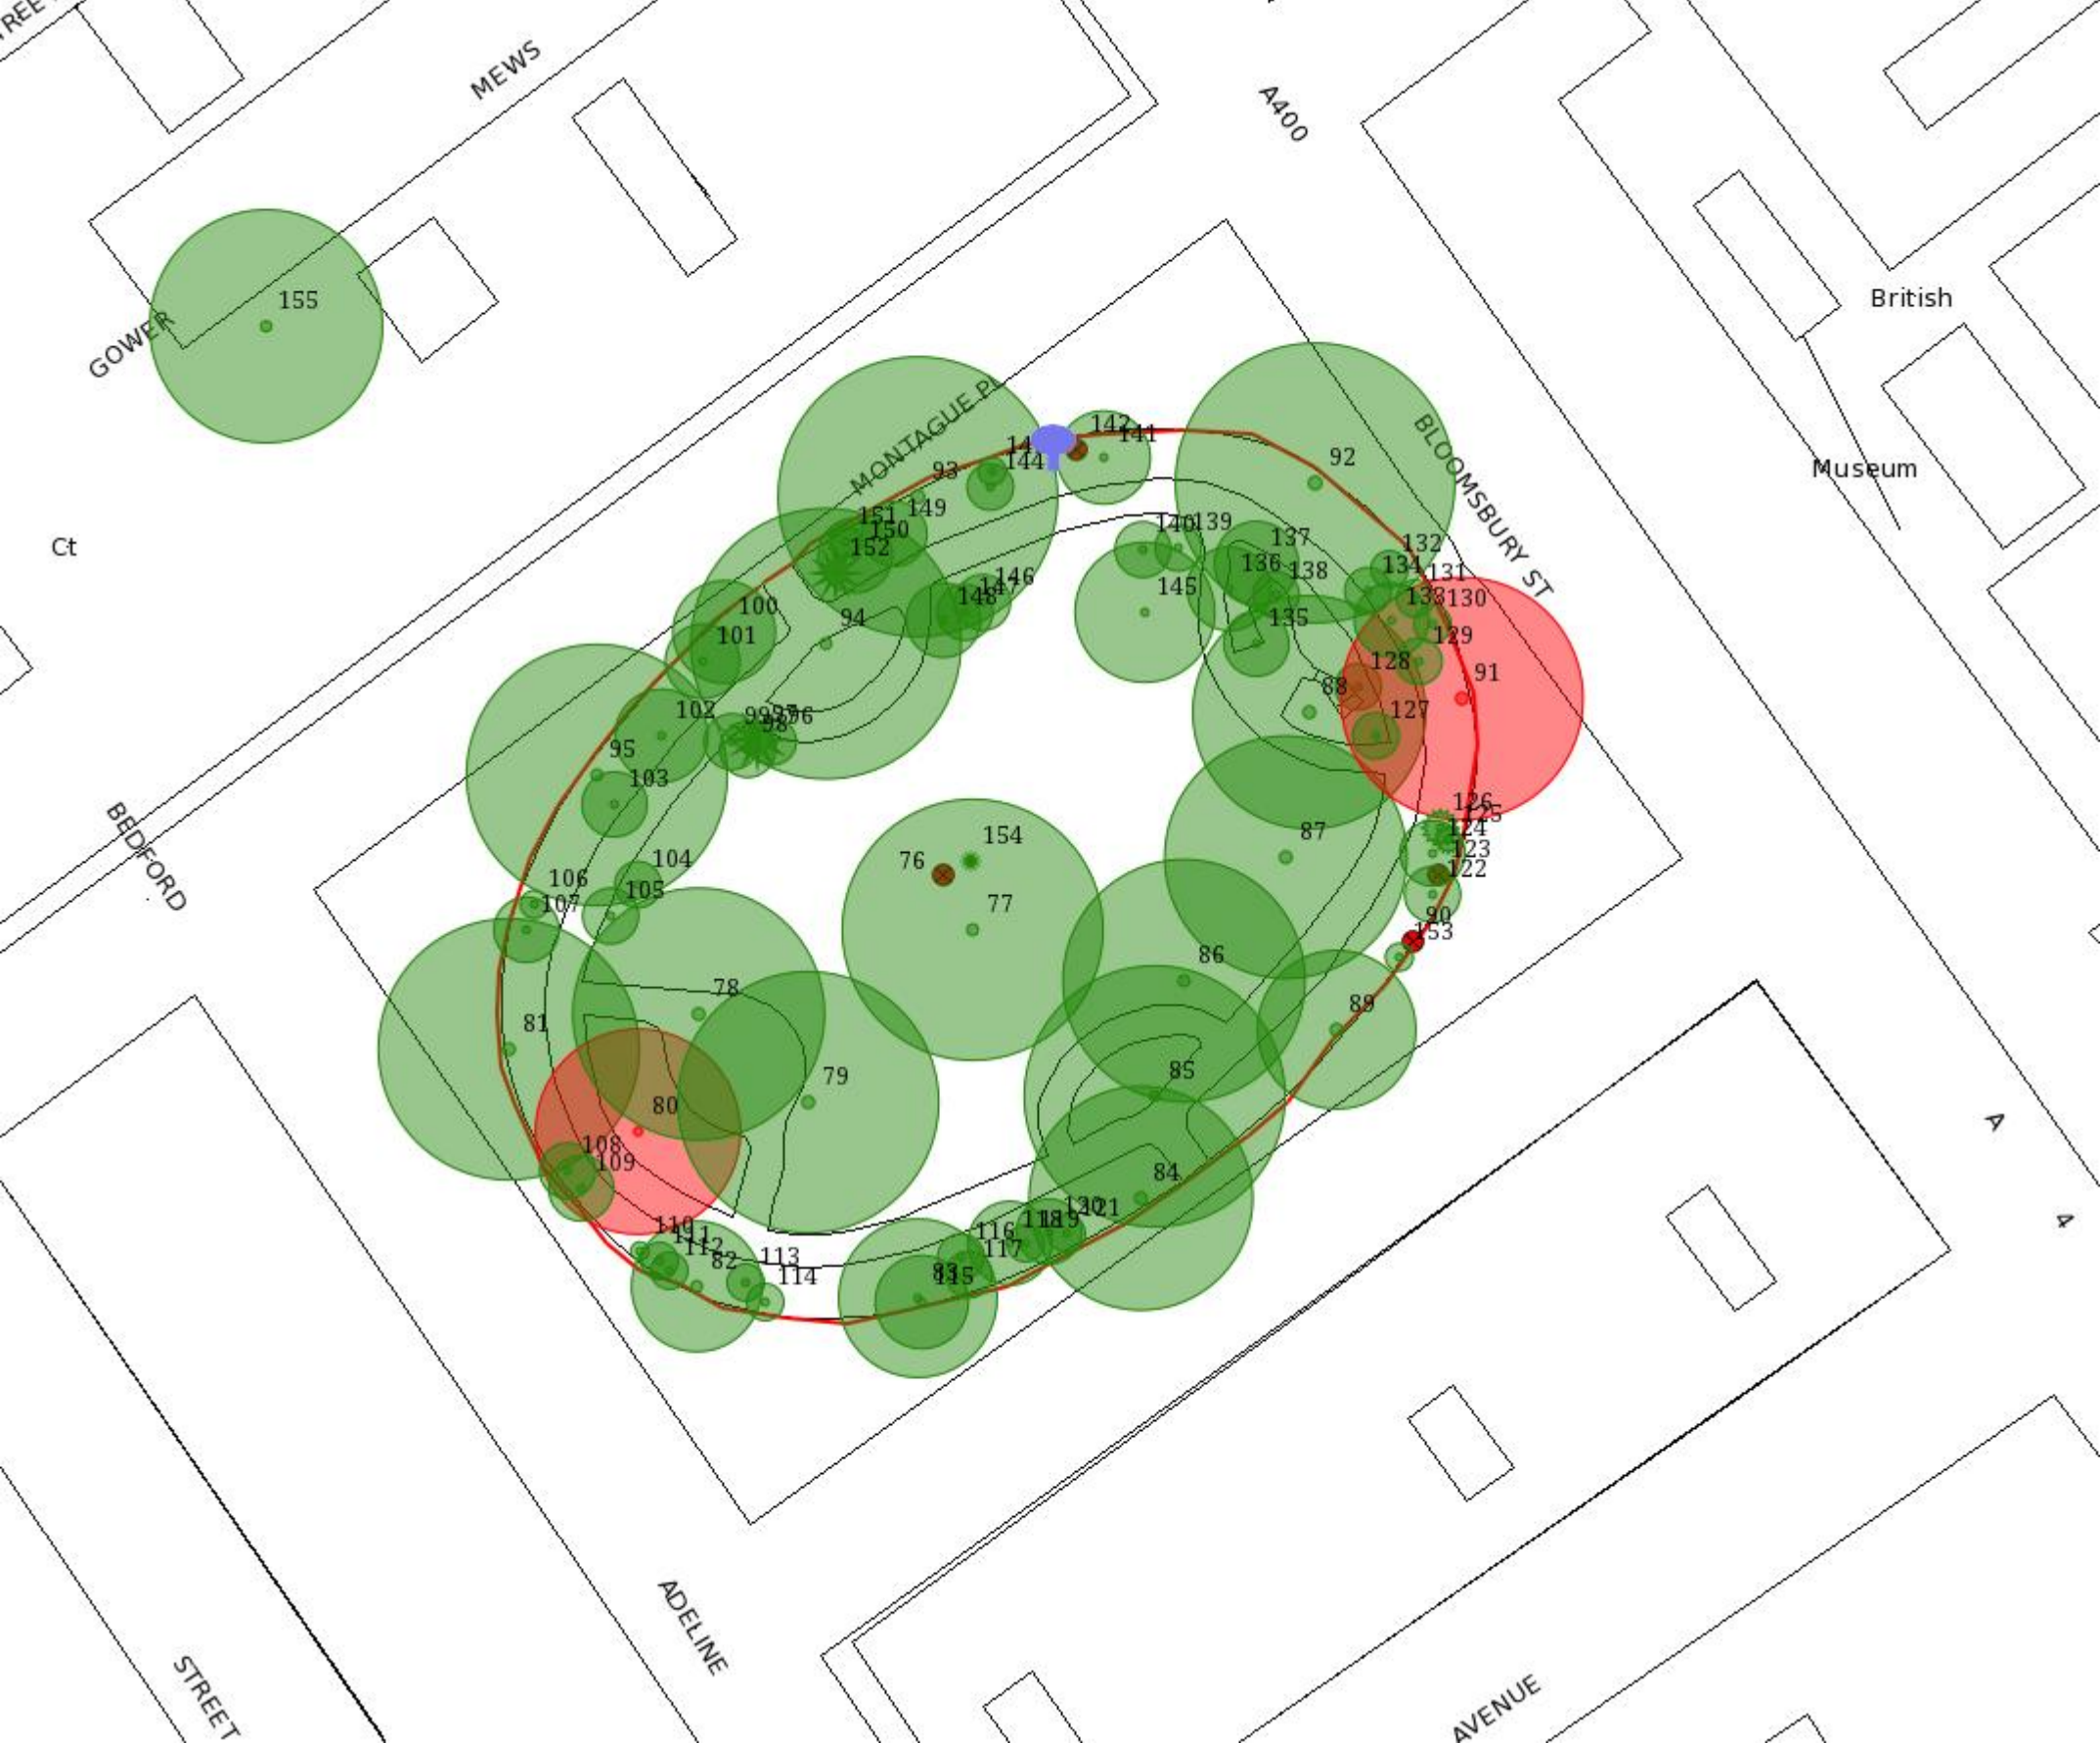
T91	1 Platanus x hispanica London Plane	12/02/20	30.0	135	26.0	Moderate	15	40-80 yrs	Mature	Fair	Fair	Footpath within crown spread. Street lamp within crown spread. Road within falling distance of tree. Seating area within crown spread.	7	323908.55	Deadwood - Minor. Epicormic growth - Base. Foreign object - Ingrown metal. Pruning wounds - Decayed. tree growing over railings Minor 'cauliflower' burring on stem and in crown Remove faulted limb / limbs damaged branch at approximately 18m north east over highway - branch decayed on upper side near junction with parent stem
