CCTV Survey

**60-89 ROYAL COLLEGE STREET
CAMDEN
LONDON
NW1 0TH**

**REPORT ON THE IDENTIFICATION, TRACING
MAPPING & CCTV SURVEY OF THE
DRAINAGE OUTFALL FROM SITE**

NOVEMBER 2019

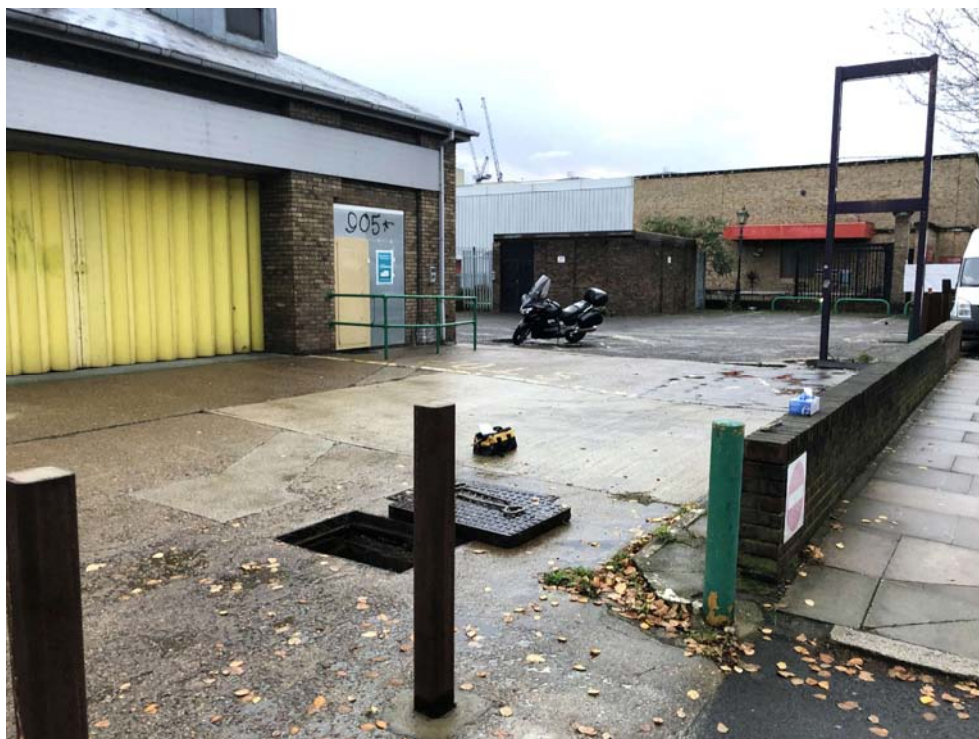
LOCATION:	Comments:
1.	GROUND LEVEL, NORTHERN FORECOURT AREA	General view of site looking south Note: MH1 with cover removed
2.	GROUND LEVEL, NORTHERN FORECOURT AREA	General view of site looking north Note: MH1 with cover removed

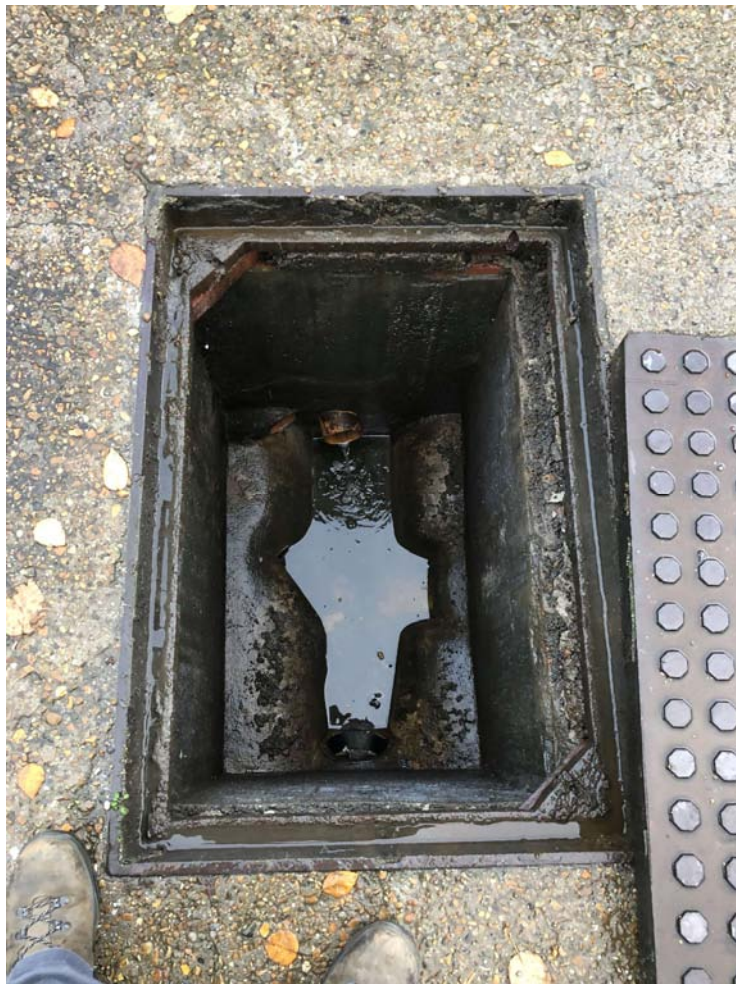
The interceptor trap within MH1 was found to be blocked, this was cleared manually to allow continuation of survey.

3.	GROUND LEVEL, NORTHERN FORECOURT AREA	Internal view of MH1 – looking upstream Note: interceptor trap is blocked, with flow via rodding eye
4.	GROUND LEVEL, NORTHERN FORECOURT AREA	Internal view of MH1 – looking downstream Note: interceptor trap is blocked, with flow via rodding eye

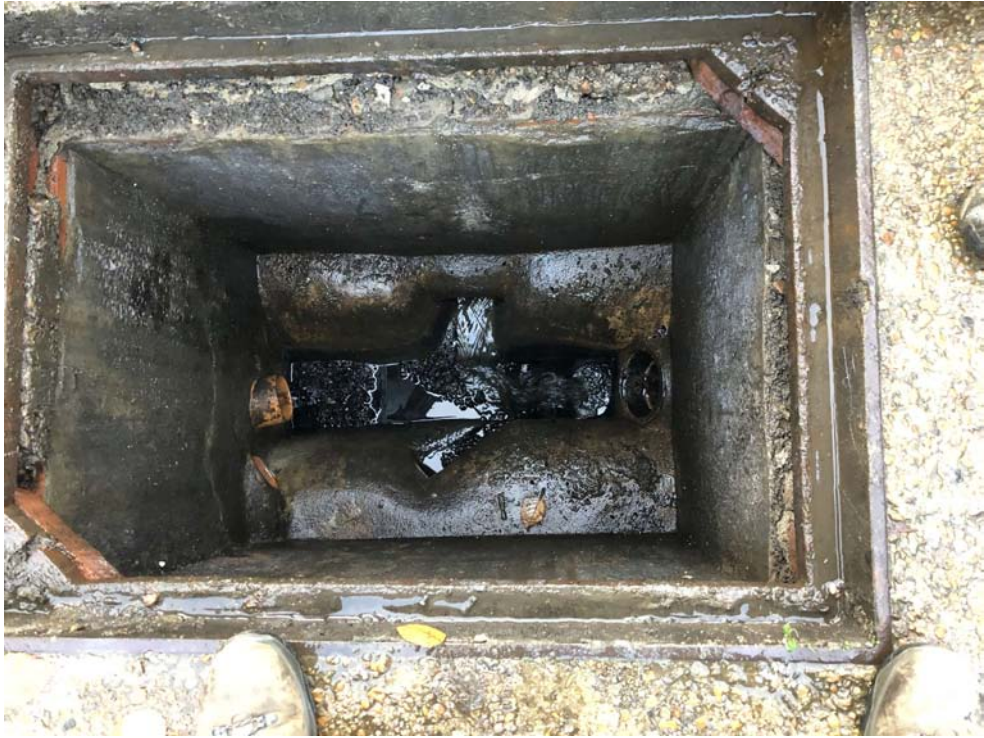
5.	GROUND LEVEL, NORTHERN FORECOURT AREA	Internal view of MH1 with interceptor trap unblocked
6.	GROUND LEVEL, NORTHERN FORECOURT AREA	Internal view of MH1 with interceptor trap unblocked

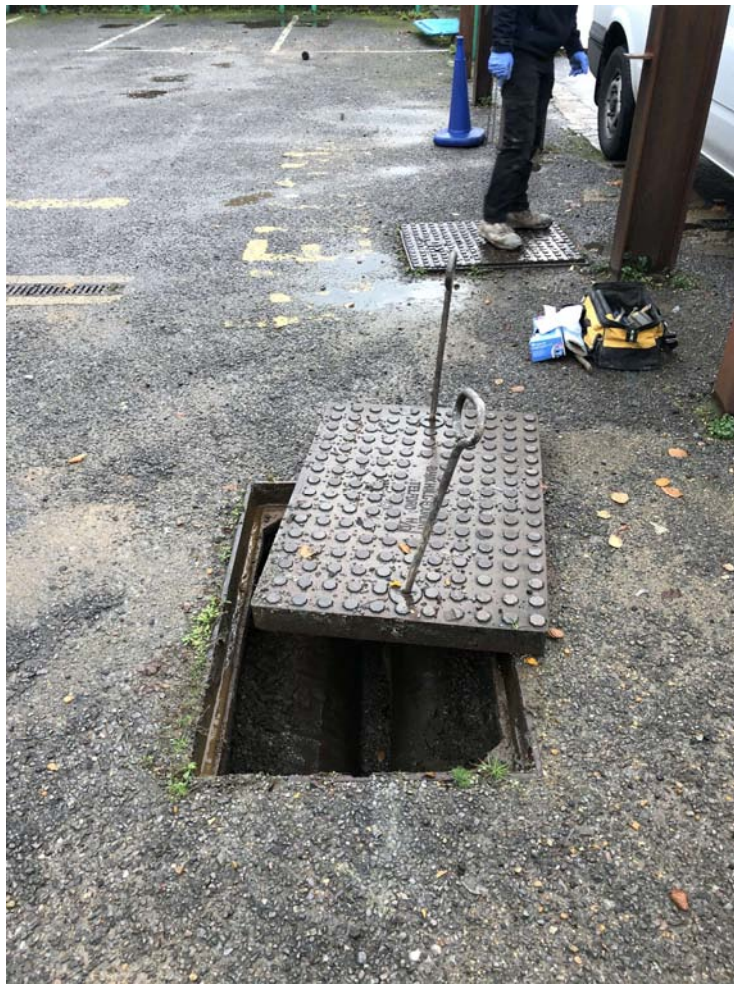
7.	GROUND LEVEL, SOUTHERN FORECOURT AREA	Location view of MH2
8.	GROUND LEVEL, SOUTHERN FORECOURT AREA	Internal view of MH2 note; debris in channel
9.	GROUND LEVEL, NORTHERN FORECOURT AREA	Internal view of MH4 note; debris in channel

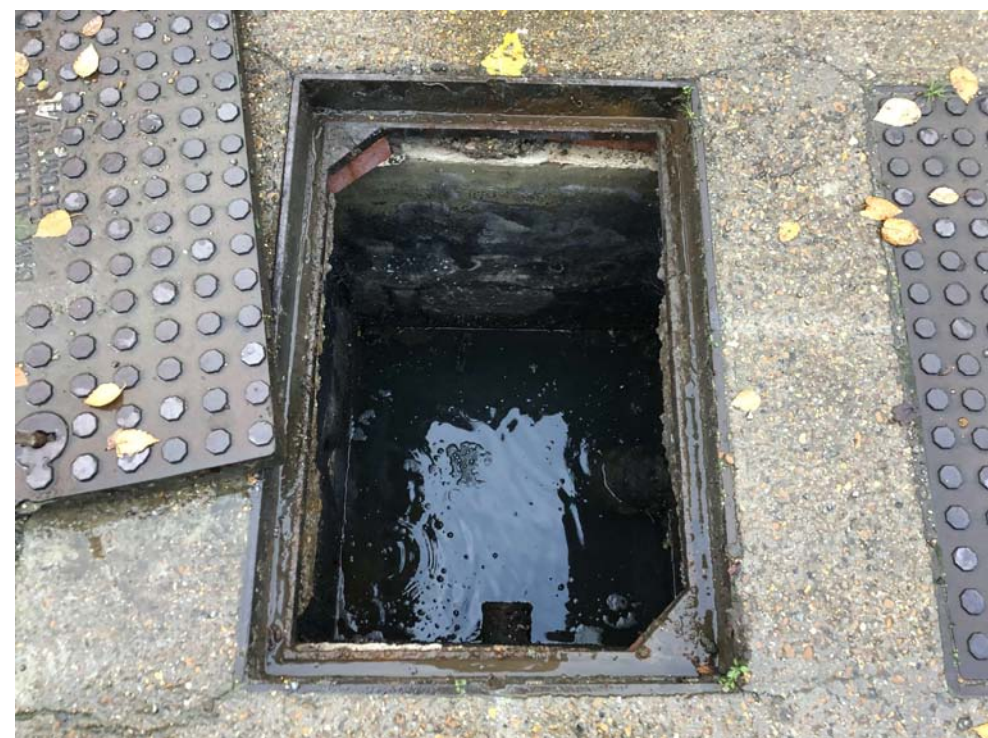
10.	GROUND LEVEL, NORTHERN FORECOURT AREA	View of Petrol/Oil interceptor
11.	GROUND LEVEL, NORTHERN FORECOURT AREA	Internal view of Petrol/Oil interceptor

The petrol/oil interceptor (PI) should be drained, washed down and cleaned out, with the waste removed for disposal by a certified waste handler. The interceptor vent pipes should be checked to ensure they have a clear bore.

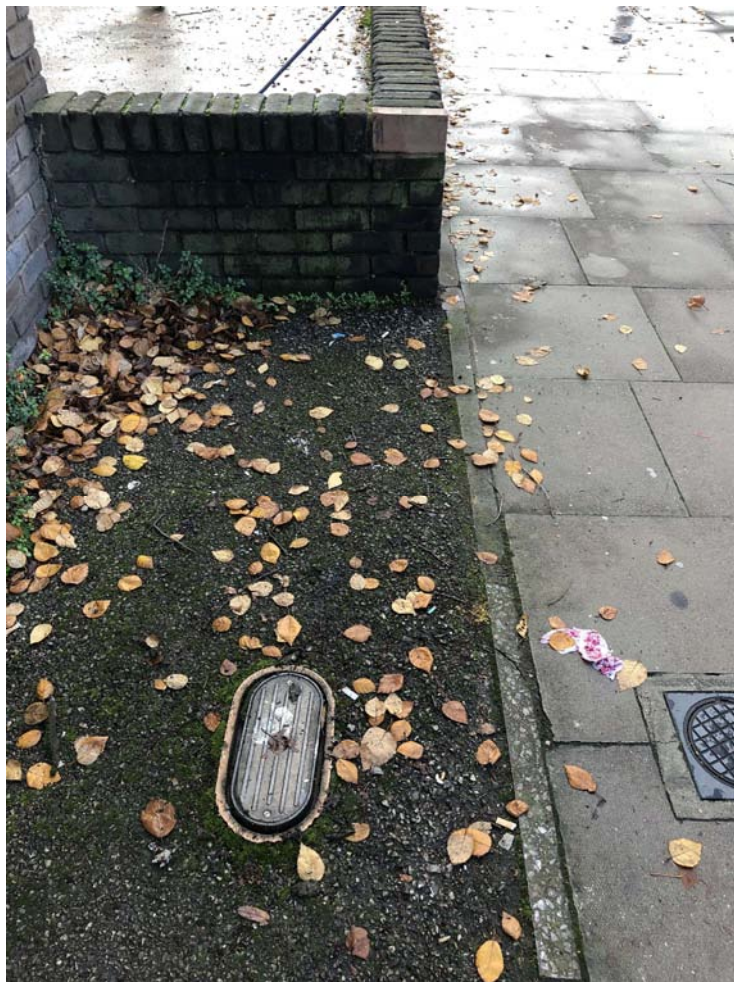
12.	GROUND LEVEL, FOOTPATH	Location view of rodding eye No.1 (RE1)
13.	GROUND LEVEL, CLOSE TO NORTHERN VEHICLE ACCESS	Location view of rodding eye No.1 (RE2)

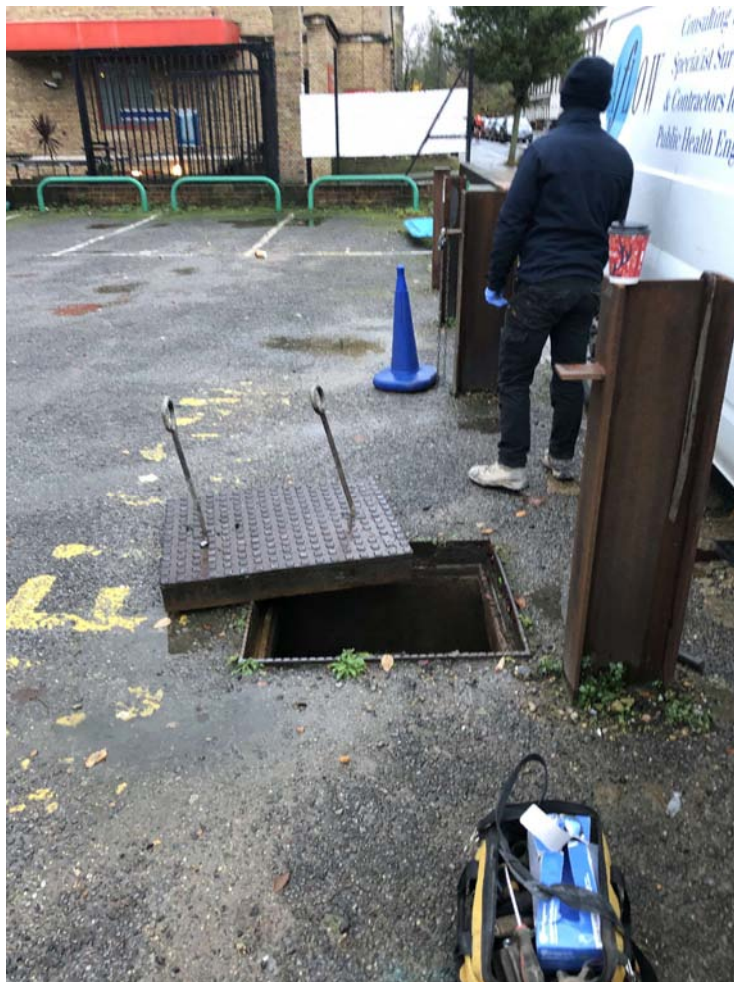
14.	GROUND LEVEL, SOUTHERN VEHICULAR ACCESS	Location view of assumed incoming water main access cover
15.	GROUND LEVEL, SOUTHERN VEHICULAR ACCESS	Internal view of assumed incoming water main
